**US Army Corps  
of Engineers** ®  
Honolulu District

## **Appendix C**

American Samoa Final Watershed Plan

# **Engineering Analysis**

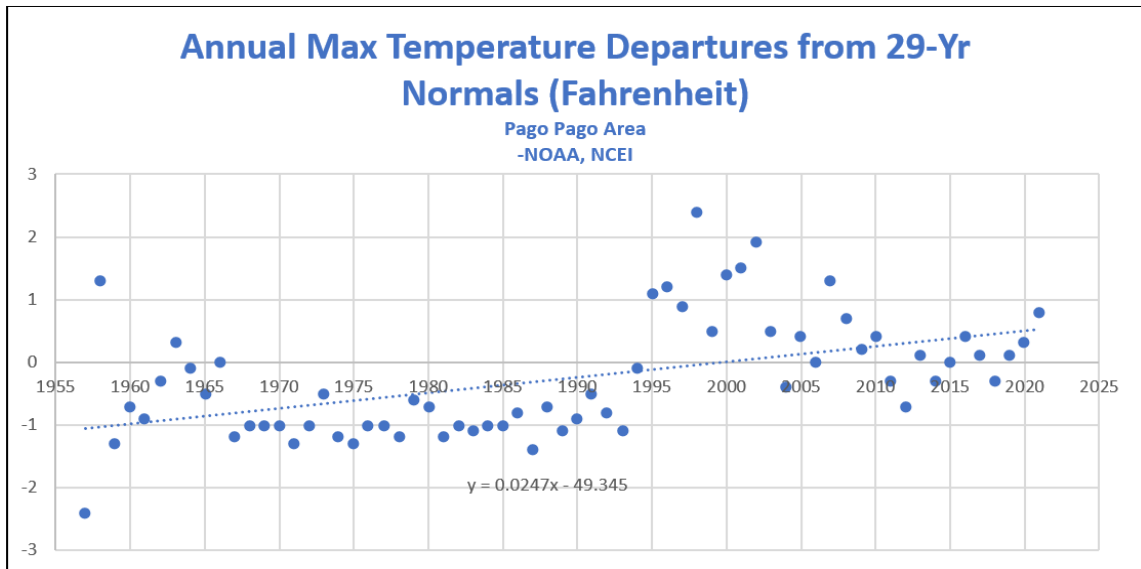
Figure 4. Pago Pago Annual Maximum Temperature Departures from Normals

The territory of American Samoa lies roughly 14 degrees south of the equator and 170 degrees west longitude, east of the Pacific date line in the Central South Pacific. Due to the location in the tropics, relatively small seasonal variations in annual air temperature exist in the region. Only 2 to 6 degrees Fahrenheit difference exists between the warmest and coolest months. The wet season in American Samoa is generally December through March, however, 300 days of the year rainfall is recorded. Trace precipitation occurs 300 days a year with rainfall exceeding 0.10 inches 175 days a year. Rainfall averages are between 125 and 250 inches per year and are seasonally and locality dependent. Humidity ranges between 73 to 84% (NOAA, 2013). Annual temperature averages have increased by 3 degrees Fahrenheit between 1957 and 2017 (USACE, 2020) and annual maximum temperatures have departed from 29-year normals (1991-2020) by roughly 0.5 degrees Fahrenheit (NOAA, NCEI) and are illustrated in Figure 4.

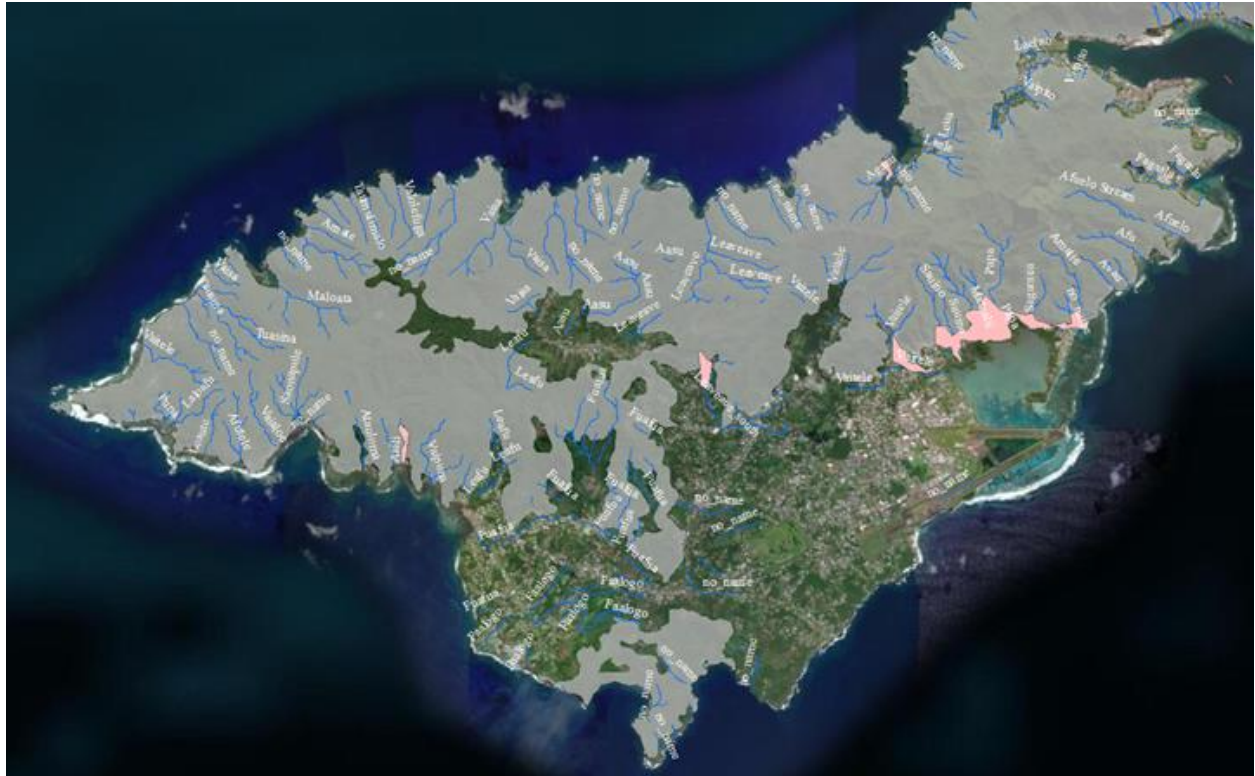
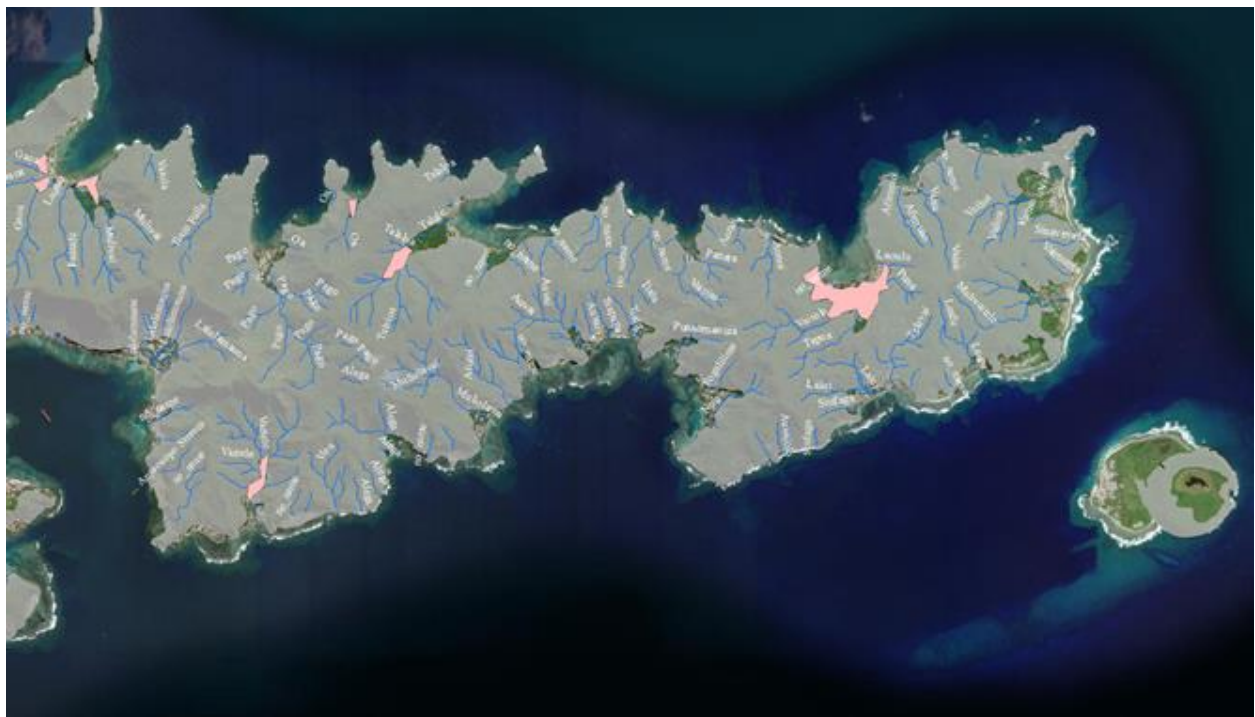
Figure 21 and Figure 22 illustrate Natural Resource Conservation Service's soil erodibility data for Tutuila and Aunu'u due to steep slope (greater than 30%, indicated in grey), and moderately erodible soil factors (indicated in pink). Steep slopes experiencing heavy rainfall can lead to erosion, however, regions with erodible soils on steep slopes exacerbate soil loss.

The two soil groups most erodible in Tutuila are the Leafu stony silty clay and Aua stony silty clay. Table 2. Locations with Moderate Erodibility in Tutuila lists locations with moderately erodible soils, their soil name, and impacted stream. Tutuila is prone to erosion island wide, owing to steeply sloping terrain, however areas categorized with erodible soil types are listed for focus. The list is not intended to replace a comprehensive survey of conditions.

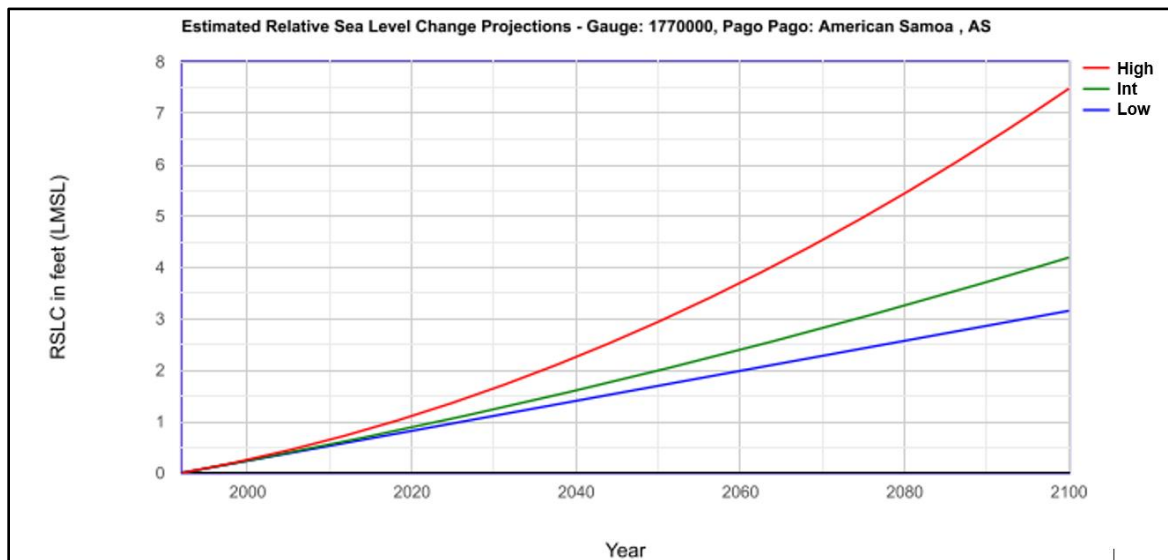
Figure 25. Relative Sea Level Change - American Samoa

Figure 25 illustrates the high, intermediate, and low relative sea level change estimates at the Pago Pago NOAA gauge (ER 1100-2-8162) utilizing the SLC rate previously discussed. This study relies on the high curve (shown in red) which is in alignment with territory and other agency projections for SLC. The USACE Sea Level Change Calculator utilized provides a way to visualize USACE and other authoritative SLC scenarios for any tide gauge that is part of the NOAA National Water Level Observation Network. The calculator includes inputs on the unique local sea level change rate that accounts for subsidence and estimates between 2.4 and 4.6 feet of relative sea level rise in American Samoa by 2070 and 3.1 to 7.5 feet by 2100 on the low and high curve, respectively. In addition, a rise of 3 feet within the next 30 years is highly consequential. Figure 26 shows the relative sea level change overlaid with historical mean sea level measurements.

An analysis of existing coastal flooding from cyclone and storm surge for existing and future conditions was performed using Department of Homeland Security (DHS), HURREVAC inundation data and NOAA SLC data respectively. Future conditions evaluate conditions through the year 2072 and utilize the high RSLC curve projections (Figure 25).

Future conditions mapping included the USACE 2070 projected RSLC high curve values have been added to existing HURREVAC MOM inundation water surface values. As Figure 25 illustrates, the RSLC for future conditions in 2070 is estimated to be approximately 4.6 feet. However, the NOAA SLC raster data are only available in integer values, therefore the inundation maps for five feet were selected for presentation and comparison. Although this 0.4-foot difference is insignificant relative to the uncertainty of SLC and based on the exponential subsidence and SLC conditions
