PRELIMINARY ASSESSMENT

Makalapa Crater Navy Salvage Yard

Halawa, District of Ewa, Island of Oahu, HI

Final – 30 June 2016

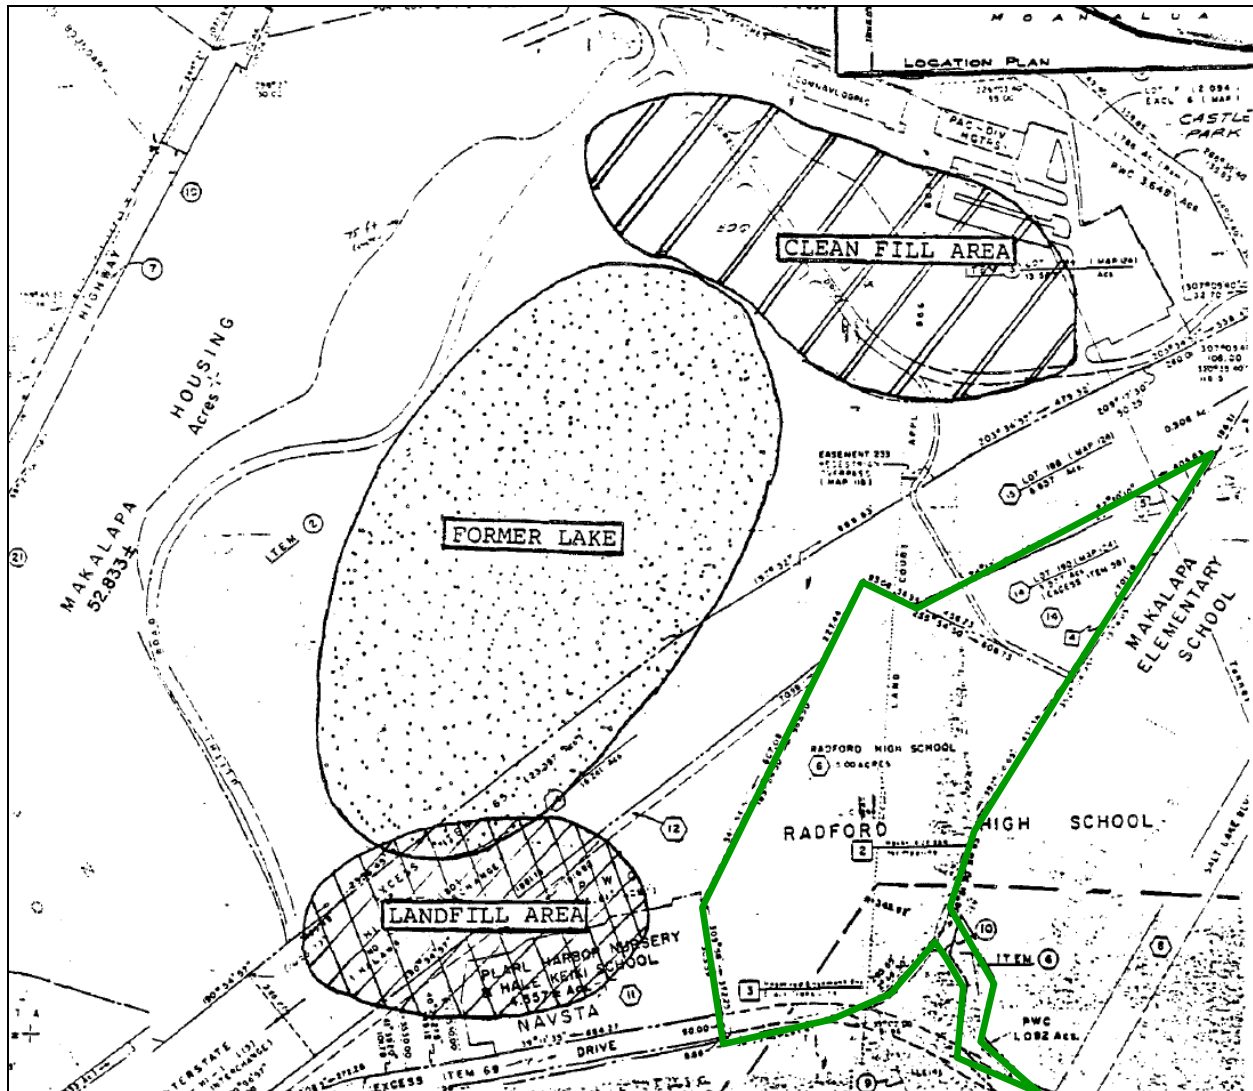
the Navy disposed of damaged equipment such as metal scrap, empty ammunition casings as well as engine, ship and airplane parts in the crater. In the 1940s, the Navy installed drains in the crater to release collecting water. Interviewees reported that in the late 1950s and the early 1960s, the Navy disposed of general wastes for approximately five years in a Landfill Area on the south side of the crater on land currently occupied by the Instate highway H-1 and the Navy Hale Keiki School (see following figure). During construction of H-1, a great deal of WWII era metal debris was encountered and removed. From 1972 to 1976 the Navy allowed contractors to develop a clean fill area with non-combustible materials such as rock, asphalt, and concrete. The Navy's Public Works Center (PWC) issued licenses to contractors (including Tajiri Lumber Ltd.; Teval Corporation; Maitland Brothers, Co.; Richard H.S. Lee and E.E. Black) for use of this Landfill Area during this period and documentation is included in Appendix C of the IAS. The identified clean fill area was on the north side of the crater (see following figure). As no hazardous waste was specifically reported to have been disposed, the IAS concluded that no threat to human health or the environment existed at Site 1 and did not recommend a confirmation study.

Figure 1 – IAS Site 1 - Makalapa Crater with Landfill Areas⁶

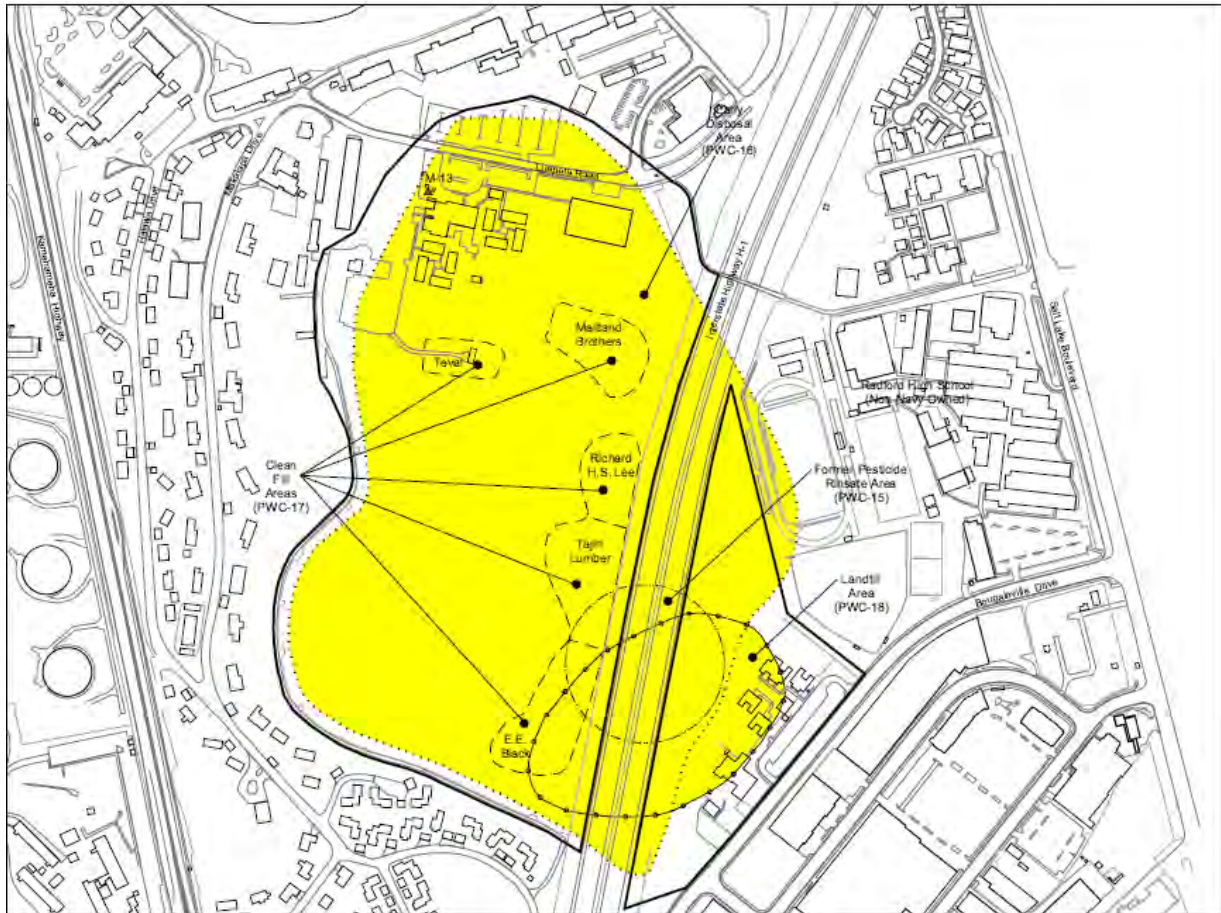
In 2002, the Pacific Division of the Naval Facilities Engineering Command (NAVFAC) completed a Site Summary Report (SSR) for the Makalapa Geographic Study Area (GSA). The SSR outlines 40 existing and demolished facilities within the Makalapa Crater GSA including fuel storage facilities, hazardous materials/hazardous waste management sites, IR program sites, lead disposal/release sites, and transformers. Of these 40 facilities or sites within the GSA, the SSR recommends no further action for 35 of them. The five remaining sites include: Transformer M-13, Clean Fill Area, Early Disposal Area, Pesticide Rinseate Area, and Landfill Area (see following figure; the red

triangle in the top left corner represents Transformer M-13 and the other areas are labeled). Transformer M-13 is a Pad-mounted Transformer outside buildings 373-380 (Bachelor Officer's Quarters), about 1,500 feet away from the subject FUDS and not considered potentially relevant to the FUDS.

Figure 5 – SSR Areas recommended for further action at Makalapa Crater GSA¹⁴

At the Clean Fill Area, samples indicated that mercury and lead may have been released to shallow soils in the area. Sampling also showed elevated concentrations of arsenic and beryllium. However, the report claims that these elevated levels likely result from background conditions at the site. The SSR claims that no immediate threat to human or environmental health exists in the Clean Fill Area; however, the SSR recommends further action and sampling in this area.

The SSR found that the Early Disposal Area remained enclosed by fences and vegetated. Sampling revealed elevated levels of metals (i.e., arsenic, beryllium, lead, mercury) in the

soil but concluded that no potential threat exists from direct exposure to soils in this area. The SSR recommends additional soil sampling and removal action for this site.

At the Former Pesticide Rinse Area, the SSR contractor conducted testing for pesticides and herbicides, finding that the pesticides and herbicides tested for in this area remained in concentrations below the laboratory limit. The SSR recommends no further action regarding hydrocarbon contamination in the area and concludes that no immediate threat to Navy Hale Keiki School or the environment exists in the area. Accordingly, the SSR recommends no further action within the Former Pesticide Rinse Area except as part of the Landfill Area (which overlaps with the Former Pesticide Rinse Area).

In regard to the Landfill Area, the SSR reports that waste oil and solvents disposed of in this area are a concern. The SSR notes that arsenic and beryllium were found at elevated levels in this area; however it asserts that these represented the site's background character. Sampling also indicated elevated levels of TPH as diesel fuel in the oil. The SSR claims that a comparison with the appropriate action levels and background character suggests that the site presents no immediate threat to the school or environment from any of the identified contaminants. The SSR recommends additional sampling for Total Petroleum Hydrocarbons (TPH), Volatile Organic Compounds (VOCs), Semivolatile Organic Compounds (SVOCs), and Polynuclear Aromatic Hydrocarbons (PAHs) in the Landfill area to further examine hydrocarbon contamination.

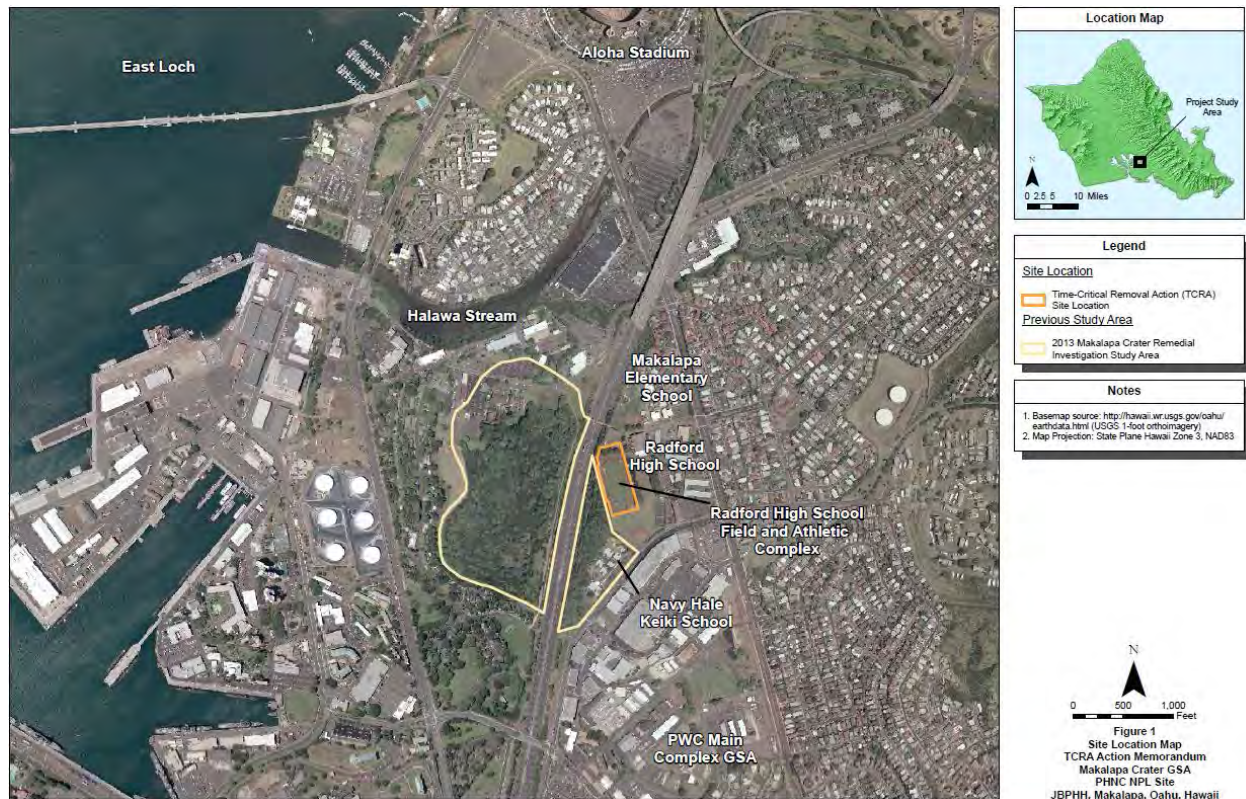
The TCRA objectives were to remove contaminated soil within the construction footprint at the RHS field and athletic complex (see following figure) to depths that will allow the DOE to resume construction work safely; to remove contaminated soil from the two outlying sites; to screen the excavated debris for material potentially presenting an explosive hazard (MPPEH); to properly address any MEC identified with support of EOD; and to properly dispose of the excavated soil and debris.

Figure 10 – TCRA Site Location and 2013 Makalapa Crater RI Study Area²⁴

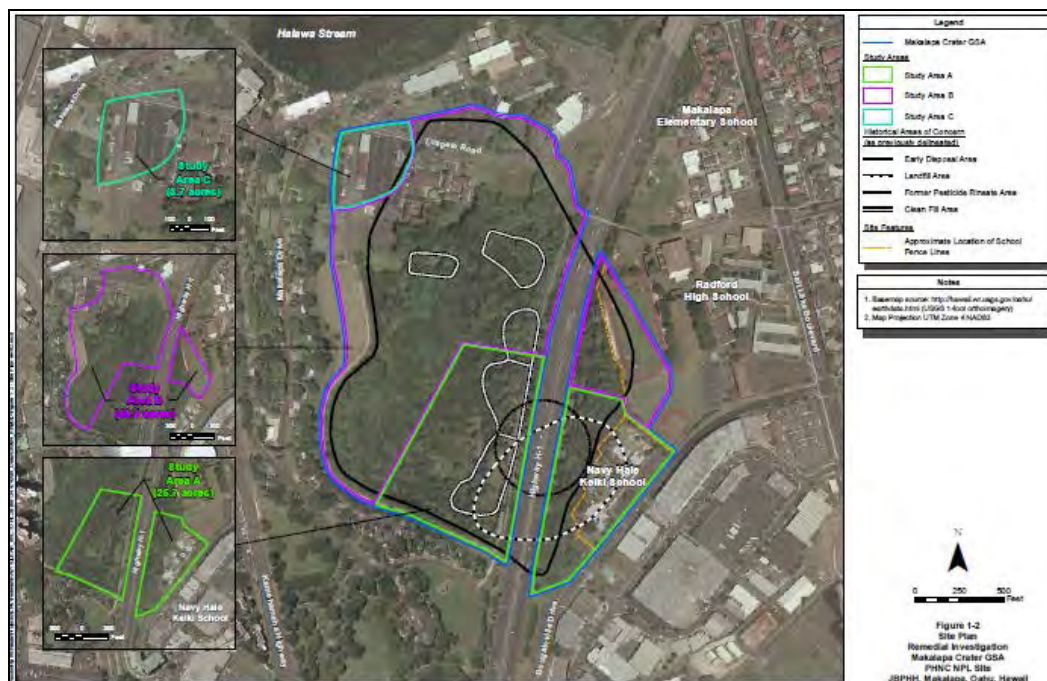
- Study Area A - portions of the Early Disposal Area and Clean Fill Area, all of the Former Pesticide Rinsate and Landfill Areas, and all of the grounds of the Navy Hale Keiki School (NHKS) and former Child Development Center (CDC);
- Study Area B - portions of the Early Disposal Area and the Clean Fill Areas; and
- Study Area C - the northwest corner of the Early Disposal Area.

Figure 11 – Makalapa Crater RI Study Areas - 2015²⁶

Although the contaminant source identified for Study Area C is the same as the principal source identified for Study Area B (the Early Disposal Area dredge spoils), the area was identified as a distinct Study Area because MEC associated with dredge spoils discharged from a hydraulic dredge pipe outfall may have been deposited in this area.

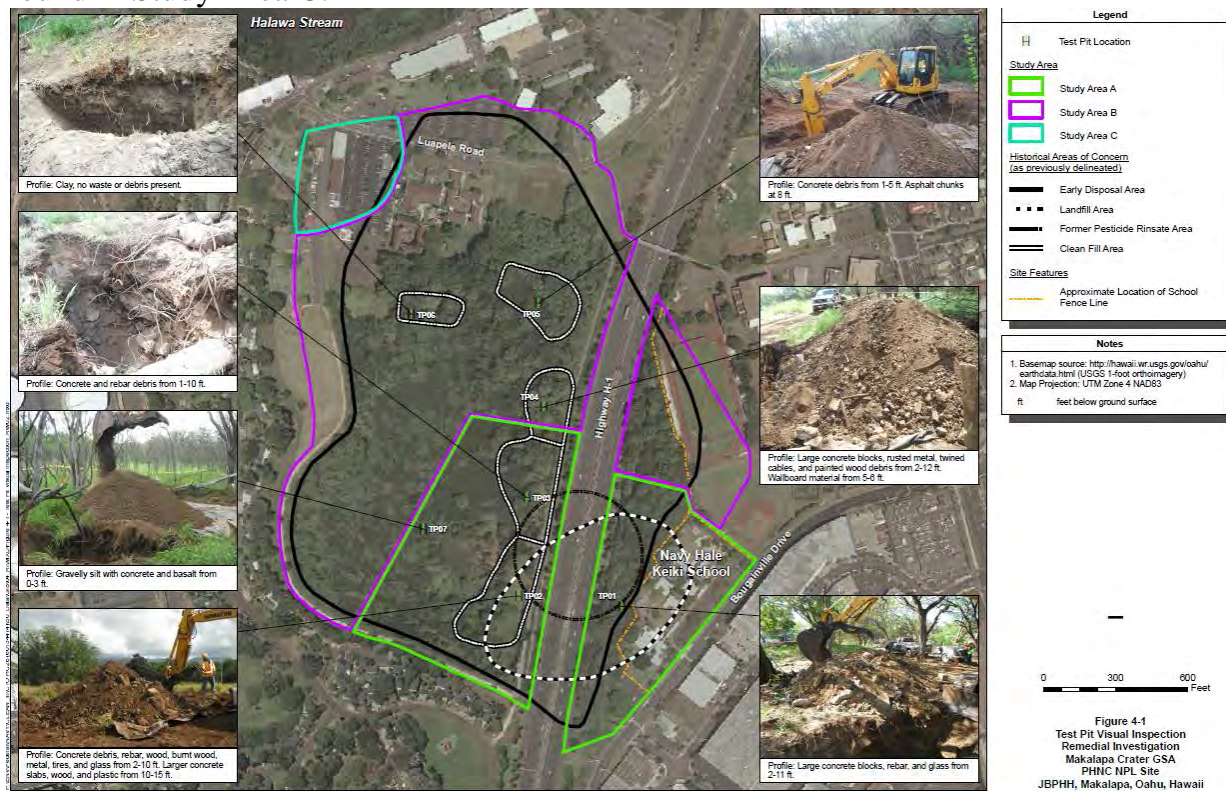
While Makalapa Crater GSA Study Area B extends into and includes a significant portion of the RHS athletic fields as outlined in purple (see previous and following figures), it did not include test pits or sample locations as part of the RI (see following two figures). RI field observations of the surface and subsurface conditions at the site confirm the presence of the dredge spoils underlying the site and the prevalence of construction and demolition debris at the test pit locations. The RI did not find municipal wastes as expected within the Landfill Area, with the exception of evidence petroleum hydrocarbons in the subsurface soils and soil gas. Anomalies related to MEC were not found in Study Area C.

Figure 12 – Makalapa Crater RI - Test Pit Visual Inspections - 2015²⁷

Based on the results of the RI, the report concluded that “unrestricted land use/unlimited exposure (no further action) may not be appropriate for the Makalapa Crater GSA.” The RI recommended a feasibility study (FS) to evaluate remedial alternatives for the GSA.

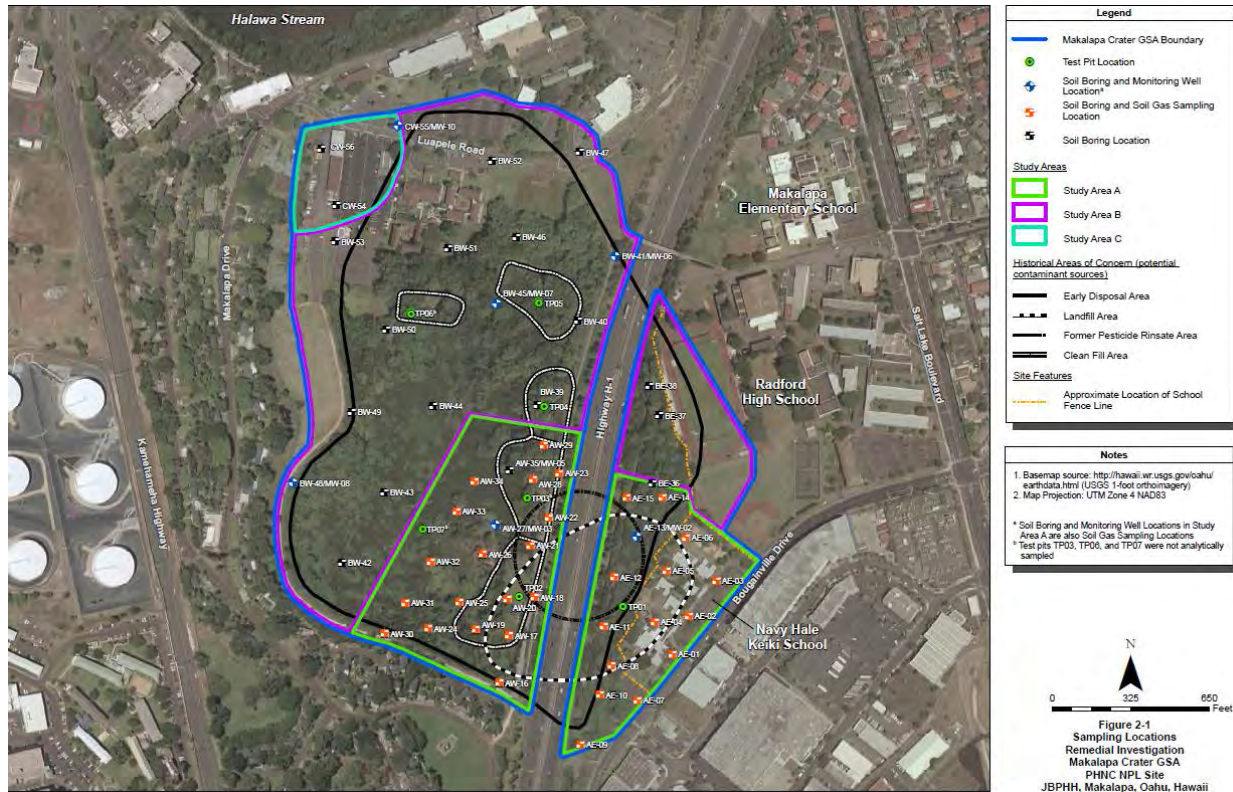
Figure 13 – Makalapa Crater RI – Sampling Locations - 2015²⁸

RI results confirmed that Contaminants of Potential Concern (COPCs) including volatile organic compounds (VOCs), polycyclic aromatic hydrocarbons (PAHs), polychlorinated biphenyls (PCBs), pesticides, dioxins, and metals occur at concentrations exceeding the protection action levels (PALs) in surface and subsurface soil in some areas of the crater. Metals were the only COPCs detected in groundwater at concentrations exceeding the PALs. Furthermore, the distribution of VOCs in the subsurface soil and soil gas indicates that contamination is most likely attributable to a source located east of the Makalapa Crater GSA (e.g., commercial/industrial area east of the property).

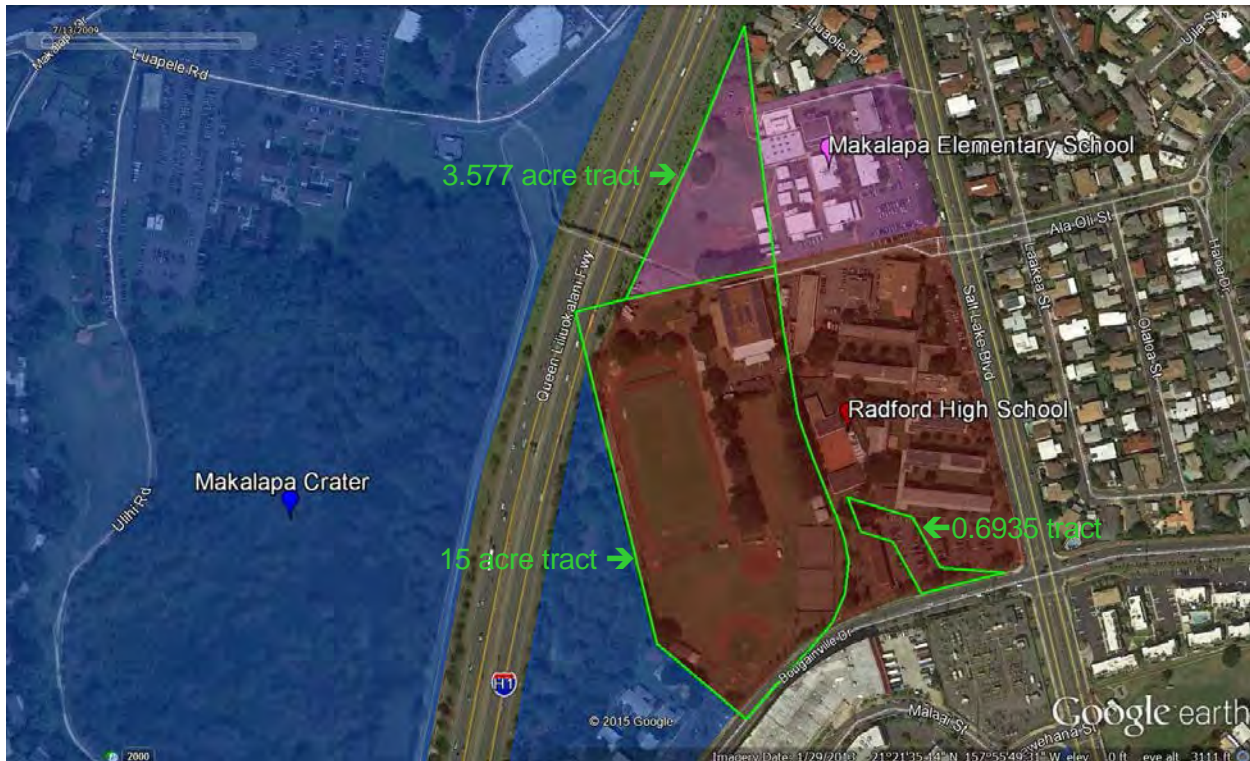
Figure 15 – Makalapa Crater Navy Salvage Yard Property Map – 1 January 2013

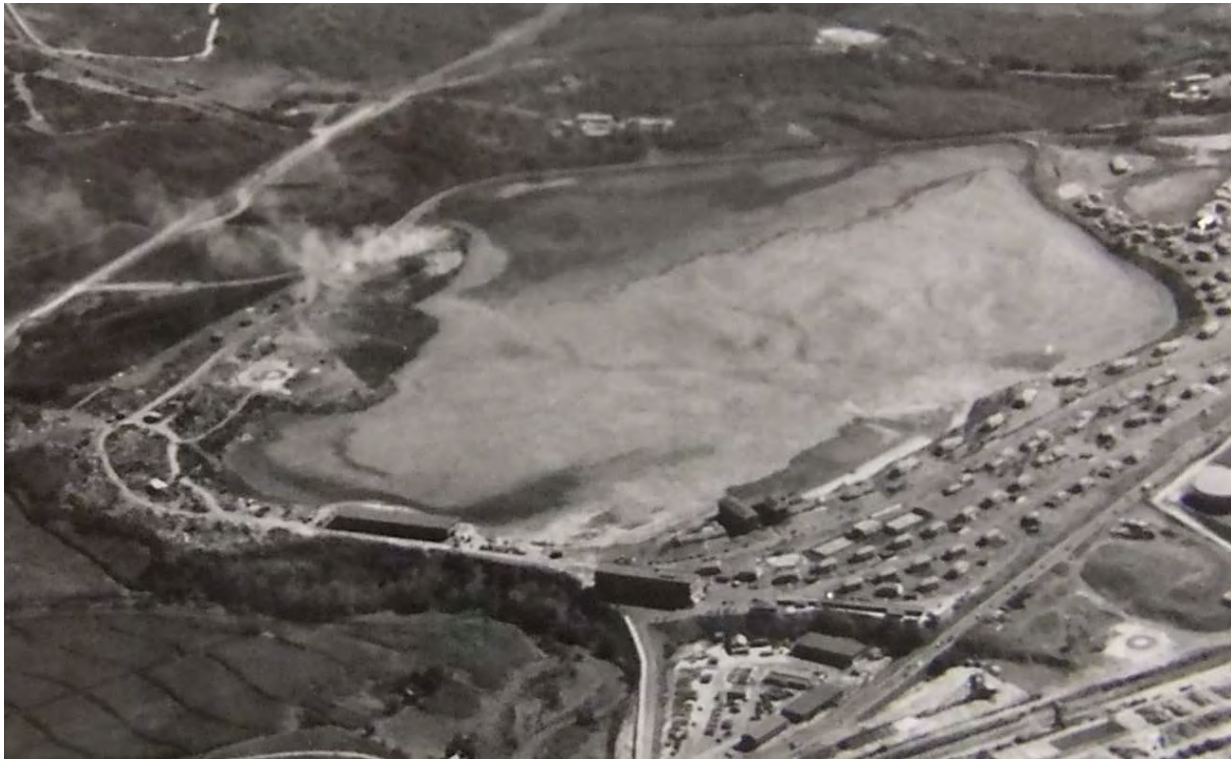
Figure 27 – Oblique Aerial of Makalapa Crater looking south-southeast - 12 December 1943⁹⁴

Note: smoke from debris burning on east side of crater

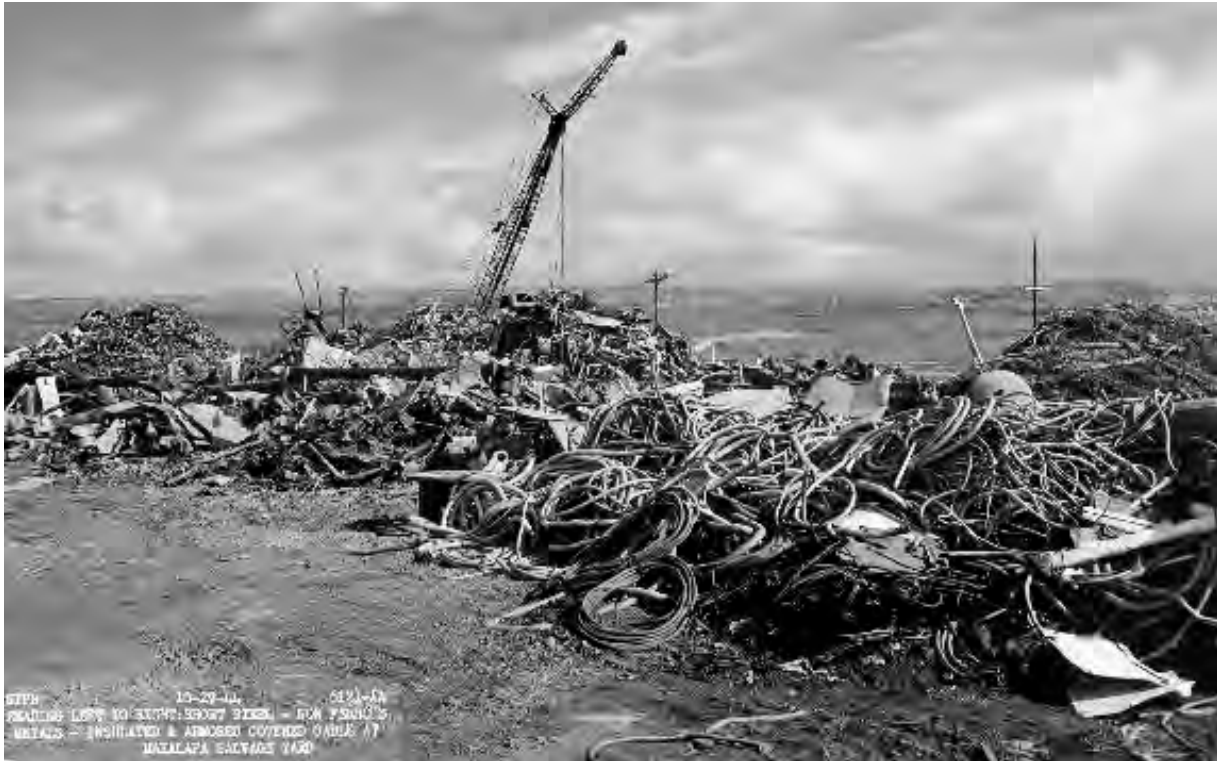
Figure 28 – Short Steel in Makalapa Salvage Yard - 29 October 1944¹⁰¹

By August 1944, reduced demand for scrap on the mainland resulted in scrap accumulation at Makalapa, to the point that the Navy Yard Commander requested the Army and its various posts "to discontinue the dumping of all kinds of scrap at Makalapa" but posing "no objection to the Army's continuing to take away metal and lumber scrap from the dump as at present." The Army agreed to this.¹⁰⁰

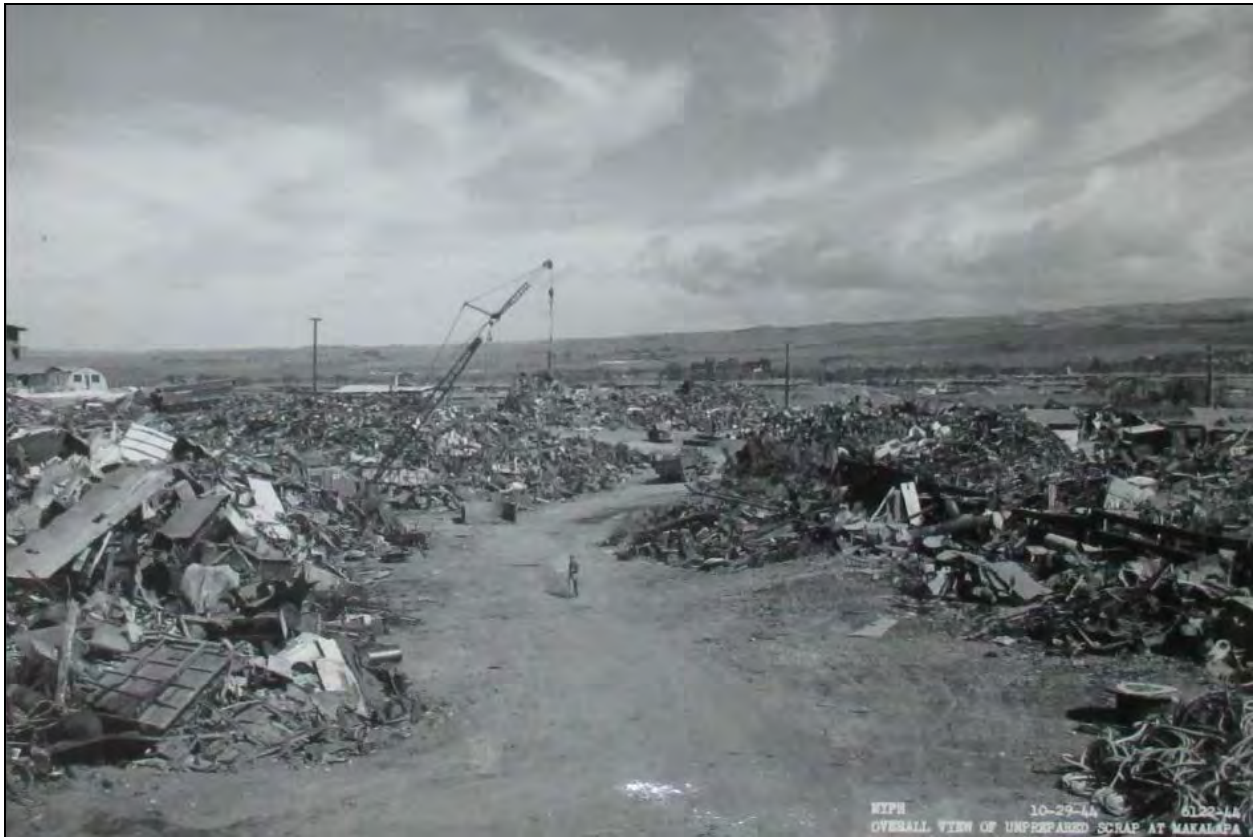
Figure 30 – Unprepared Scrap at Makalapa Salvage Yard – 29 October 1944¹⁰⁶

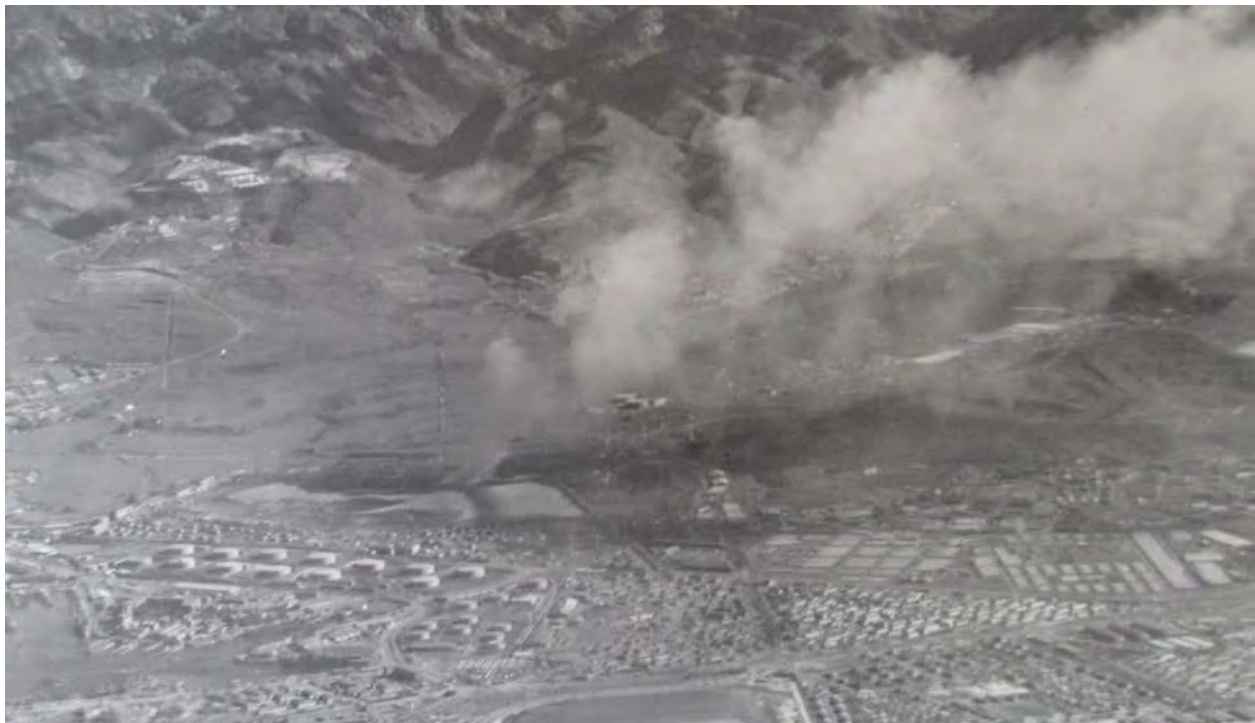
Figure 32 – Oblique Aerial of Makalapa Crater looking northeast - 29 December 1944¹⁰⁹
Note: smoke from debris burning on east side of crater

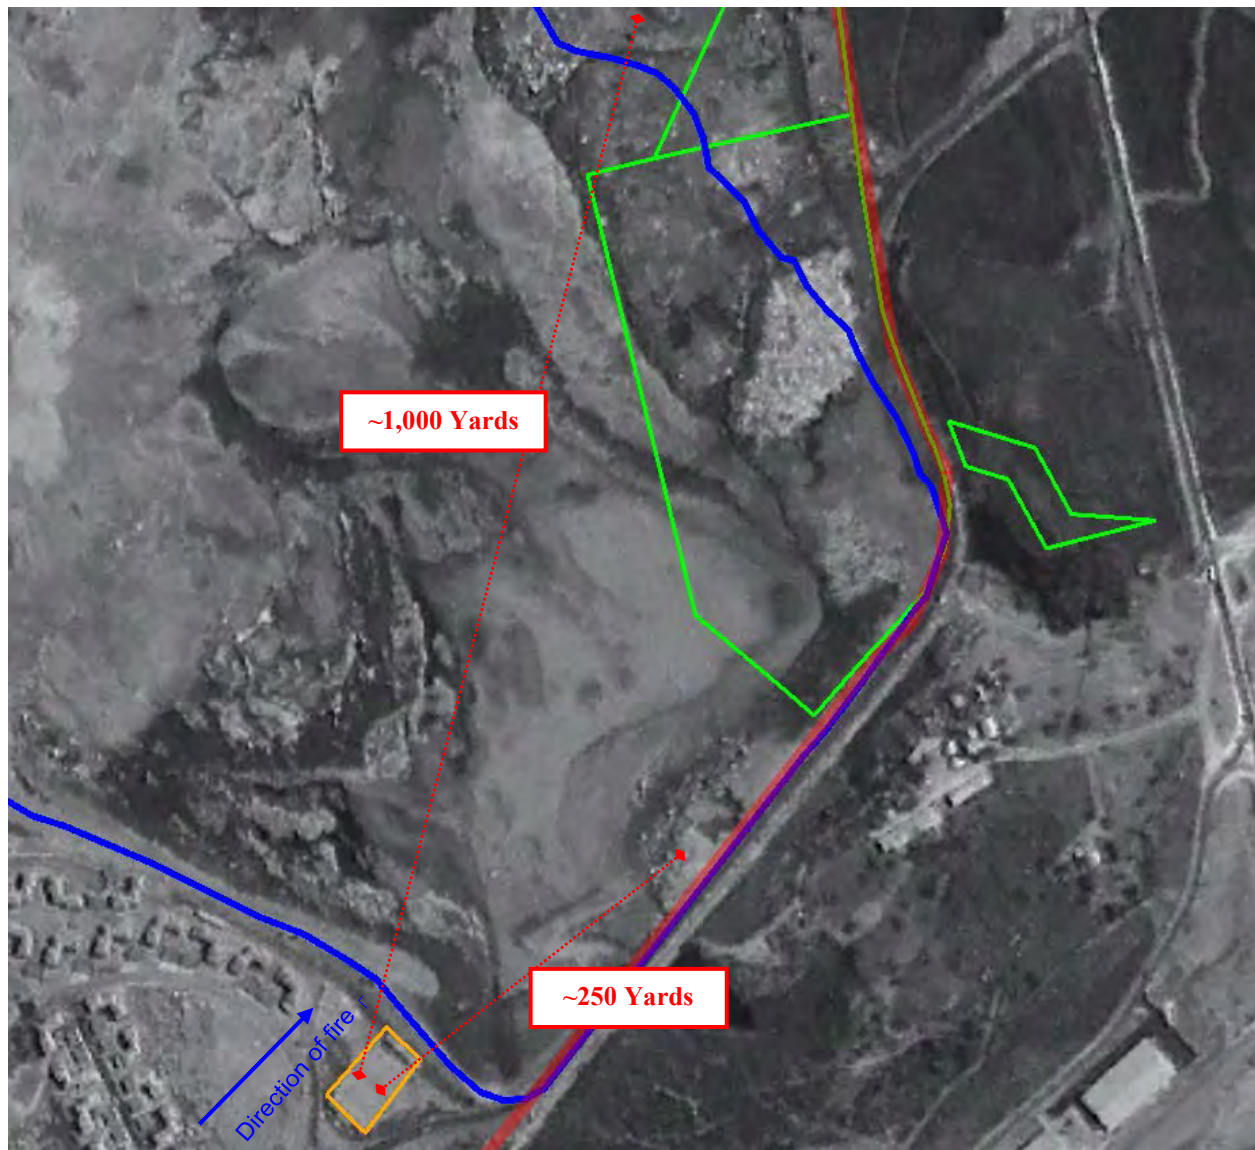
Although, the range is not on the subject FUDS property, the range fan for pistol firing (1,600 yards) would extend onto the Makalapa Crater Navy Salvage Yard FUDS property.¹⁴⁷ On 19 March 1946, a civilian was shot in the head by an overshoot from the Makalapa Crater Pistol Range. Prior to that, the Base Security Officer recommended closing the range due to frequent complaints and safety concerns from personnel working at the Makalapa Dump.¹⁴⁸ The Pistol Range is readily discernable on aerial imagery in the 1940s, with the main salvage yard area about 1,000 yards away but fill areas existing as close as 250 yards (see following figure). The former range firing lines and targets are currently covered by Interstate Highway H-1.

Figure 37 – Makalapa Crater Pistol Range - Aerial Imagery 14 July 1945

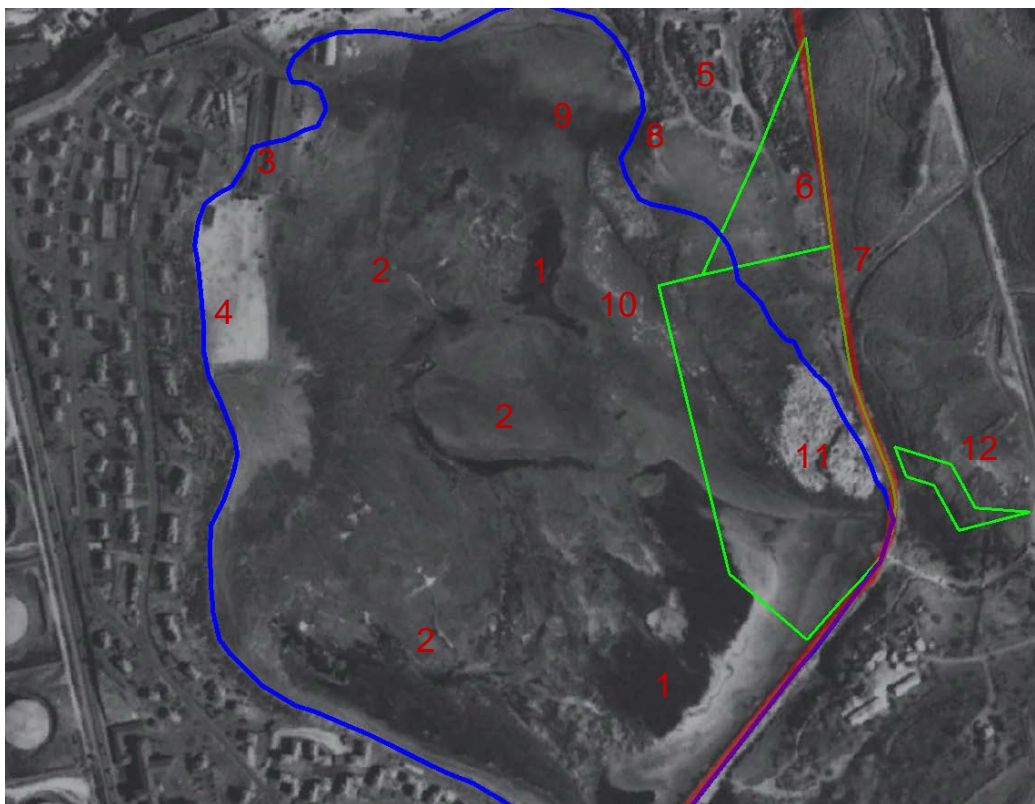
This imagery is just under two years after the previous image. There are only a few areas of pooled water in the crater (1) with dredge spoils (2) appearing to fill the rest. Along the northeast perimeter, the Navy has constructed buildings on areas formerly covered by water (3) and prepared another rectangular area for construction (4) (blue polygon annotation equates to November 1941 water level extent). The stockpiles of material (5) in the Navy salvage yard, established approximately nine months earlier, are readily visible on the northeast side of the crater, with a road network between them. A few buildings exist in the area (6) on the eastern edge of the property near the road entrance just north of the rail line (7). There is not a clear delineation between the salvage yard and burning ground dump. Evidence of active burning (8) is visible with a dark shadow smoke to the west (9)^v. On the eastern edge of the crater, there is evidence of a shelf above the lower dredge fill (10) that had apparently been covered by water in the 1941 imagery. It is unclear if this is a natural shelf or evidence of dumped fill. There is clear evidence of recent material dumping occurring at the southeast end (11) of this area. Outside the naval boundary (FUDS), east of the railroad, a portion of the field has been cleared with some signs of activity at the location of the possible gun emplacement, though the features are indistinct, possibly camouflaged (12).

Figure 40 – Aerial Imagery 24 September 1943

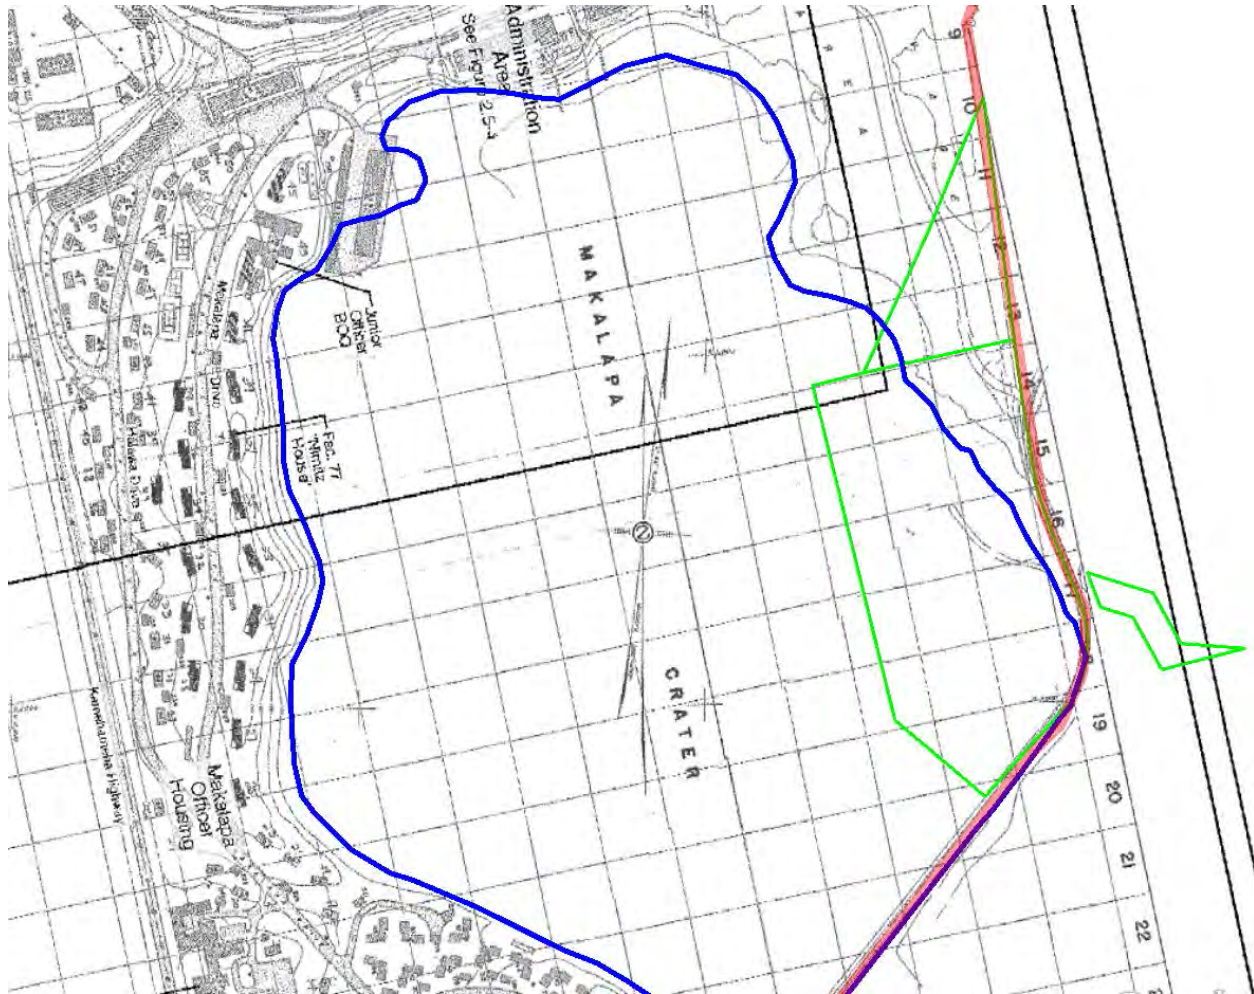
For comparison the Navy site plan does not delineate the features or land use evident on the aerial imagery.

Figure 41 – Site Plan Pearl Harbor Naval Yard Makalapa Crater– 30 June 1944

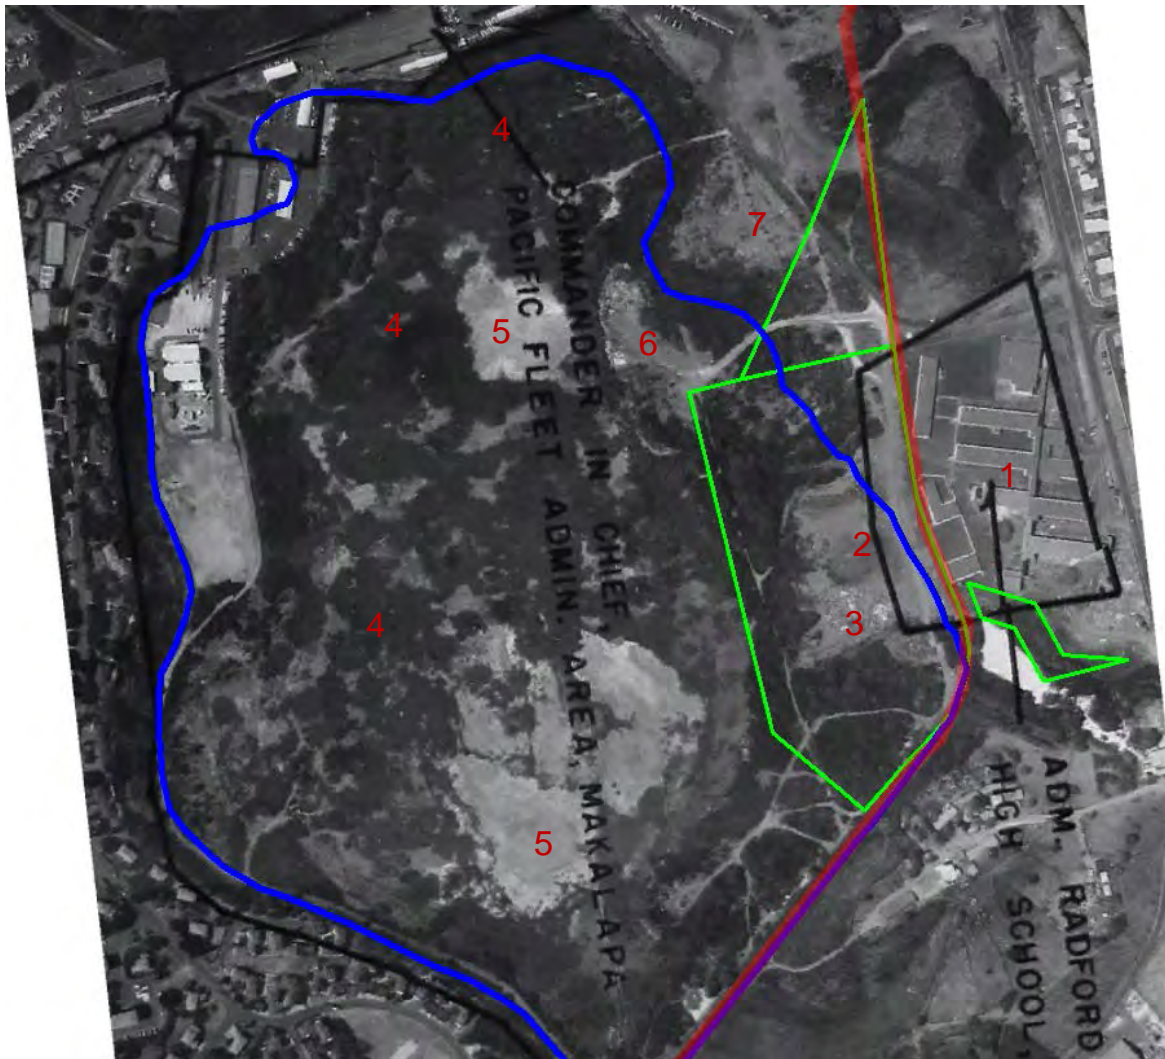
The Navy annotated this single overhead frame image with land use descriptions. Of particular interest is the newly constructed Radford High School (RHS) building complex (1) to the east of the crater and outside the Navy property boundary. The April 1957 imagery is about a month after the Navy officially leased the 15 acres immediately to the west (RHS FUDS) for use of the school (although the lease was back dated to take effect in August 1956). Some of this area has been cleared (2) but its active redevelopment is unclear. There are possible debris piles (3) present although this is uncertain with the poor image resolution. The crater appears filled and much of the center is covered by vegetation (4), though there are few open clearings or areas of ponded water (5). There are probably additional fill operations occurring on the northeast perimeter (6). The bare earth area on the former salvage yard (7) remains as before with vegetation on one of the lineations.

Figure 47 – Aerial Imagery 10 April 1957

Note: black labels & annotation are on a contemporary overlay and are approximations

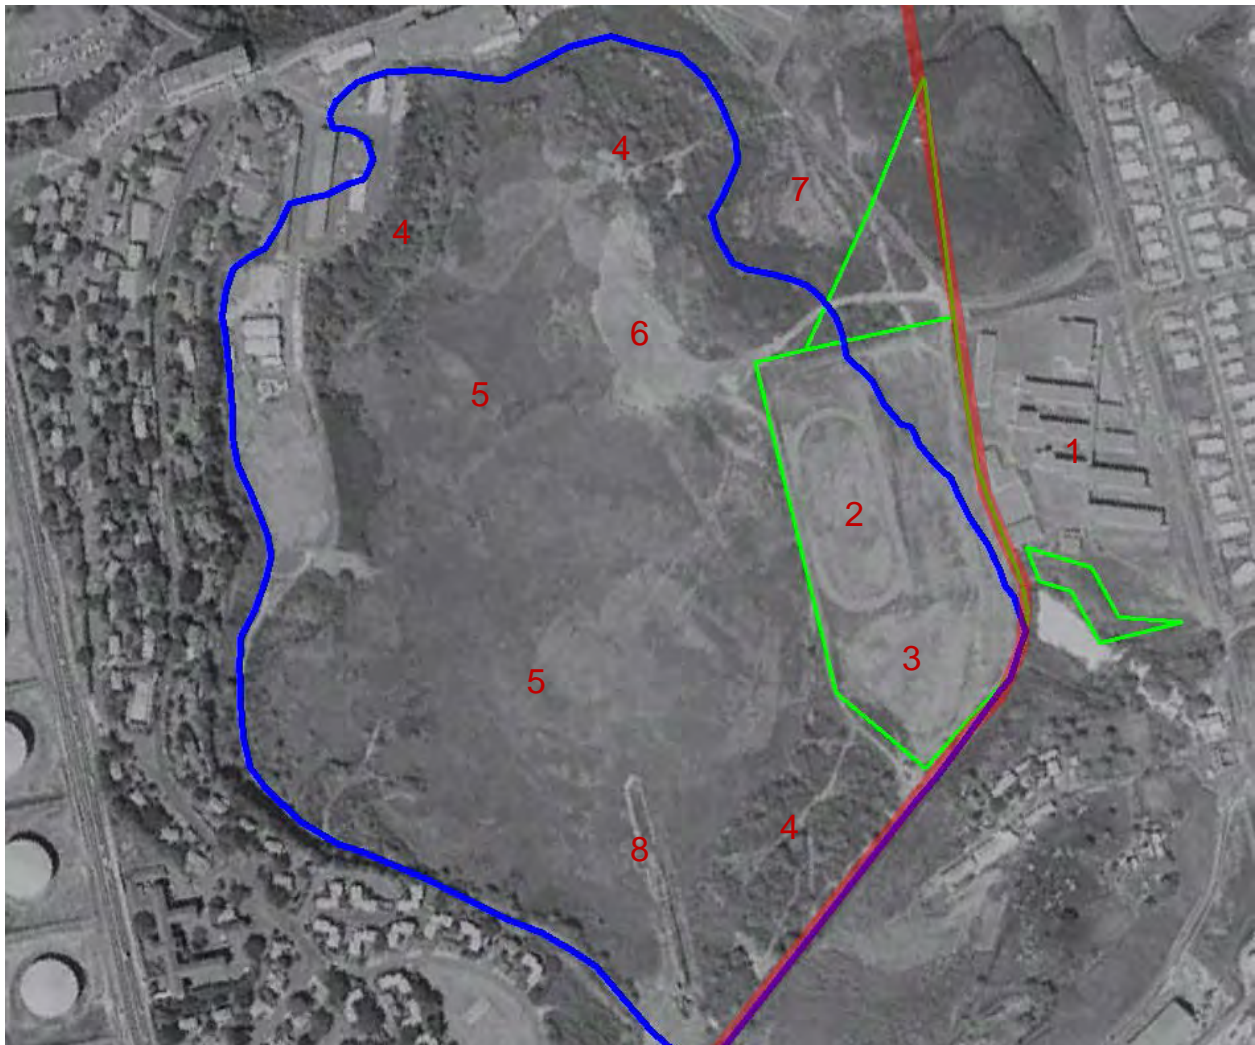
In 1959, the RHS building complex (1) is clearly visible and the 15 acre leased area has been cleared of vegetation and developed to include a running track with a probable football field (2) within it and a baseball field (3) to the south. Parts of the perimeter of the crater have leafy vegetation (4) growing but the majority of it appears to be open clearing covered with grasses (5). The probable fill operations noted in 1957 appear to be lightly vegetated or bare ground (6) with no clear active operations. The area on the former salvage yard (7) remains mostly bare but is vegetating besides the lineation. At the southern end of the crater, an approximately 700 foot straight linear elevated road has been added (8).

Figure 48 – Aerial Imagery 19 January 1959

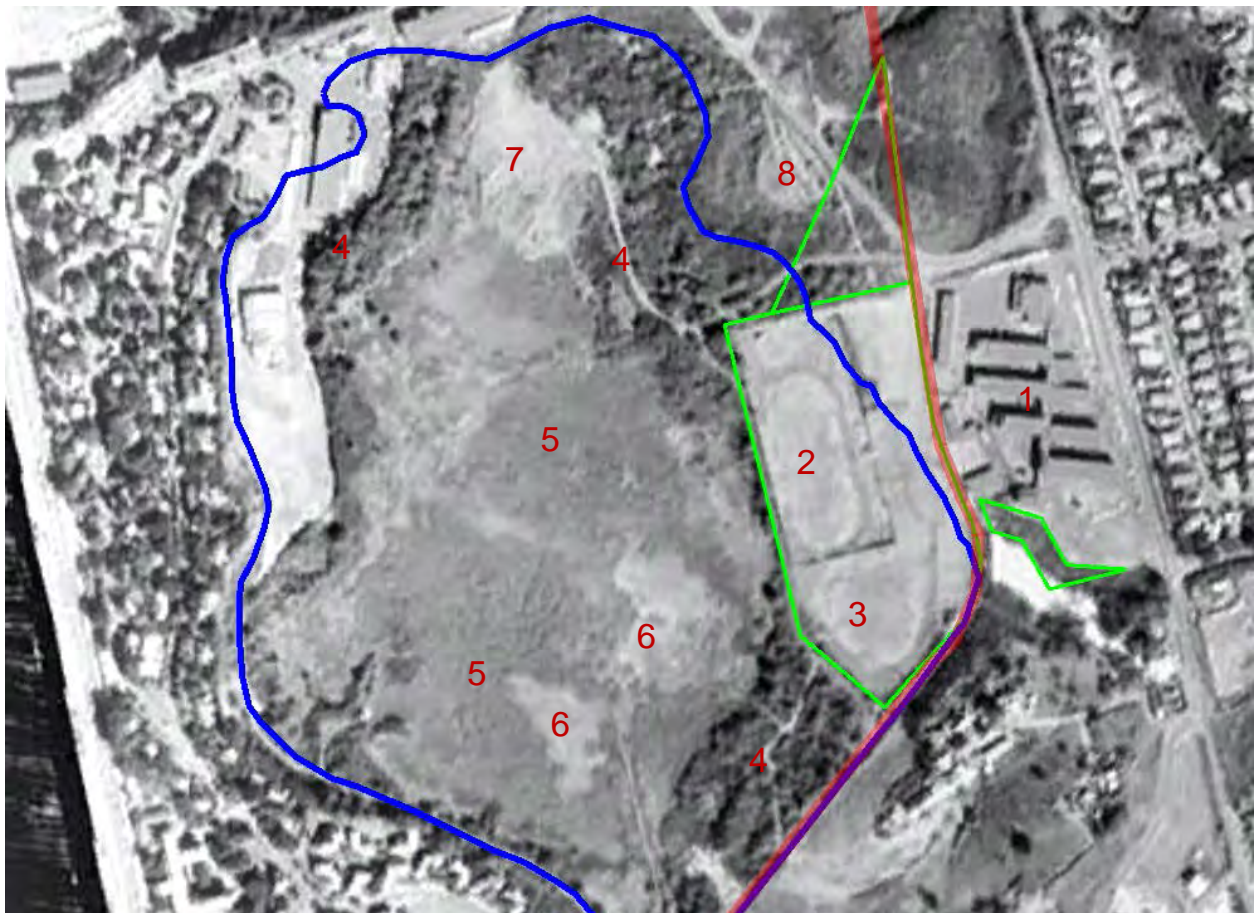
Nearly four years after the 1959 imagery, the RHS building complex (1) is clearly visible, as is the running track and football field (2) within it and a fence surrounding it. There is a probable baseball field (3) to the south. Leafy vegetation at the perimeter of the crater (4) continues to grow but the majority of the crater appears to be open clearing covered with grasses (5), though a couple areas may be bare (6). The probable fill operations noted in 1957 appear to be lightly vegetated or bare ground (7) and are not clearly active. The area on the former salvage yard (8) continues to vegetate but the lineations remain discernable.

Figure 49 – Aerial Imagery 4 December 1962
