PRELIMINARY ASSESSMENT

Makalapa Crater Navy Salvage Yard

Halawa, District of Ewa, Island of Oahu, HI

Final – 30 June 2016

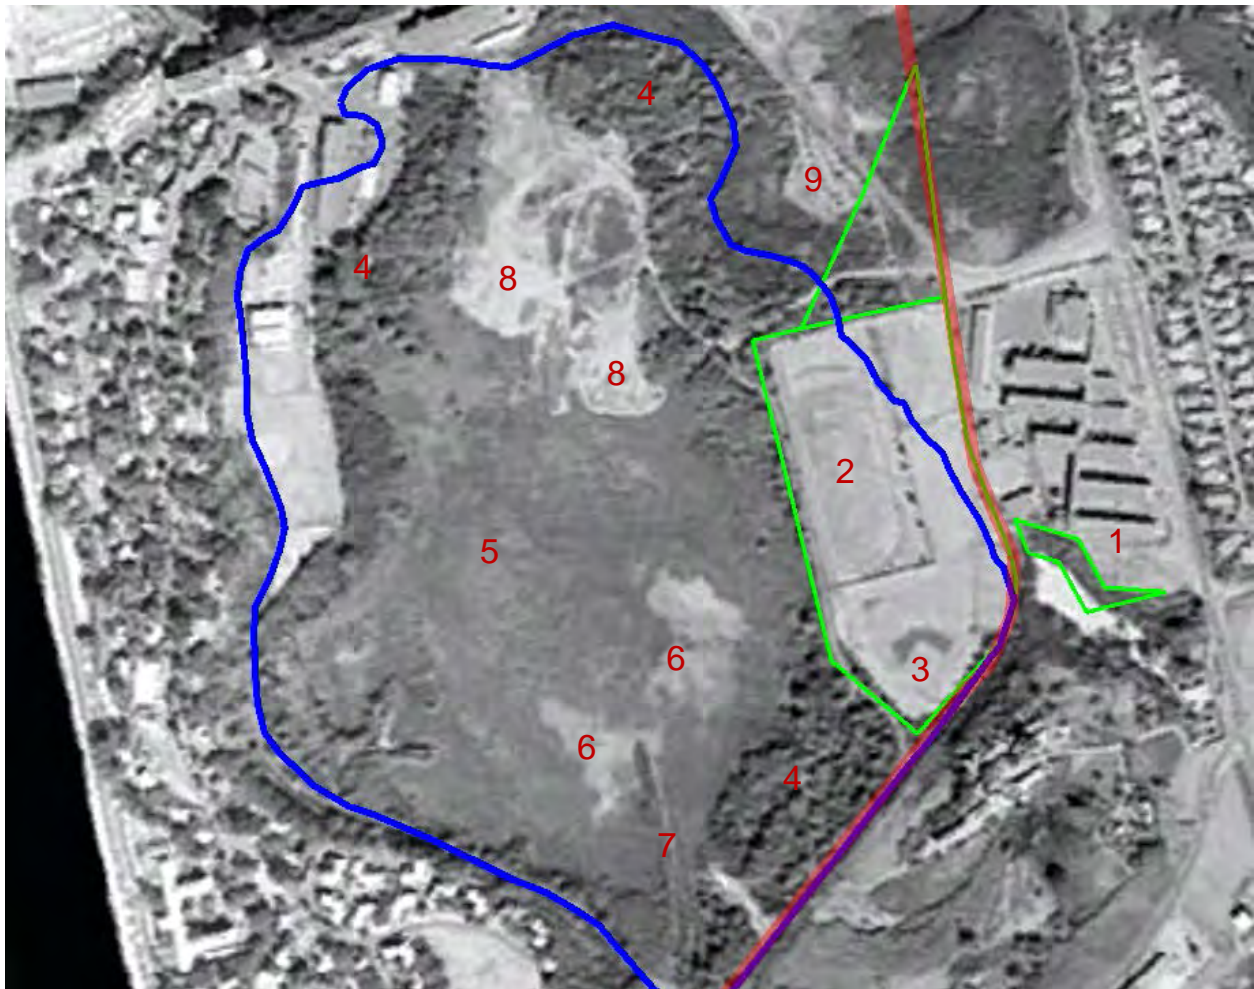
Just over two years later, the RHS building complex remains similar; however an additional 270 by 50 foot building has been added to the southwest of the complex (1). The running track around the football field appears similar (2), with the field to the south definitely configured for baseball (3). The crater perimeter leafy vegetation continues to grow (4) with the center generally being open clearing covered with grasses (5). A couple areas continue to be bare or less vegetated (6) at the end of the north-south road into the crater from the south rim (7). Fill operations on the northwest side of the crater have reactivated (8) if stopped in 1962. The area on the former salvage yard is mostly revegetated (9) except for the area around the lineations.

Figure 50 – Aerial Imagery 15 February 1965

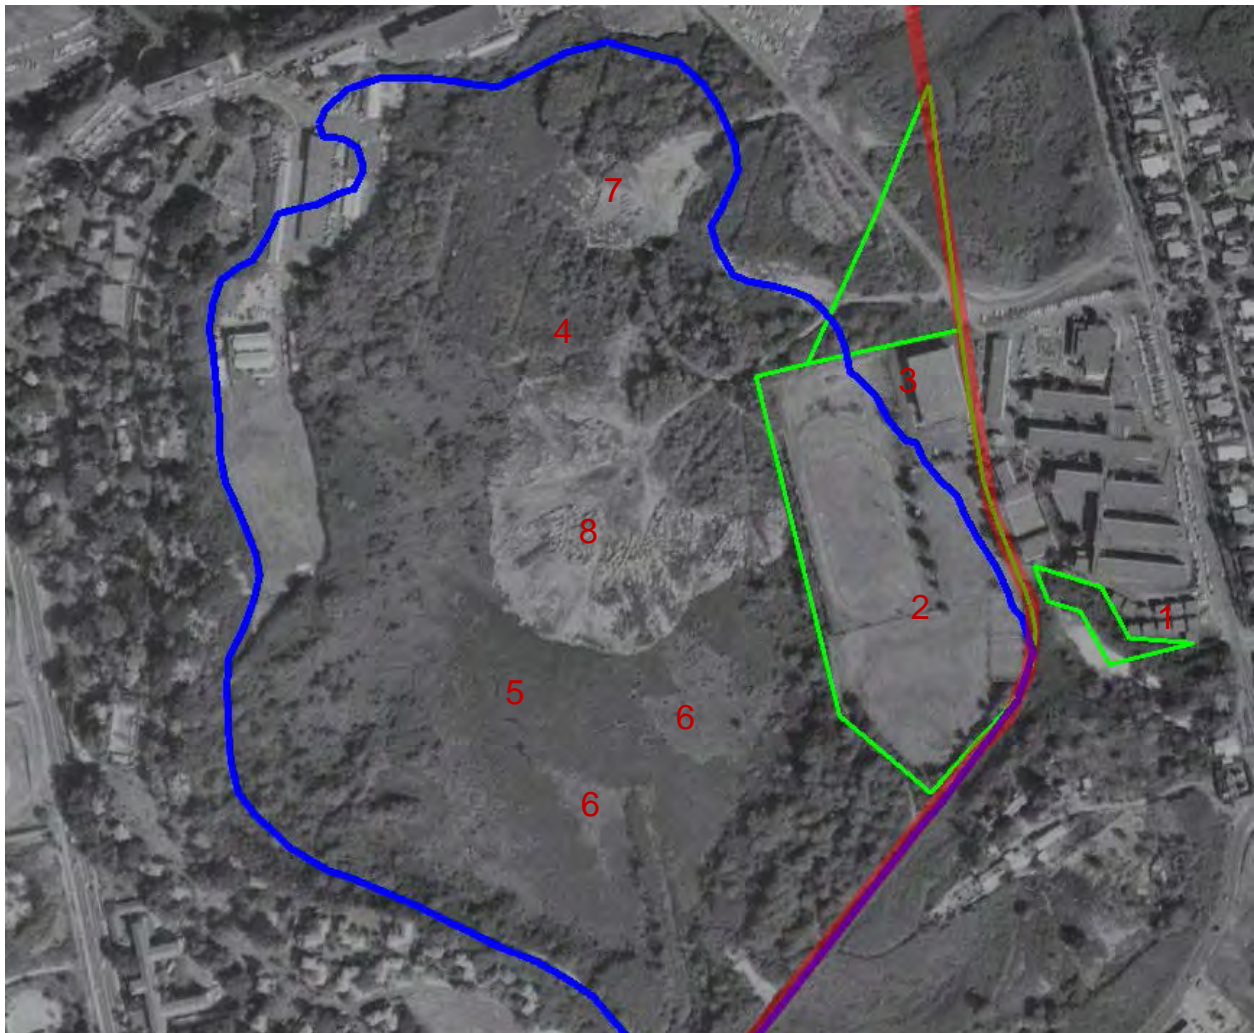
Three years later conditions appear essentially the same at RHS, although a dozen approximately 30 by 30 foot structures have been added at the southeast end (1). The athletic fields appear the same (2) though it is clear there are lights for the field by this point. The lineations at the former salvage yard area remain visible (3). The leafy vegetation around the crater perimeter continues to grow (4). The vegetation in the center appears thicker and brushier (5) with less or different vegetated areas (6) remaining. Fill operations on the northwest side of the crater have ebbed (7) but others have begun more toward the center of the crater (8) as material mounds are readily apparent.

Figure 51 – Aerial Imagery 26 February 1968

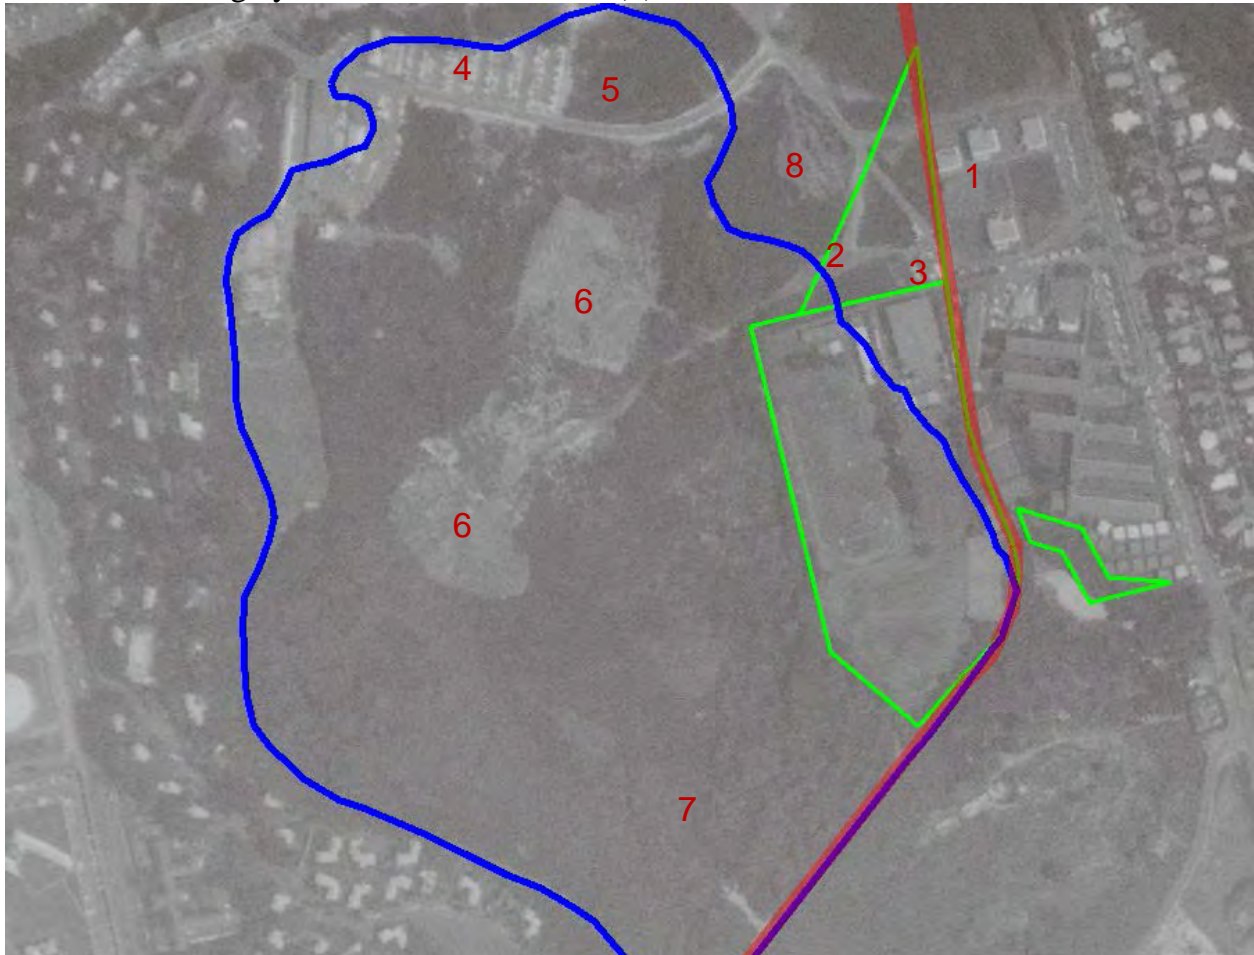
The image quality in 1972 limits detailed analysis but some changes are clear in the 2 ½ years since the 1969 imagery. Construction of the Makalapa Elementary School (MES) (1) has occurred (students began attending in January 1972) and roadway paths to the west on the 3.577 acres (FUDS, lease beginning in August 1971) appear well traveled (2). Equipment or material (3) is staged at the southwest most corner of the MES FUDS parcel. On the north end of the crater, a parking lot (4), roadway and vegetated lot (5) are evident at the location of the 1969 fill operations with no clear material mounds remaining. To the south are large clearings (6), possibly indicative of active fill operations or earth work. The rest of the crater fill area in the center appears vegetated with leafy growth (7) but the image resolution does not provide clarity. The lineations at the former salvage yard area remain visible (8).

Figure 53 – Aerial Imagery 24 March 1972

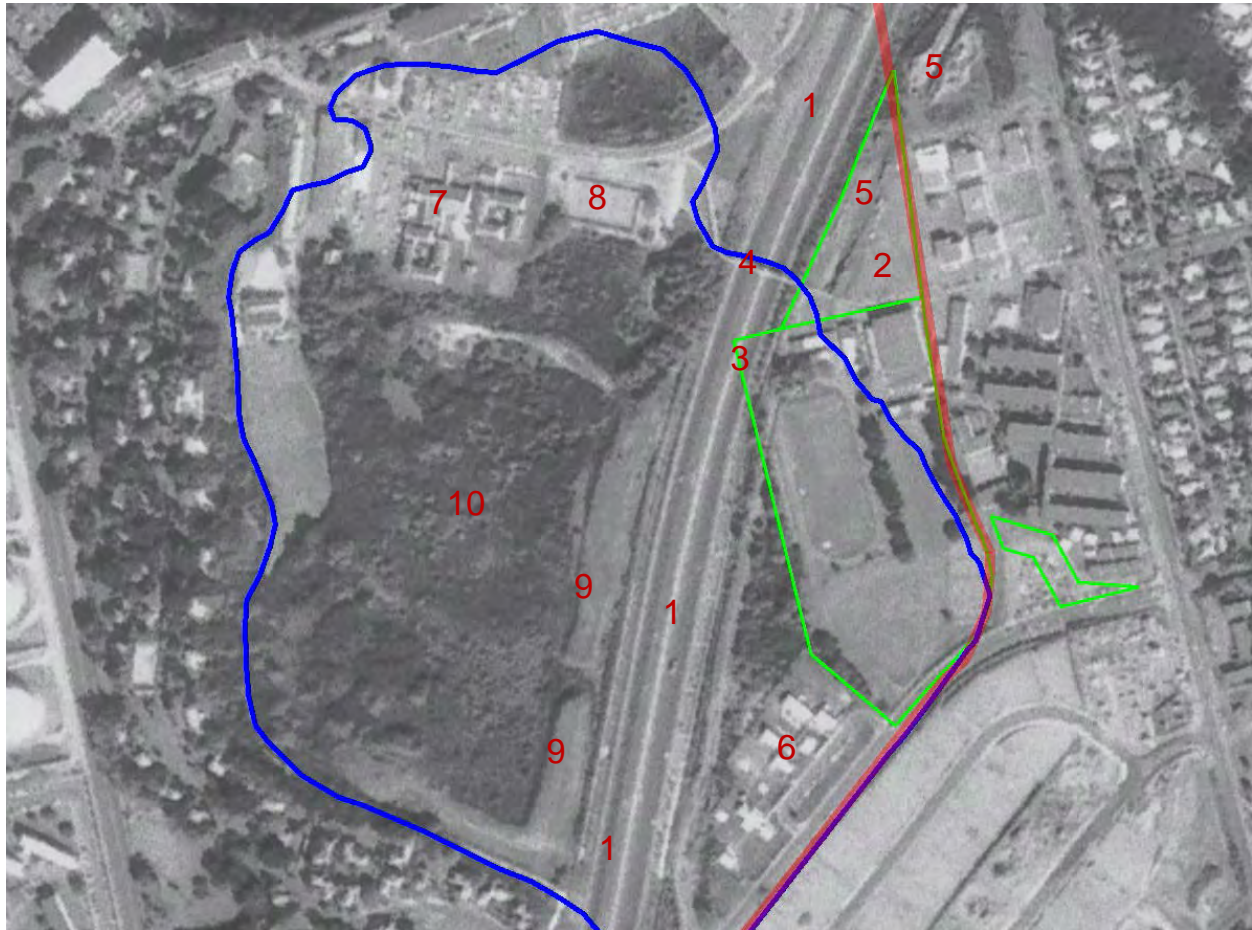
The big change in the mid-1970s is construction of Interstate Highway H-1 (1) through Makalapa Crater, with a right-of-way immediately adjacent to the MES FUDS parcel (2) and including the northwest corner of the RHS FUDS (3). A pedestrian overpass (4) and sidewalk connects the installation to the west with MES and RHS to the east side of the highway. There appears to be some trenching work parallel to the northeast-southwest leg of the MES FUDS (5) that continues to the northeast but is not clearly related to highway work. To the southwest of the RHS FUDS, an area has been cleared and the Navy Hale Keiki School (6) has been constructed. On the west side of the highway, the Navy has constructed a number of structures (7) and possibly a tennis court (8) on previous fill areas. Aligning the highway to the west are two approximately 125 foot wide grassy areas, possibly berms (9). The rest of the former crater is covered in leafy vegetation (10).

Figure 54 – Aerial Imagery 5 January 1978

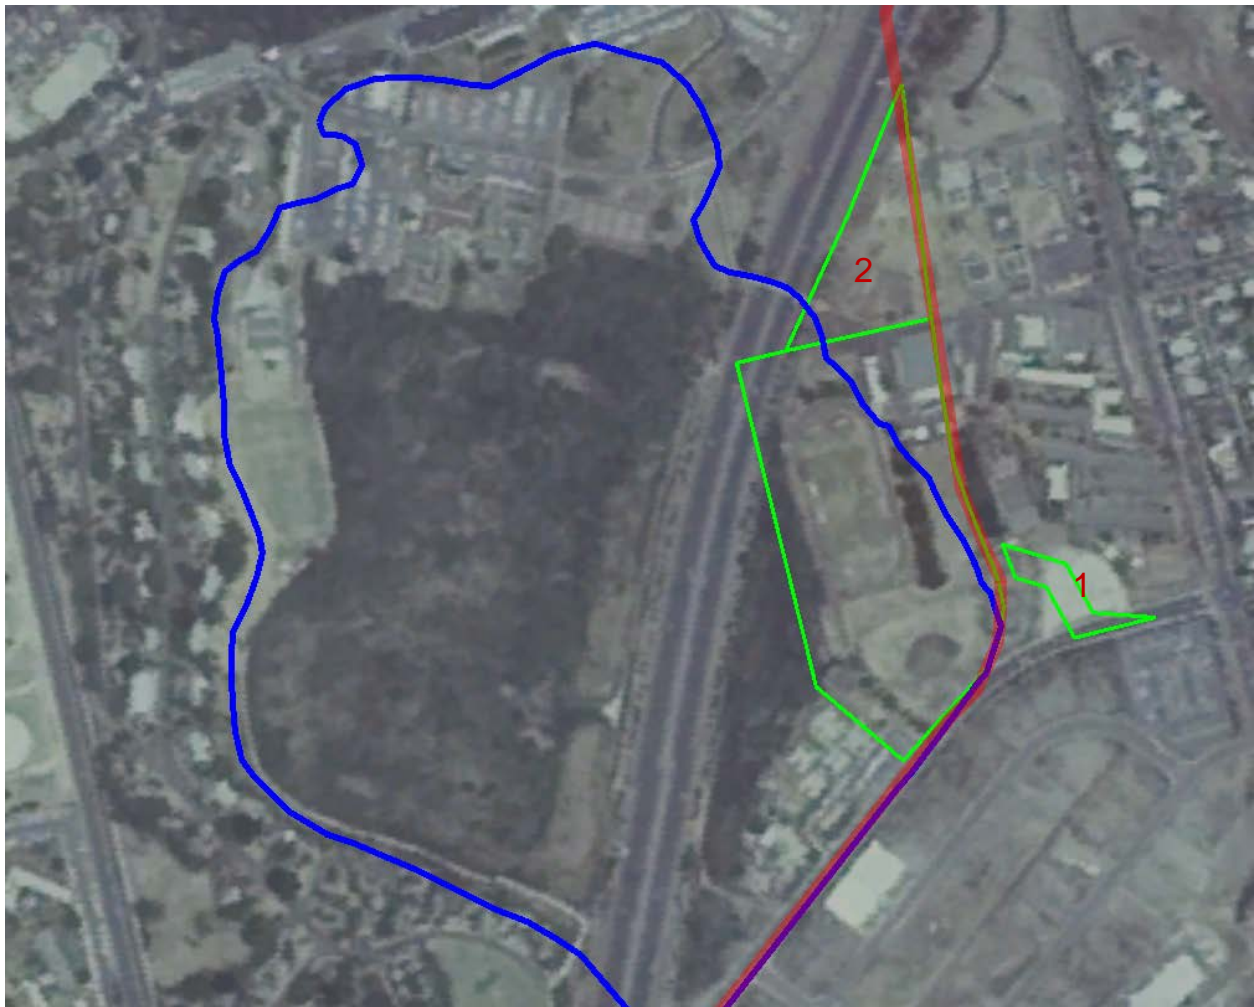
The 1985 imagery occurs over seven years after the 1978 imagery but changes or further development appear minimal, though poor photo resolution restricts detailed analysis. The imagery is only a month after the third FUDS parcel has transferred from NAVFAC to RHS and the area appears to be cleared and unvegetated (1). At the MES FUDS, the area appears grassy with a few trees (2). Other features appear similar to those previously discussed.

Figure 55 – Aerial Imagery 2 May 1985

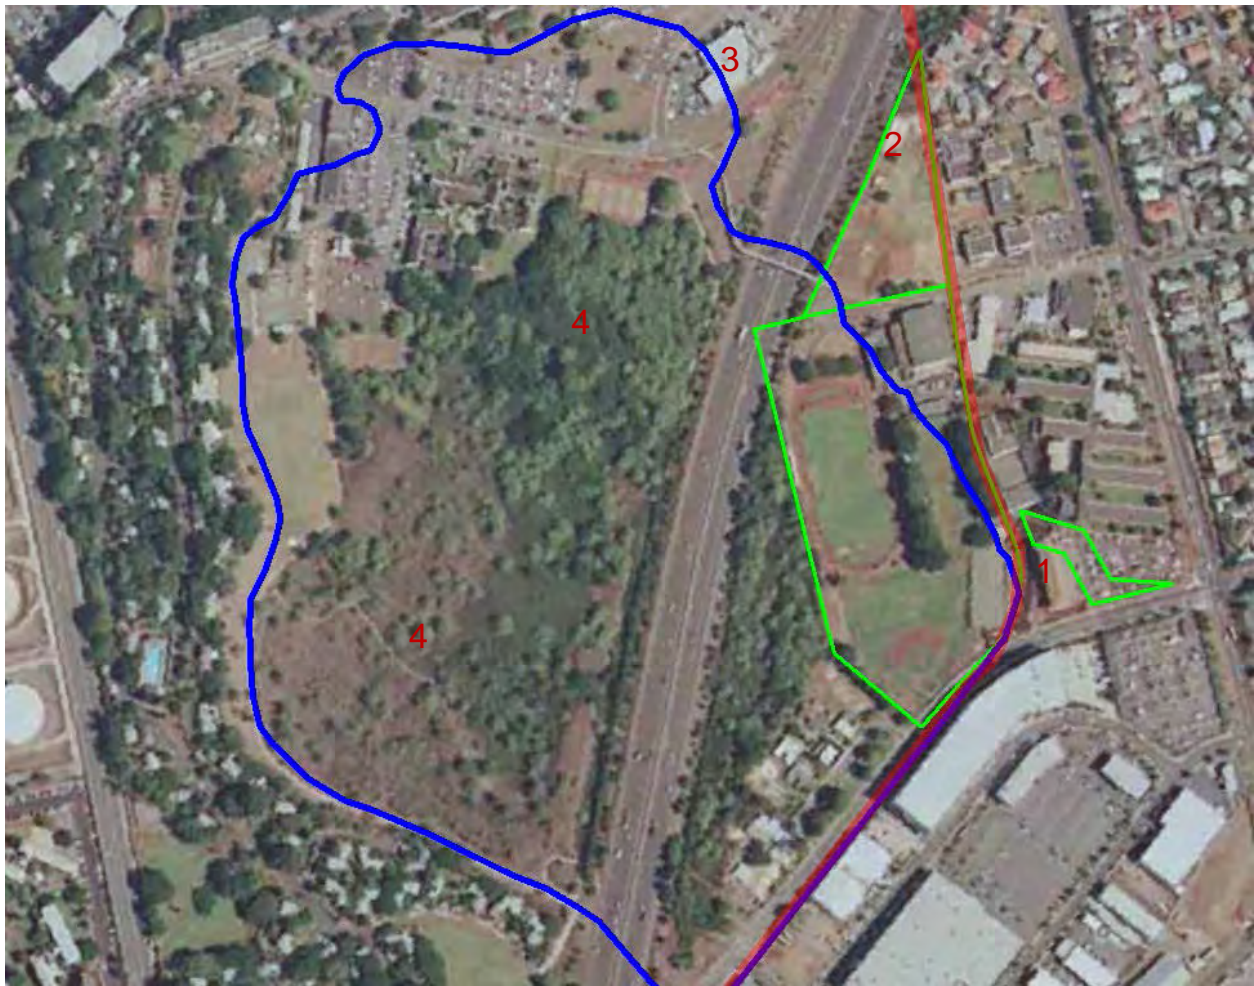
Figure 56 – Aerial Imagery 25 September 1993

About 8 ½ years later, noted additional development includes a new approximately 60 by 200 foot building on the third FUDS parcel transferred to RHS in 1985 (1). At the MES FUDS, the area appears grassy with a few trees and a parking lot is at the northern tip (2). On the west side of the highway, the Navy has further developed the former northwest portion of the crater with a building and parking lot (3). The color imagery provides a clearer sense of the height and health of the vegetation within the undeveloped center of the crater (4).

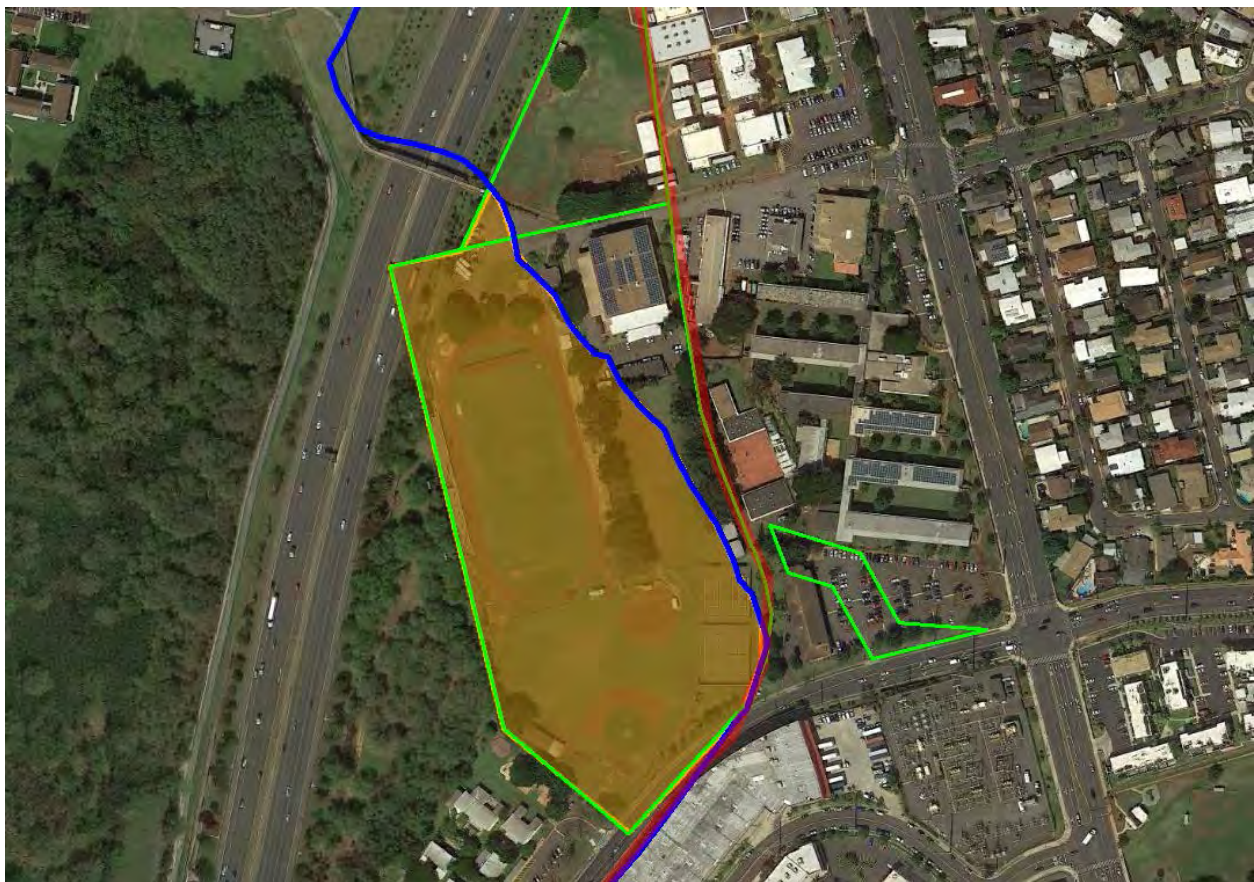
Figure 58 – *Approximate Lateral Extent of Fill based on 1941 Aerial Imagery*

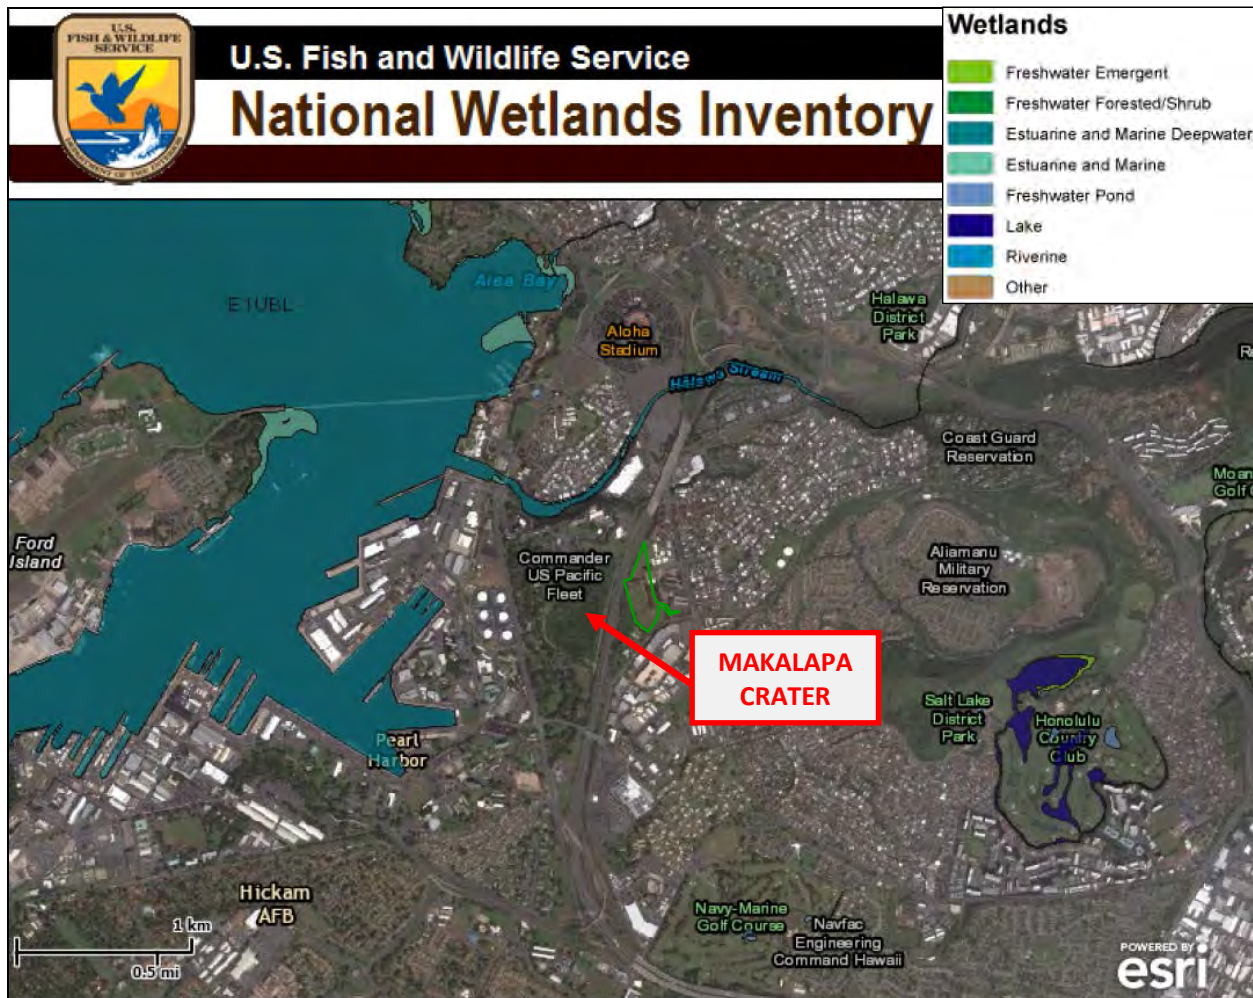
Figure 63 – USFWS Wetland Map of Makalapa Crater Area¹⁸⁷

Although wetlands exist in the vicinity of the subject FUDS within and adjacent to the Pearl Harbor area, there are no wetlands specifically within the Makalapa Crater Navy Salvage Yard FUDS according to the USFWS National Wetland Inventory (see following figure). The wetlands along the surface water migration path from the property should be considered a secondary target.¹⁸⁶

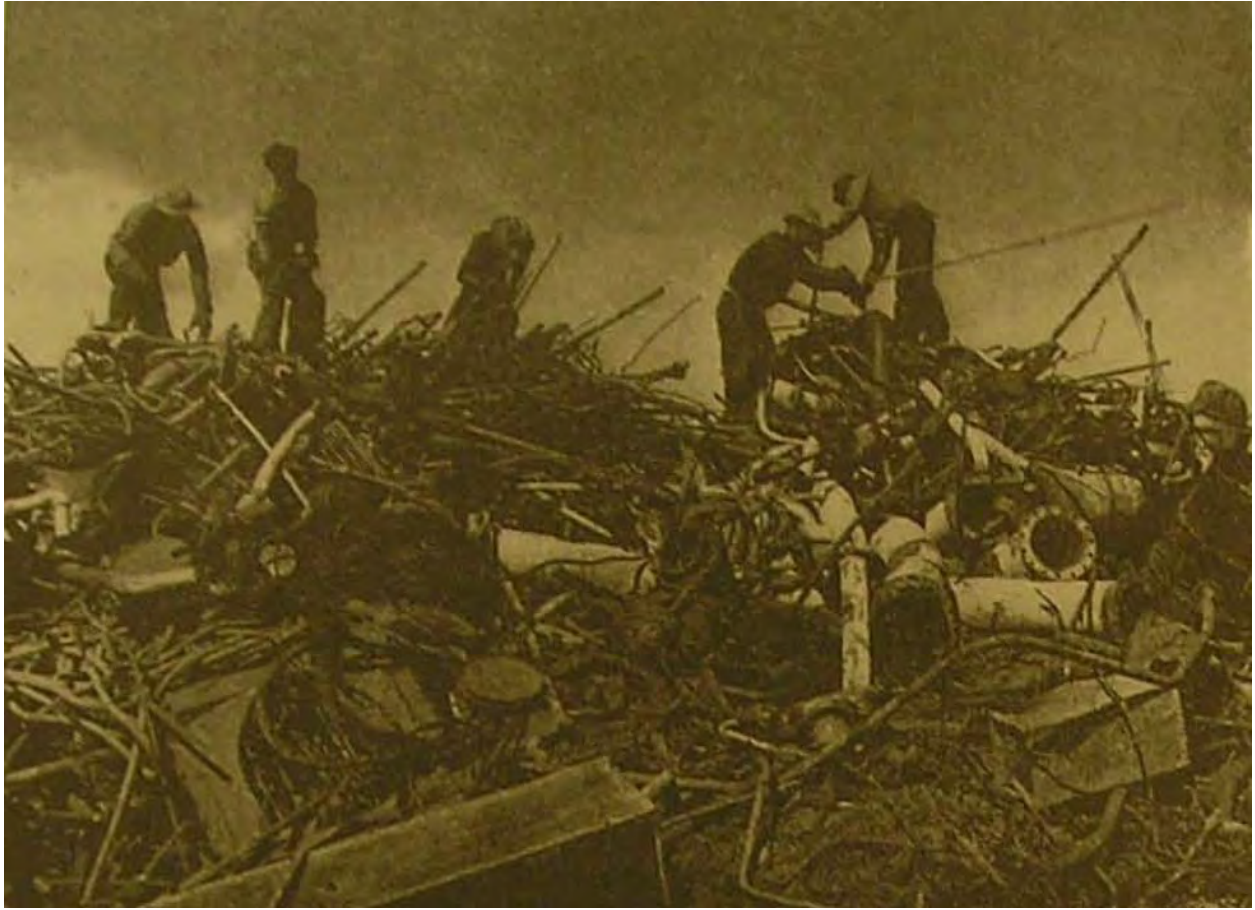
Figure 11 – Sorting Scrap to be Reclaimed at Makalapa Salvage Yard - September 1943
xi

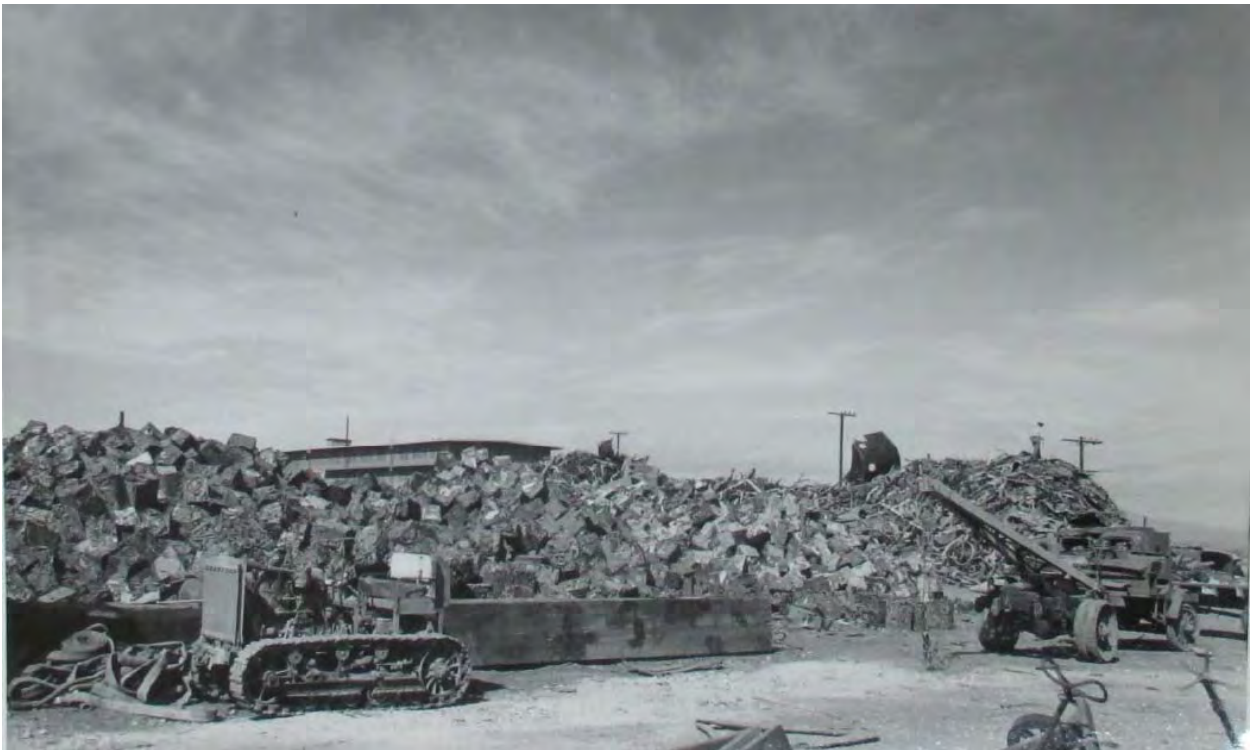
Figure 14 – Non-Ferrous Metal Pile at Makalapa Salvage Yard - 29 October 1944^{xiv}

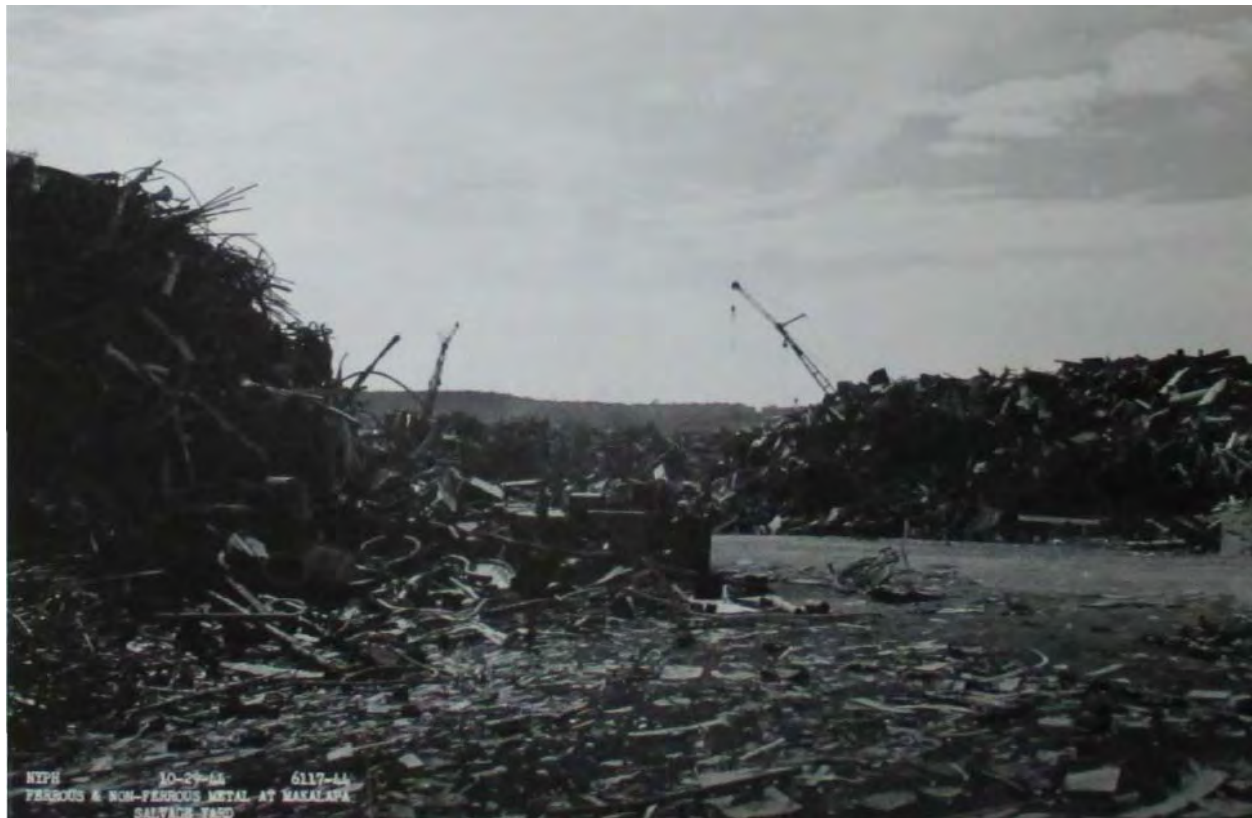
Figure 15 – Ferrous and Non-Ferrous Metal at Makalapa Salvage Yard - 29 October 1944^{xv}

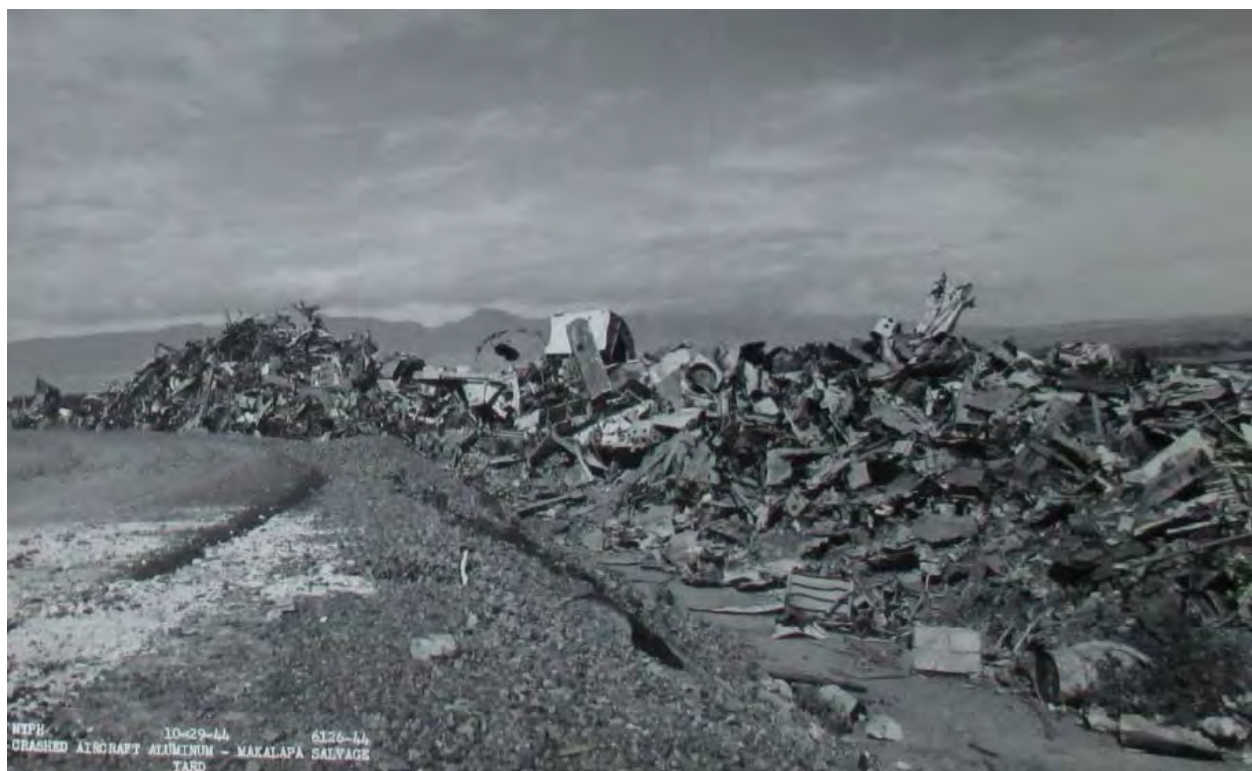
Figure 16 – Crashed Aircraft Aluminum at Makalapa Salvage Yard - 29 October 1944^{xvi}

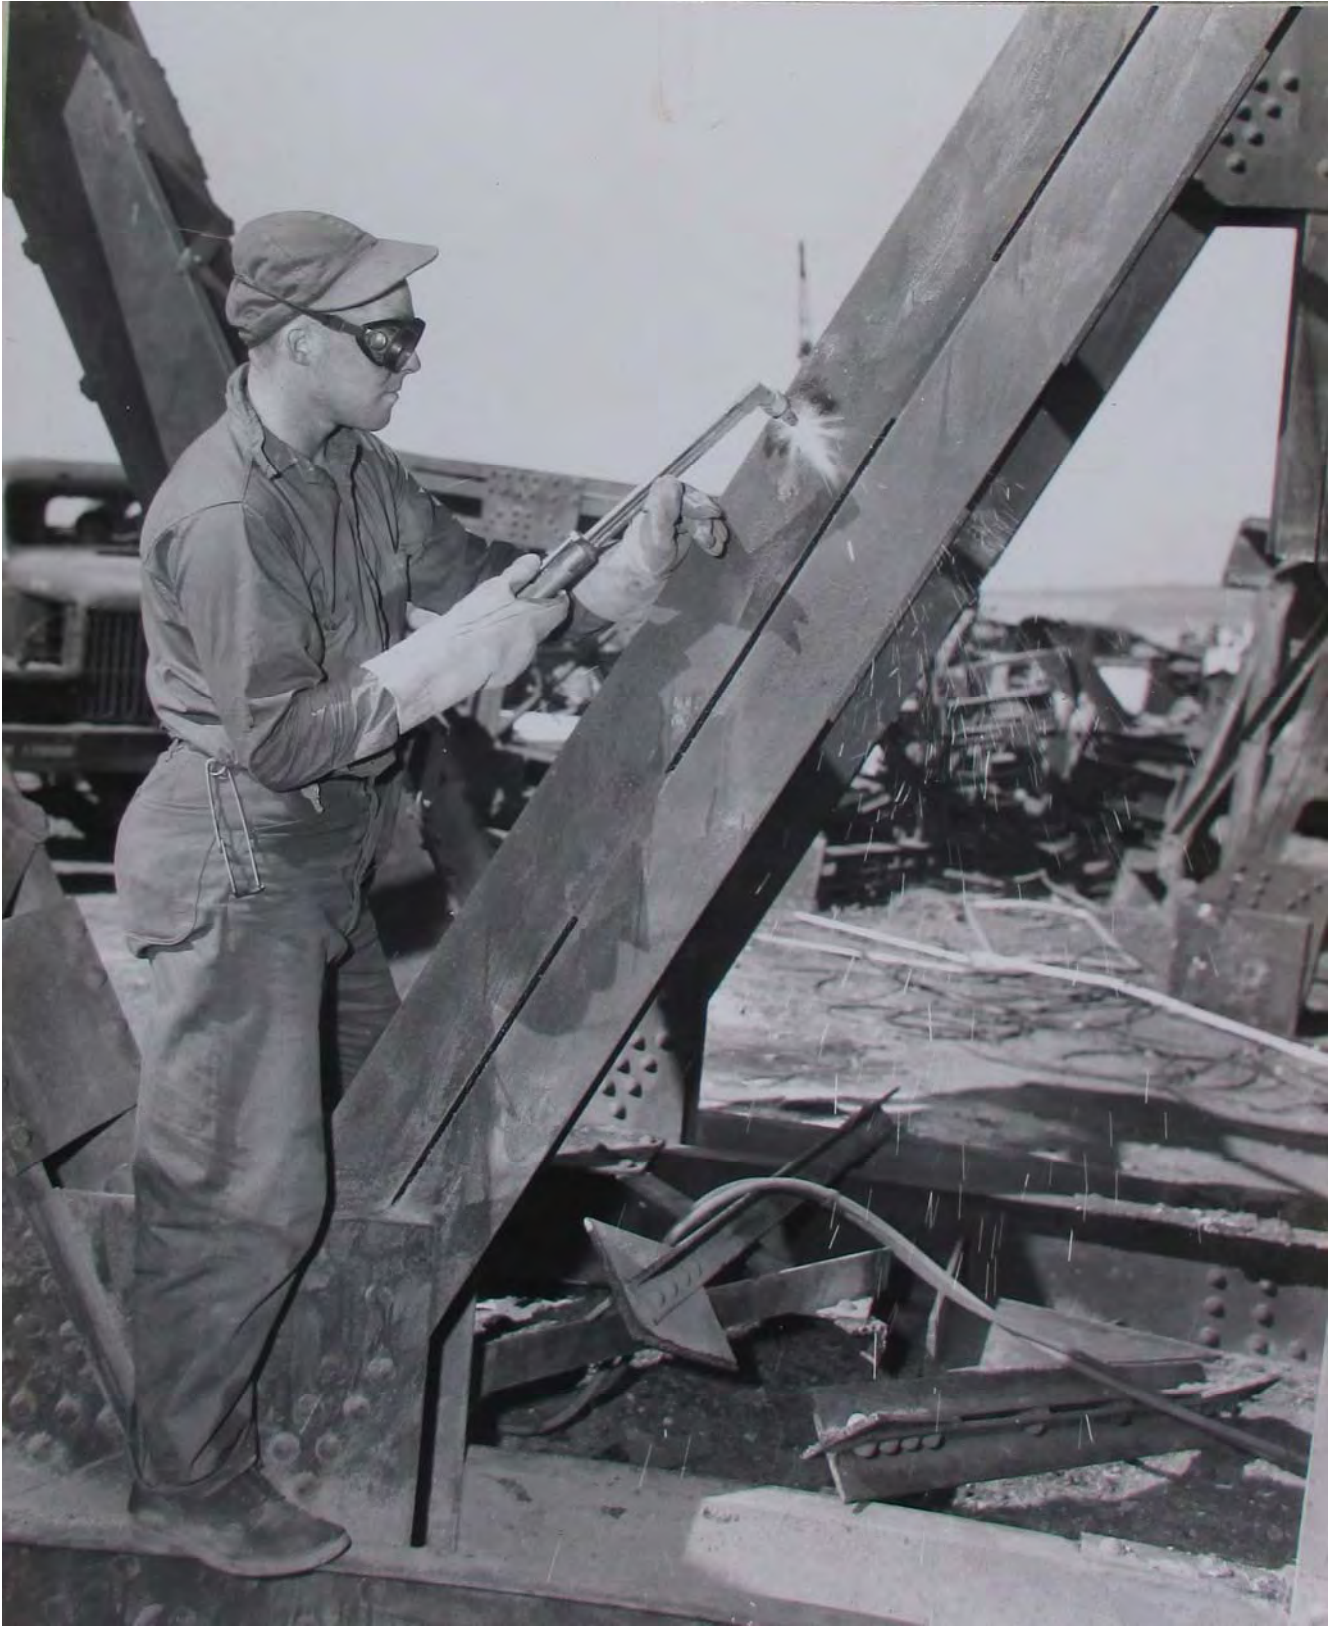
Figure 19 – “Heavy beams are cut with acetylene torches into suitable sizes for shipping at the salvage yard of the Naval Supply Depot of the 14th Naval District, Pearl Harbor” - 12 February 1945^{xix}

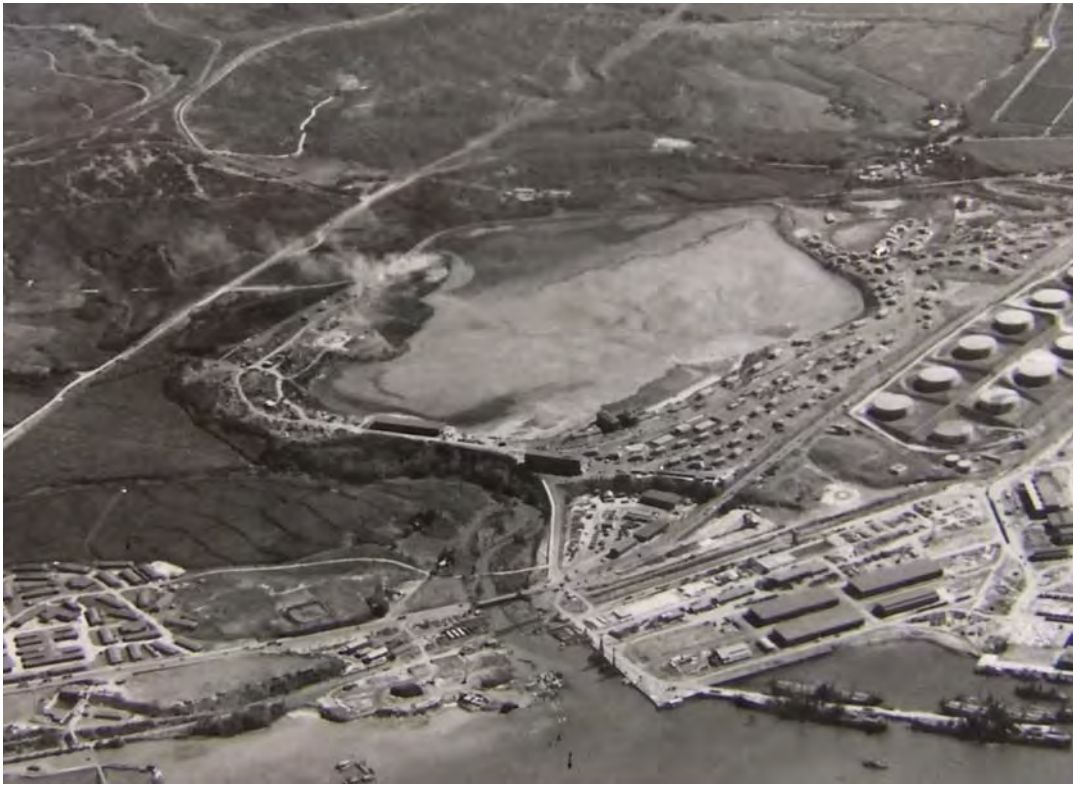
Figure 31 – Oblique Aerial of Makalapa Crater Looking South-Southeast - 12 December 1943 ^{xxxi}

Note: Smoke from debris burning on east side of crater.

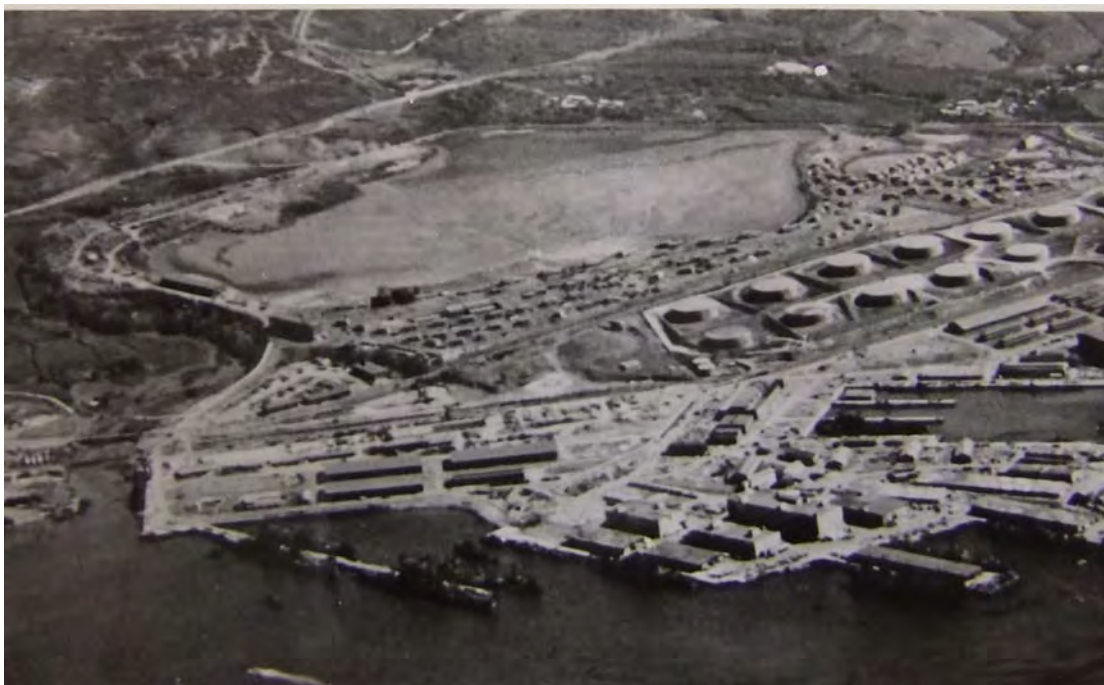
Figure 32 – Oblique Aerial of Makalapa Crater Looking East-Southeast - 12 December 1943 ^{xxxii}

Note: Smoke from debris burning on east side of crater.

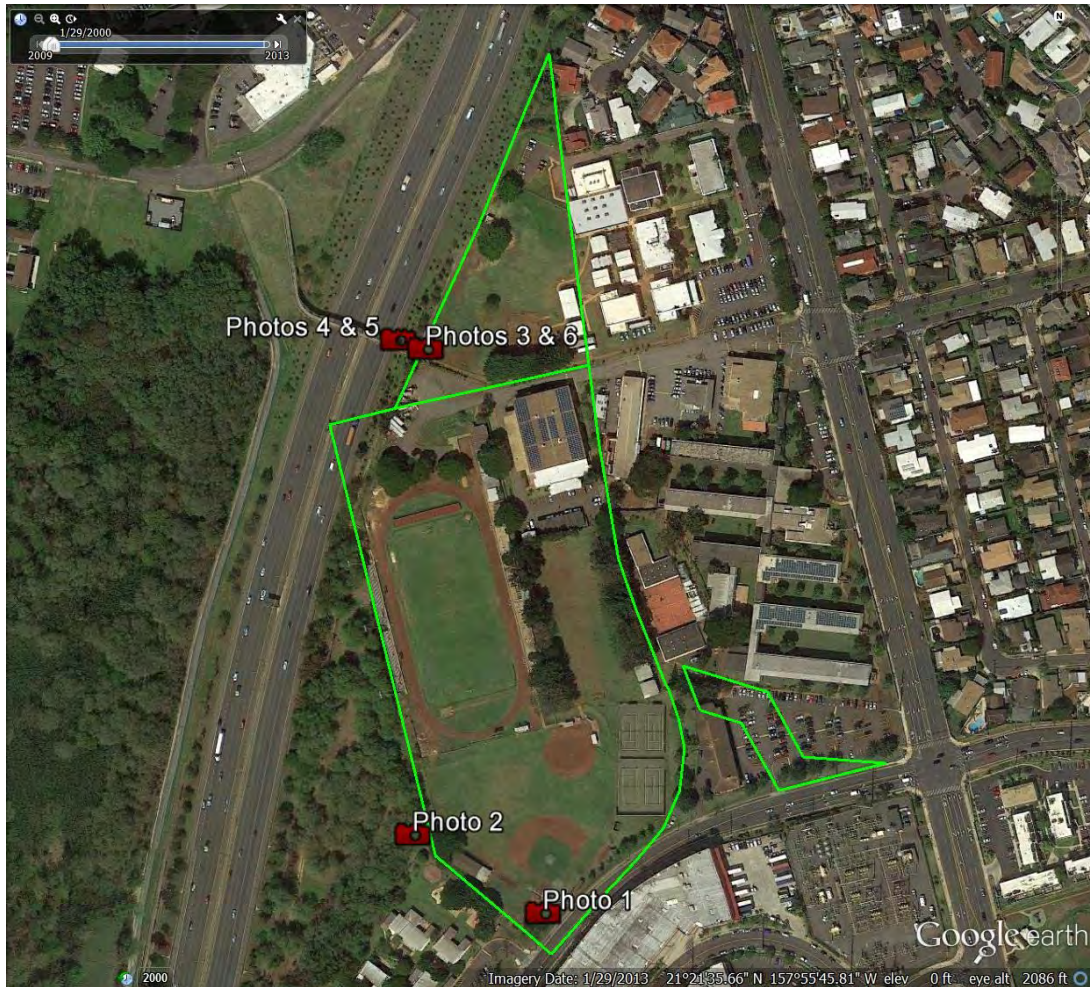
3. The St. Louis District team traveled to Halawa, District of Ewa, Hawaii to conduct a property inspection of the former Makalapa Crater Navy Salvage Yard on 11 August 2015. Given the ongoing NAVFAC activities on the property and that school was in session at both Radford High School (RHS) and Makalapa Elementary School (MES), the team limited the visit to a periphery visit to familiarize themselves with the property and the current conditions primarily from Joint Base Pearl Harbor-Hickam (JBPHH) property. The recent aerial photo image (see following figure), created with [Google Earth](#) software, shows the scope of the PA property visit inspection and the location of where the subsequent photo were taken.

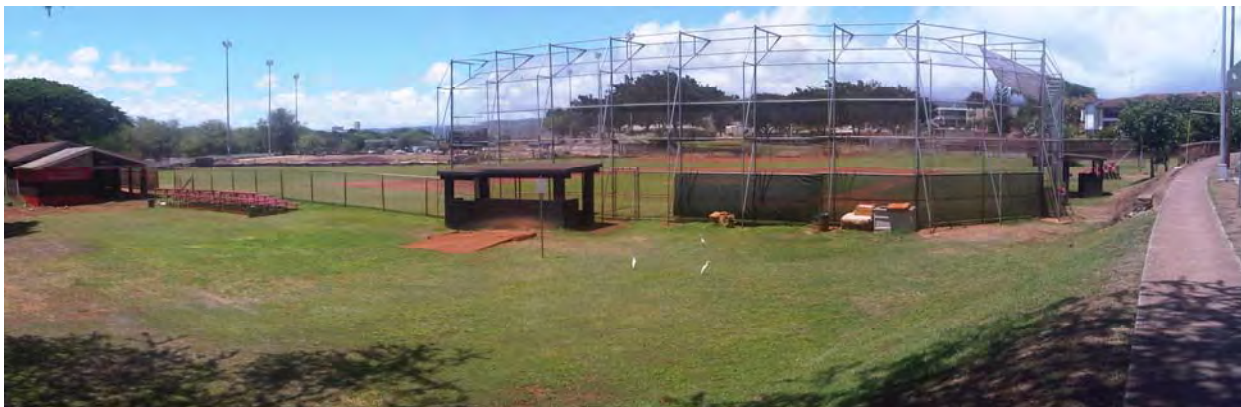
Photo 1 – Panorama looking northwest to northwest towards the RHS baseball field from the southern end of the FUDS - 11 August 2015

Note: slope from the sidewalk along Bougainville Drive to baseball field.

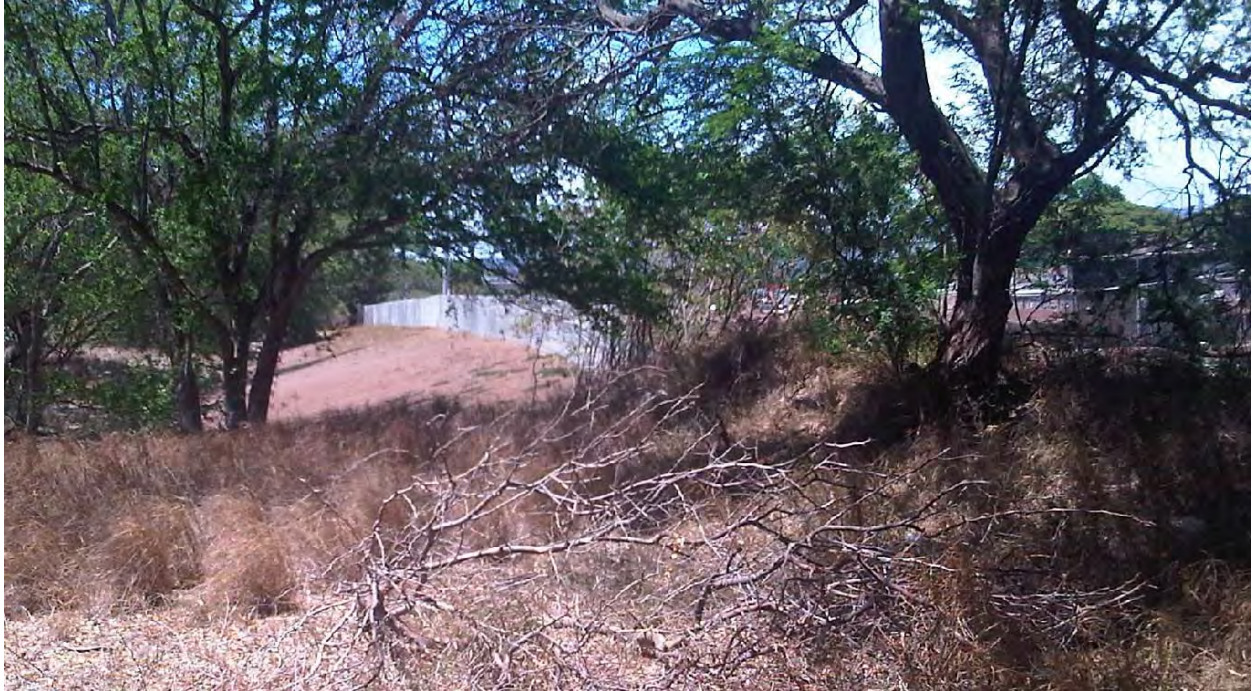
***Photo 2 – Looking northwest along RHS fence line at western boundary of FUDS - 11
August 2015***

Note: slope from the fields to lower lying vegetated area of JBPHH property behind the Navy Hale Keiki School.

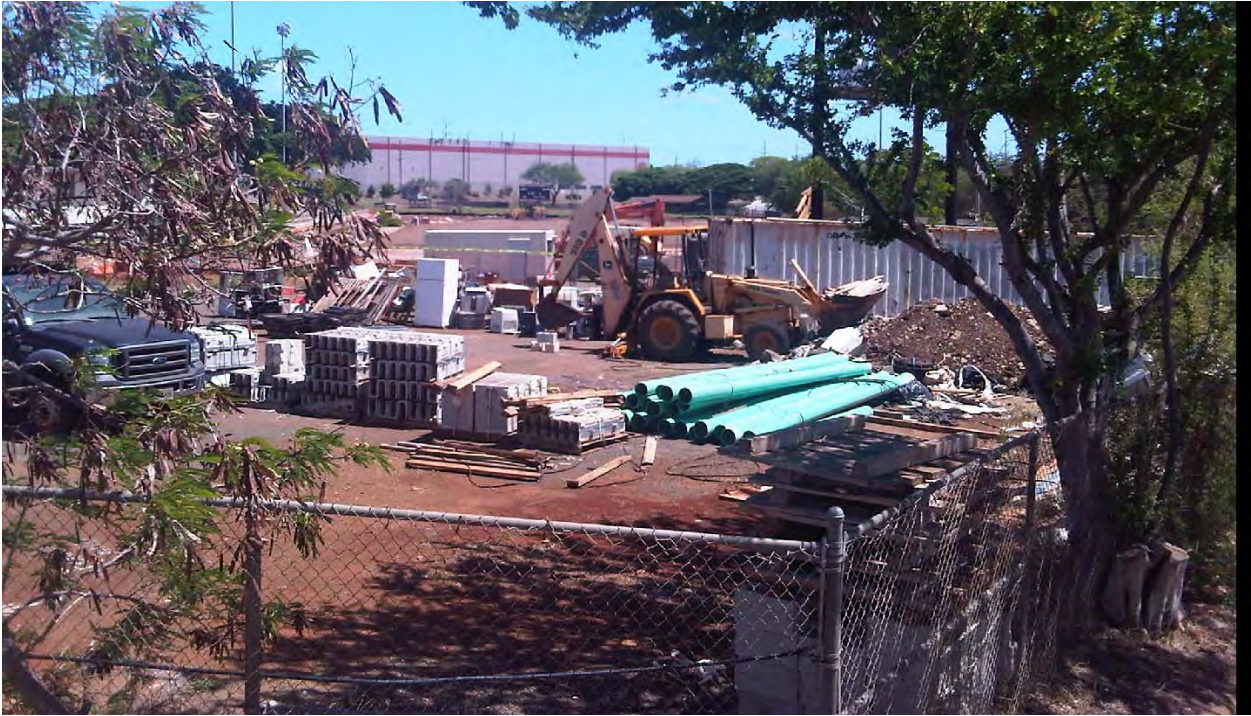
Photo 3 – Looking south, southwest at RHS material and equipment yard north of football field - 11 August 2015
