PRELIMINARY ASSESSMENT

Makalapa Crater Navy Salvage Yard

Halawa, District of Ewa, Island of Oahu, HI

Final – 30 June 2016

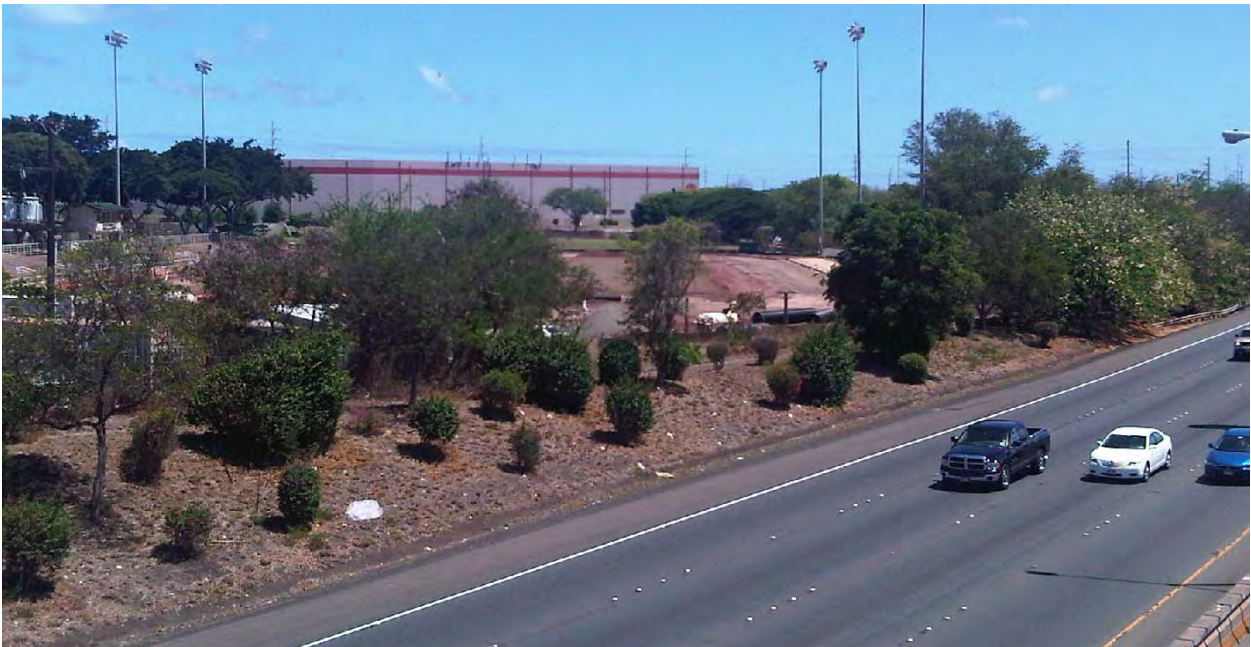
Photo 4 – Looking south, southeast at RHS football field from pedestrian bridge overpass of Interstate Highway H-1- 11 August 2015

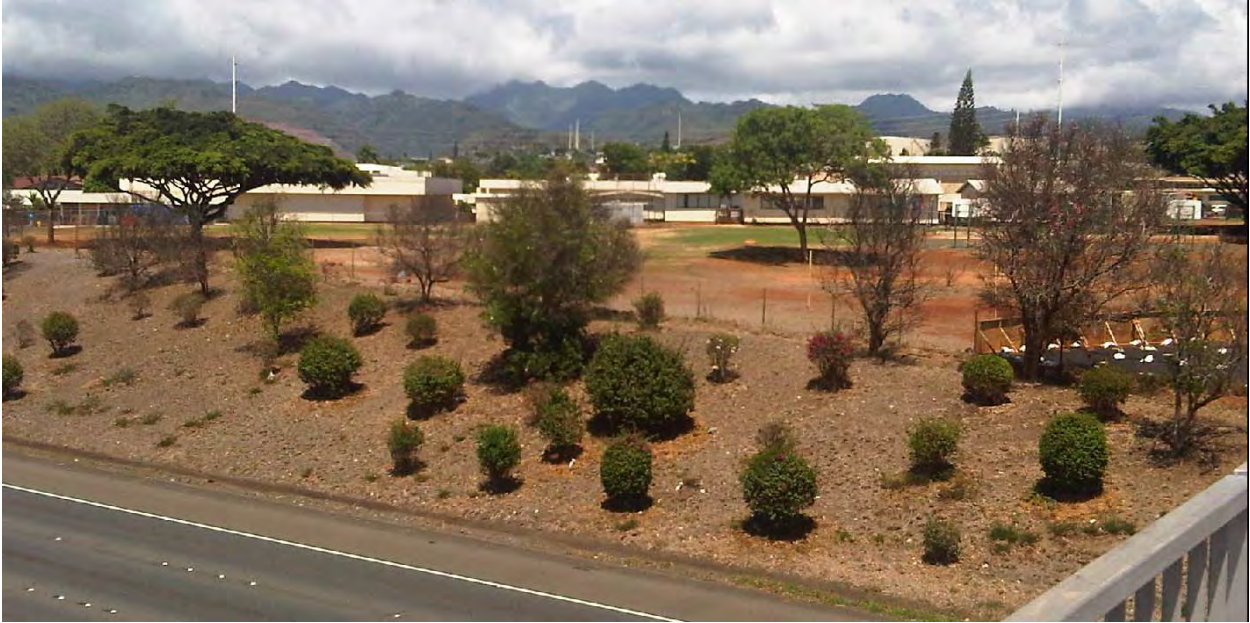
Photo 5 – Looking east, northeast at MES playground and buildings from pedestrian bridge overpass of Interstate Highway H-1 - 11 August 2015

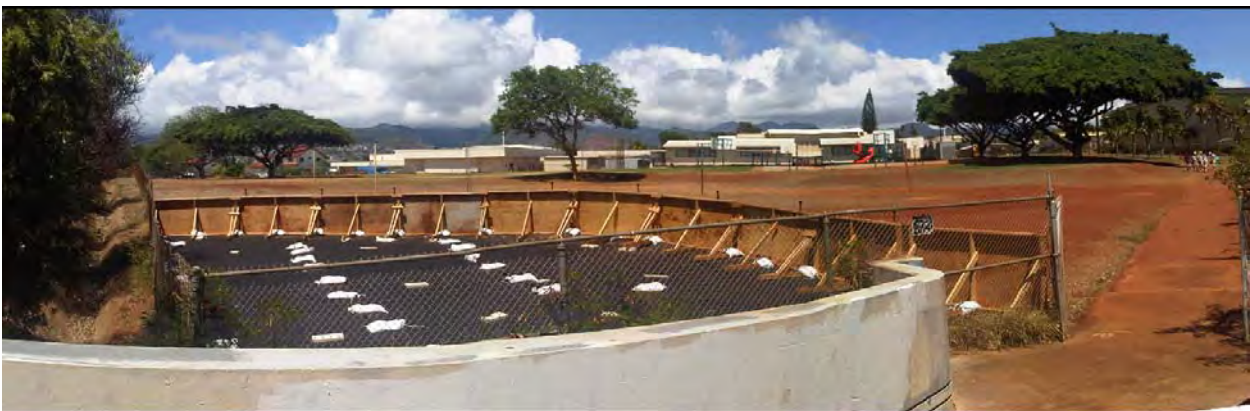
Photo 6 – Panorama looking northeast to southeast across the MES playground from the east end of the pedestrian overpass from JBPHH - 11 August 2015

Note: barricaded area
