Proposal for an "Umbrella" Coral Reef Mitigation Bank

Corps File No.
POH-2013-00221

Hawai'i Department of Land and Natural Resources Aquatic Umbrella Mitigation Bank Prospectus

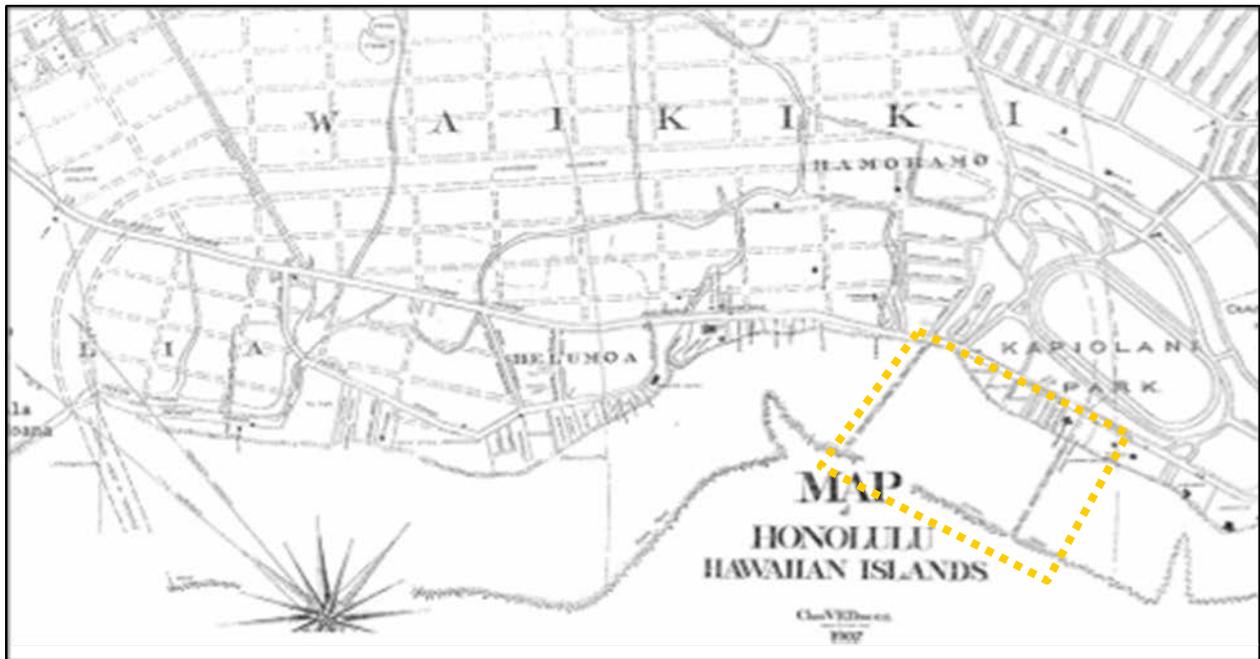
FIGURE 5. 1907 MAP OF WAIKĪKĪ, NOTE EXTENSIVE CORAL REEF DIAGRAMED IN LOCATION (IN YELLOW) OF THE CURRENT MLCD (CHAS. V.E. DOVE, FROM WIEGEL (2008)).

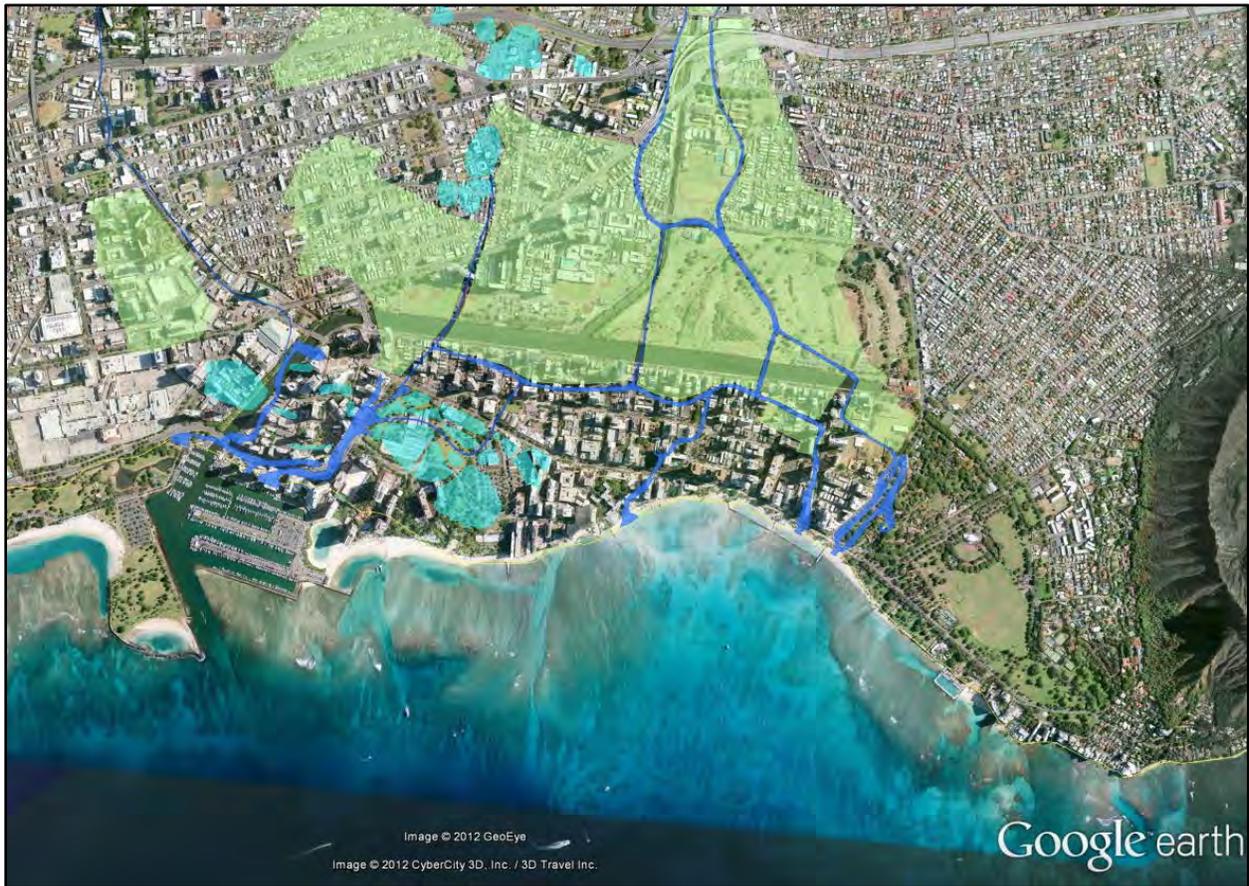
FIGURE 7. WAIKĪKĪ WITH HIGHLIGHTS FROM 1893, PRIOR TO DRAINAGE, SHOWING STREAMS (DARK BLUE), TARO/RICE LO'I (GREEN), PONDS (LIGHT BLUE). BY PETER T. YOUNG, HO'OKULEANA LLC.

The natural marshy wetland of Waikīkī was once quite vast, receiving water from Makiki, Mānoa, and Pālolo streams. However, over a century of urban development has devastated this watershed. In the 1920's, these streams were all diverted into the Ala Wai canal, drying the original Waikīkī marshland and permanently altering fresh water flow to the entire area. Figure 7 shows present-day Waikīkī overlaid with circa 1893 wetland areas, streams, and fishponds.

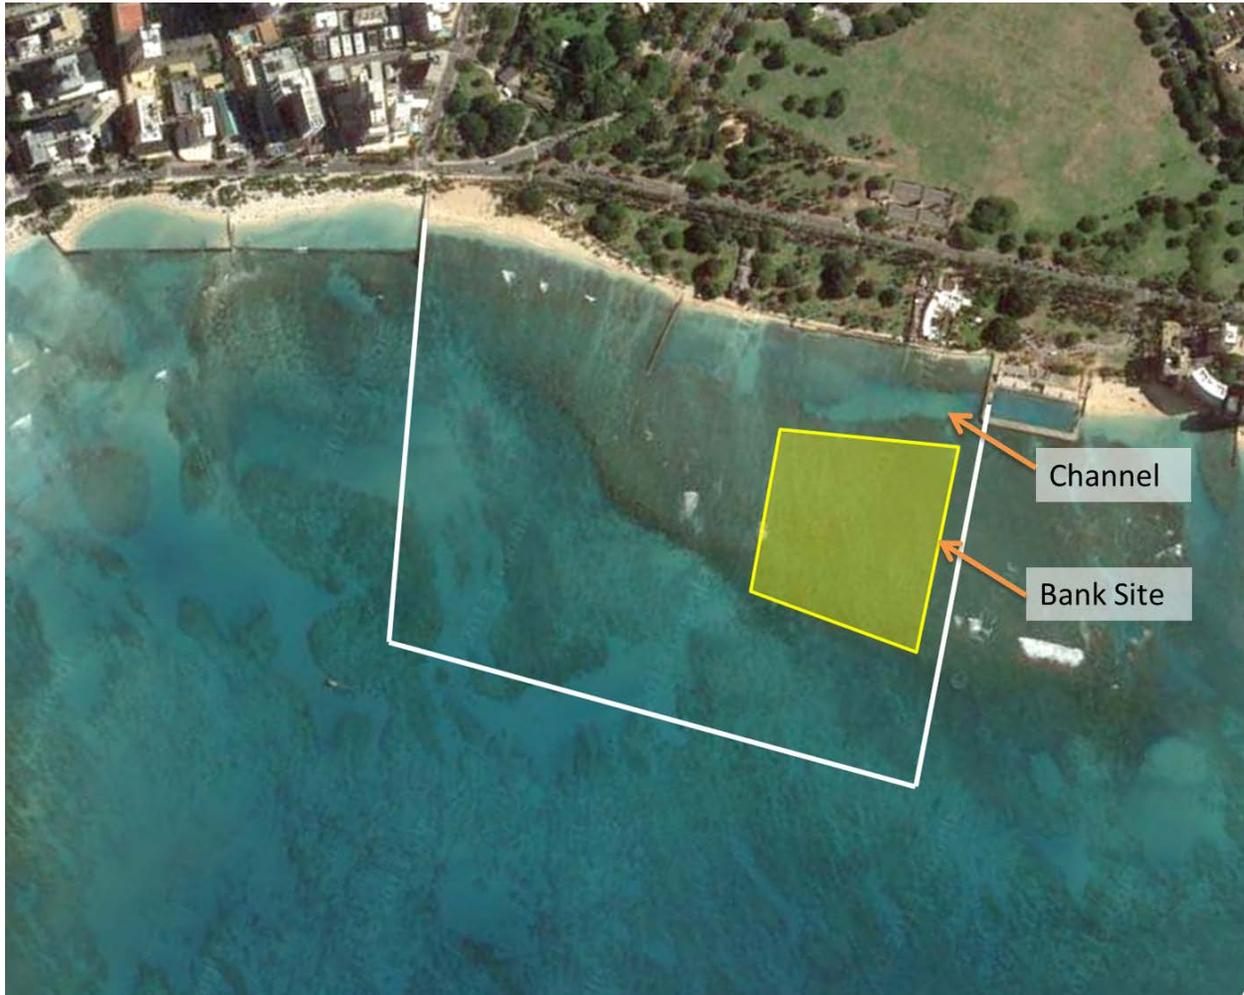
FIGURE 9. PROPOSED BANK SITE/TARGET CORAL RESTORATION AREA (YELLOW) WITHIN THE MLCD

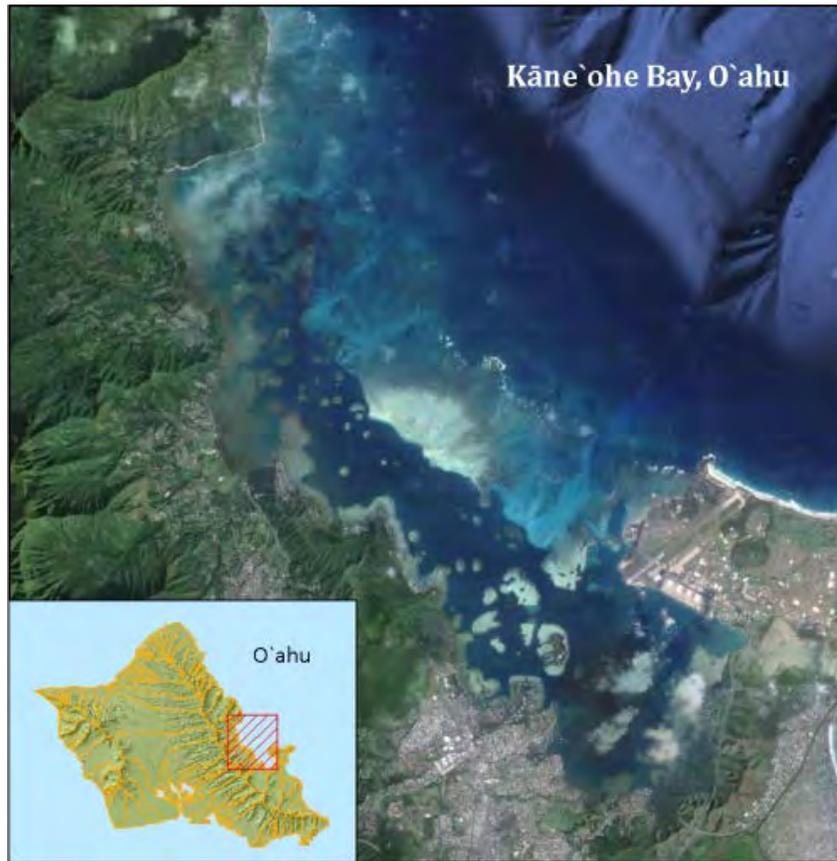
FIGURE 10. KĀNE`OHE BAY, O`AHU

Kāne`ohe Bay (Bay) is the largest embayment in the Hawaiian Islands and contains a diverse array of marine ecosystems including open water, sand flat, barrier reef, patch reefs, and fringing reef (Figure 10). The large (~2.5 mile) barrier reef shelters the bay from tradewind swell and creates ideal conditions for coral growth. The Bay is extremely unique in that it contains numerous patch reefs, which are distinct island-like reef features providing an abundance of coral and marine life.

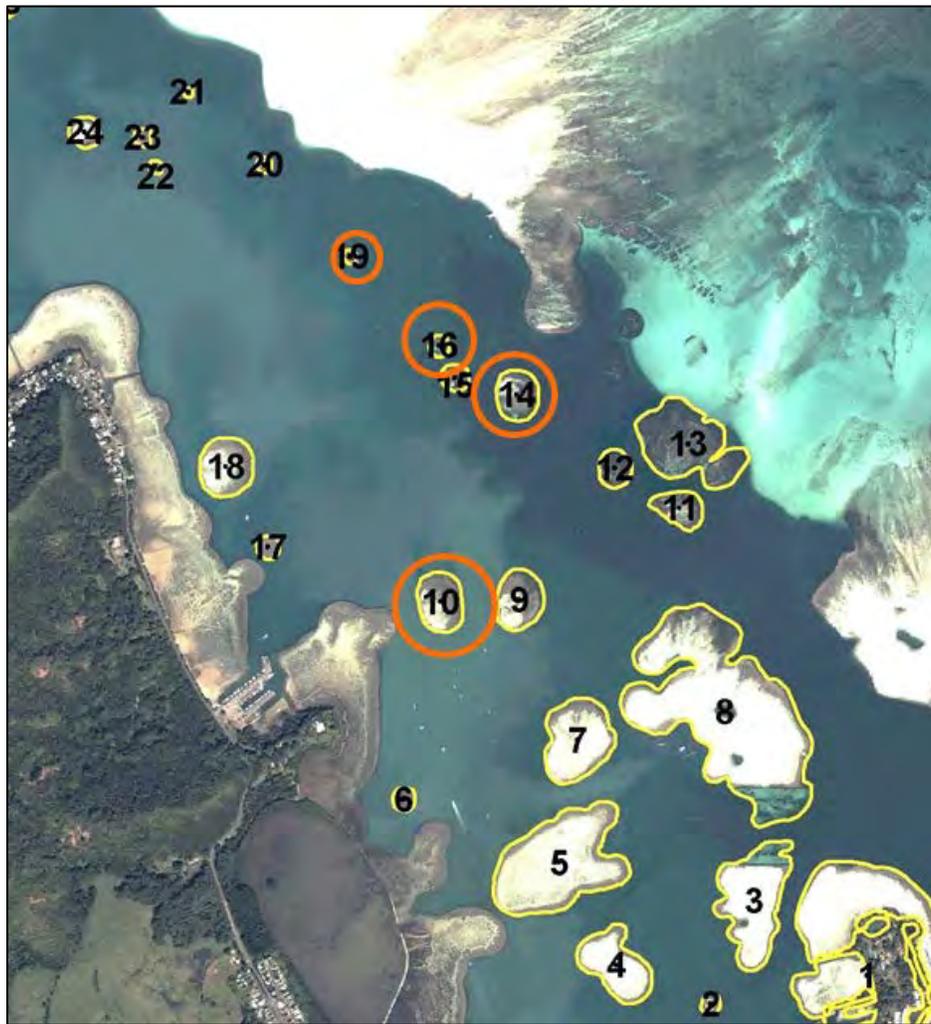
FIGURE 11. BANK REEFS, #10,14,16,19

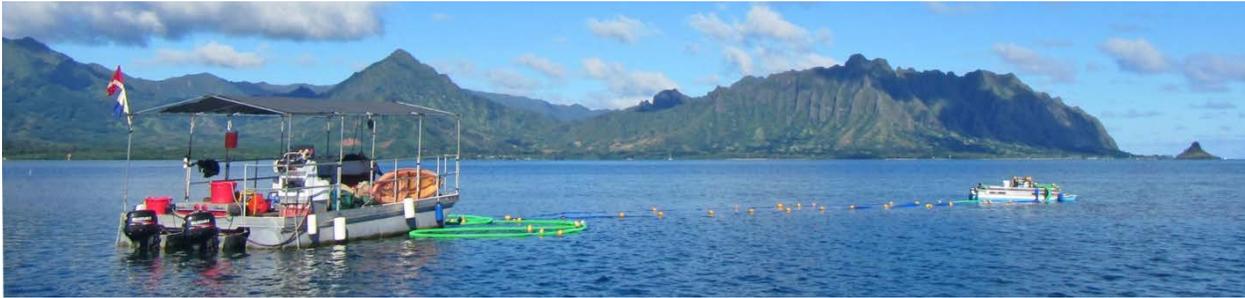
FIGURE 12. SUPERSUCKER BARGE WORKING IN KĀNE`OHE BAY

Reef restoration is carried out in two phases; first the invasive algae are removed mechanically and secondly the biocontrol agents (native sea-urchins) are outplanted to the reef. The “SuperSucker,” (Figure 12) designed by the University of Hawai`i and the Nature Conservancy, mechanically removes the algae from patch reefs in the Bay. The SuperSucker is an underwater vacuum system designed to remove and transport invasive algae from the reef (see Appendix H). Divers remove the algae from the reef by hand and feed it into a vacuum hose. The hose moves the algae from the reef to the barge. Once the algae reaches the barge it is sorted and bagged and then given to local farmers in the watershed for compost.

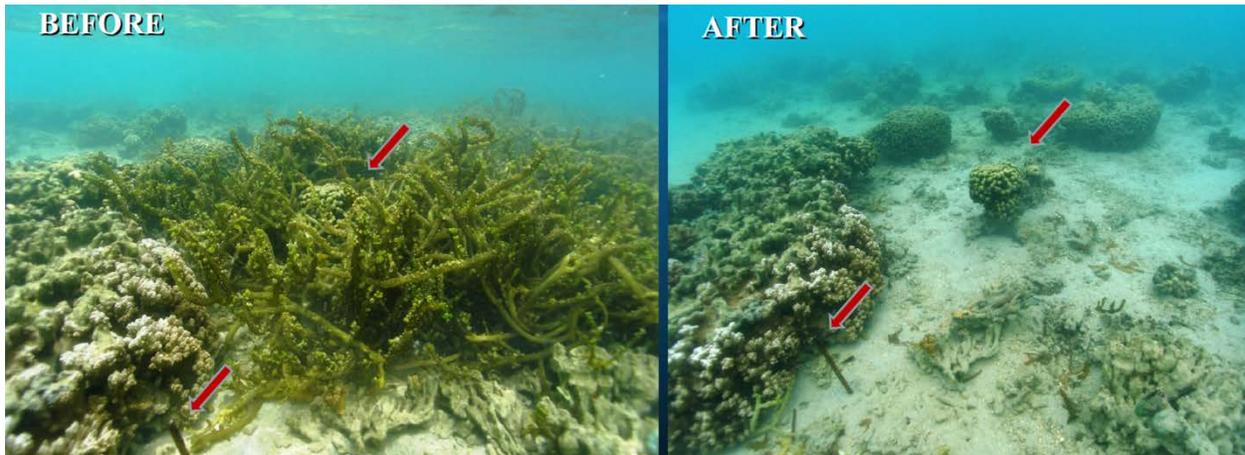
FIGURE 13. PHOTOS OF A REEF BEFORE AND AFTER CLEARING WITH THE SUPERSUCKER, ARROWS SHOW POINTS OF REFERENCE

DLNR's early projects in the Bay revealed that the SuperSucker efforts alone cannot restore the reefs in the Bay. A single reef can require 2-3 months to clear, and the removed algae grows back within 4-6 months. DLNR determined that grazing animals can be an effective natural bio-control, particularly the native collector urchin *Tripneustes gratila*. This short-spined species is found throughout the Hawaiian archipelago, can be reared via aquaculture, and is an effective grazer of *Kappaphycus/Eucheuma spp.* Once outplanted, the urchins remain on the desired reefs because urchins do not like to traverse the sand channels between patch reefs. In 2008, DLNR began a project on small patch reef #16 to test a combination of mechanical removal of algae with the outplanting of native grazing sea urchins (See Appendix B for a full description). The success of this project prompted DLNR to research, design, and build the state's only aquaculture facility for native urchins in order to supply the anticipated numbers needed for landscape scale algae control. Subsequently, DLNR conducted a larger multi-year restoration project on three additional reefs (see Appendix C).

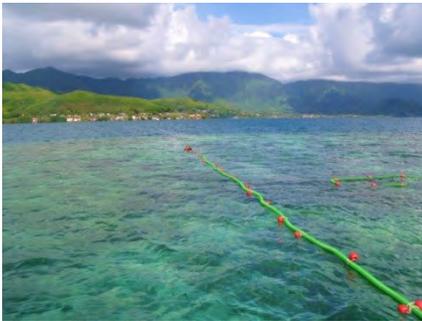
Reef 16: $\approx 3000\text{m}^2$ area and $\approx 10,450$ lbs. algae removed by SuperSucker.

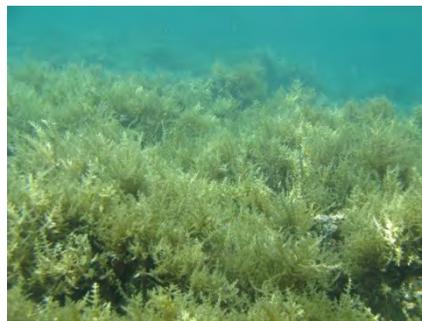
***Kappaphycus/ Eucheuma* spp. coverage on Reef 16.**

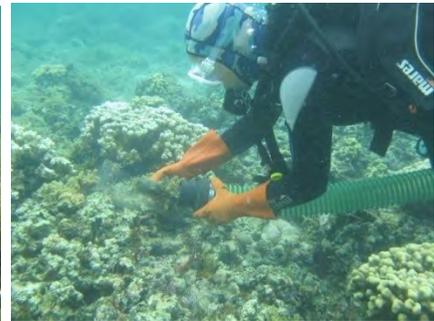
Removing algae from Reef 16, utilizing Super Sucker underwater vacuum hose.

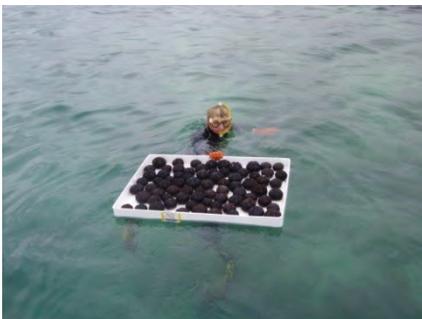
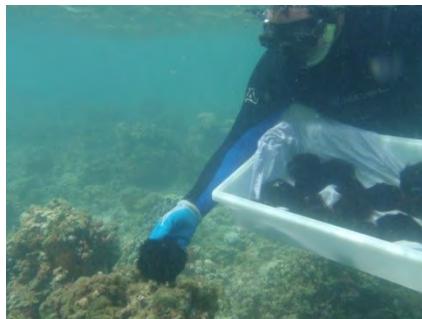
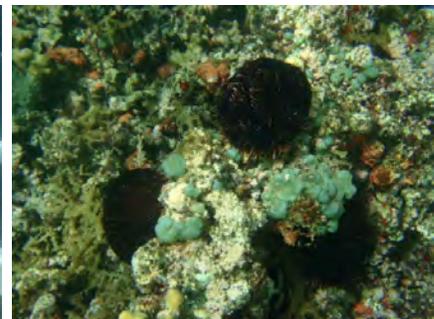
Divers hand-transplanted collector urchins directly to areas of Windward side of Reef 16 with residual *Kappaphycus/ Eucheuma* spp. fragments.

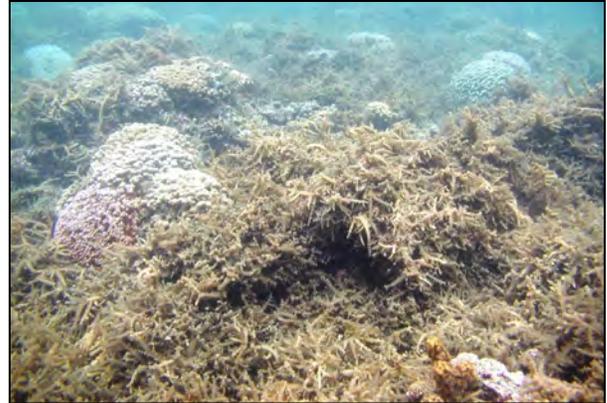
Algae covered reef prior to clearing by the super sucker

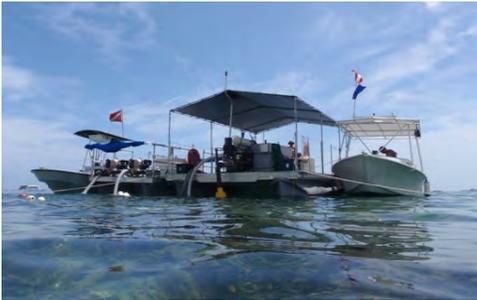
Super Sucker at Work

The Super Sucker “senior” operates primarily in Kāne’ohe Bay, while the “junior” can be launched from any boat ramp on the island. The algae removal process is accomplished with a five-person crew: 2 divers, 2 top-side sorters, and a boat driver. The divers, equipped with hundreds of feet of flexible four-inch hose, descend below the surface, where they selectively feed the alien algae into the suction hose. Invasive algae re-grows easily from even small fragments, so care is taken to minimize breakage during suction. The venture-style pump has no blades and deposits the algae intact on the barge’s sorting table, where any native by-catch is removed and returned to the reef. All remaining algae is drained and bagged, and then recycled through a partnership with upland taro farmers, who utilize the algae as high nutrient fertilizer.

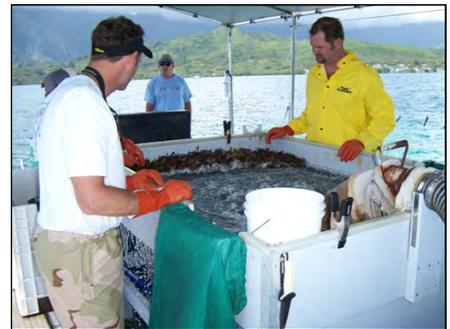
The Super Sucker can remove up to 3,000 pounds of algae per day from severely infested reefs. Often the underlying coral, while stressed from the smothering algae, can thrive once exposed. The team revisits target reefs regularly to keep the algal cover to a manageable level. New methods are being developed to control invasive algae and restore reef health, but until those are implemented the Super Sucker remains the only tool capable of removing significant algal overgrowth and preventing further coral reef decline.
