PUBLIC NOTICE

Public Notice No. POH-2006-338

WATERWAY NAME: Kuhio and Hilo Bays, Hilo Commercial Harbor, Hawaii Island

Dredge Material Evaluation for Ocean Disposal: Construction of Inter-Island Cargo Terminal Facility at Hilo Harbor, Hawaii

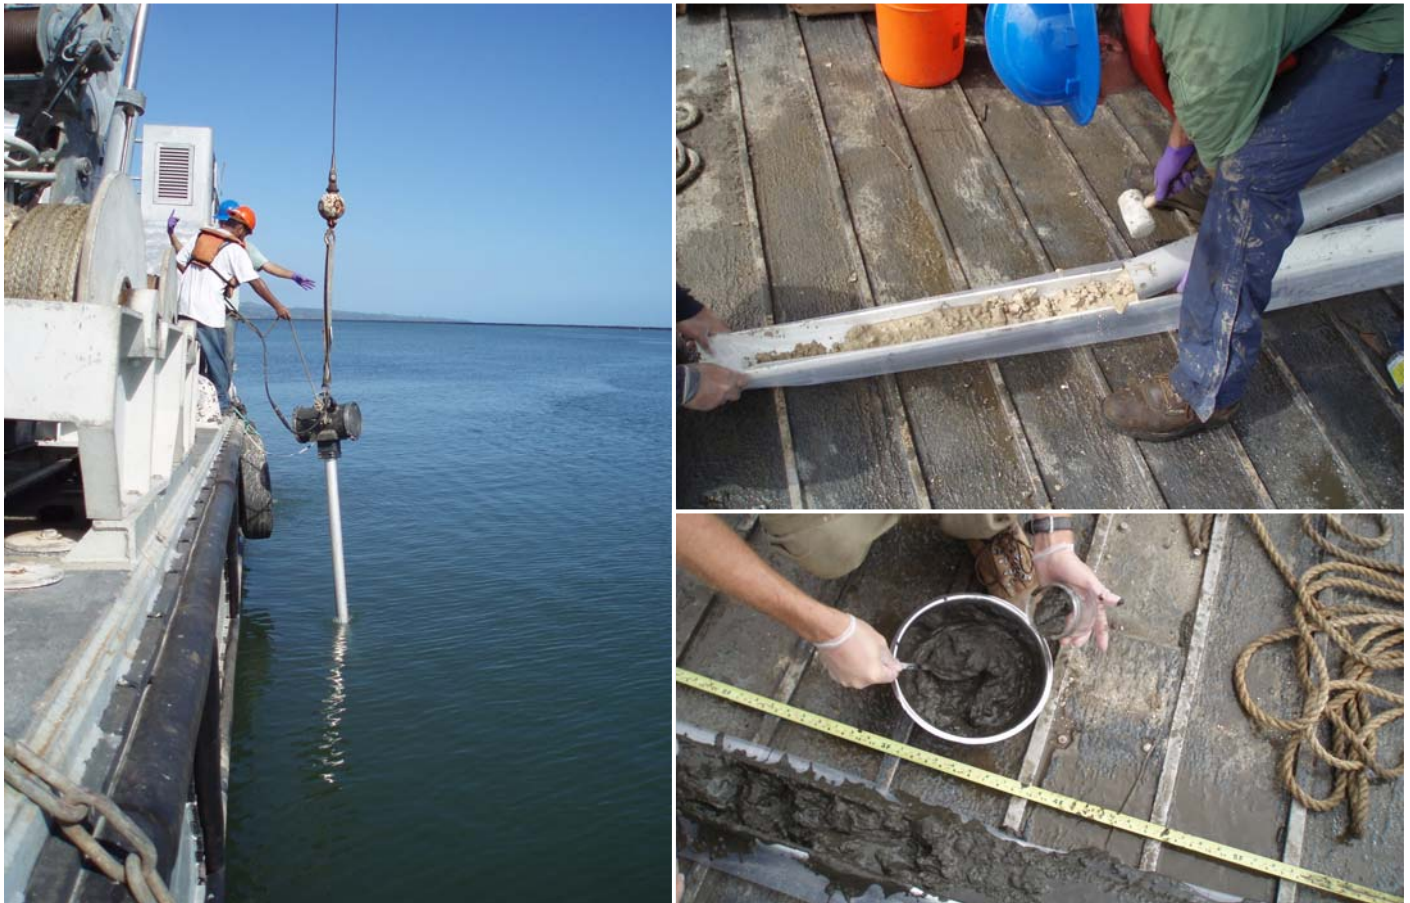
Figure 5. Sampling activities. Left: Positioning of vibracoring equipment. Upper-right: Extraction of the core contents into lined sampling tray. Bottom-right: Sub-sampling the core contents, homogenization, filling sample jars.

landing, has a very shallow draft, allowing the boat to maneuver very close to shore. A vibracore with a four-inch outer diameter aluminum pipe was suspended from the onboard hydraulic crane, and swung over the side of the ship. A GPS reading of the actual sampling point was taken at the side of the ship during coring. All cores were expected to encounter refusal prior to reaching the planned dredging depth of 25 feet. The vibracore was allowed to advance to two feet past dredging depth or until it met refusal. Refusal was defined as the vibracore advancing less than 2 inches per minute. Most of the stations required coring twice to ensure sufficient sediment volume for all analyses.

Sediment cores were deposited into a sampling tray freshly lined with plastic, where strata were identified and samples collected. In the field, sediment subsamples were collected from along the length of the core and deposited into a stainless steel bowl where they were homogenized. Multiple jars were then filled with the homogenized sample material for archiving, physical analyses, and chemical analyses. Sediment remaining in the sampling trays was deposited into bags for bioassay analyses. All sediment collected for analysis was placed in closed coolers on ice. The laboratories were given instructions for compositing the samples into two groups (inshore, seaward) proportionally by sampling depth and volume.

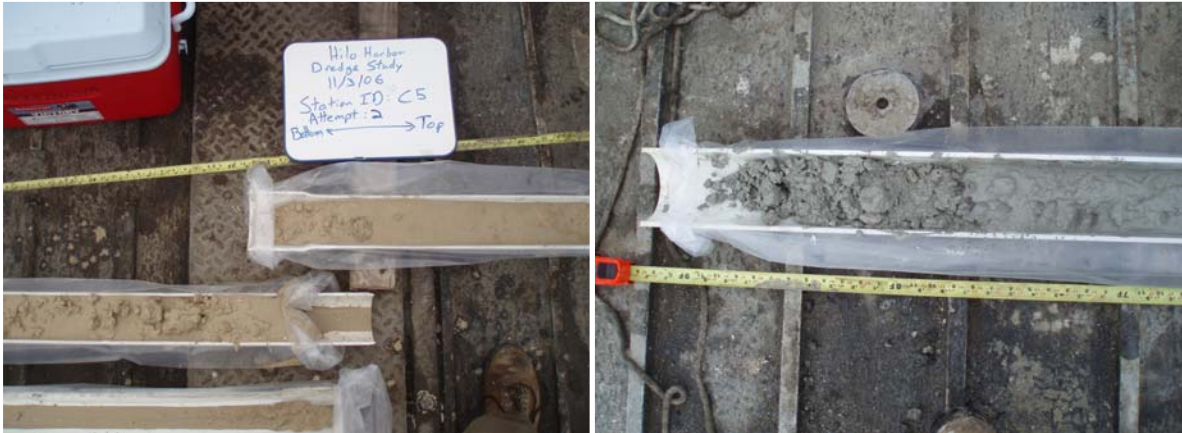
Figure 9. View of typical core, laid out in sampling trays. Coral detritus in sand matrix (left). Coral detritus in a silt/sand/basalt matrix (right).

The vibracore was not able to penetrate to the proposed dredge depth at many of the sampling points. Physical characterization of the sediments concurred with the jet probe and boring analyses, however, confirming a mixture of coral detritus (dead coral pieces) and sand making up most of the proposed dredge volume. A 1–3 foot layer of silt was found at sampling points close to shore, as well as along the drop-off to the existing active shipping channel. The plateau had a much thinner layer of mud/silt. Ultimately, compacted coral detritus cemented together by sand particles caused vibracore refusal at all but one of the points. At point E1, both vibracore attempts ended with refusal against a solid substrate, presumably the basalt bench encountered during the geotechnical borings.
