SITE SPECIFIC FINAL REPORT
Munitions and Explosives of Concern (MEC) Removal Action and Supporting Functions
Former He‘eia Combat Training Area and Former Pali Training Camp, Island of O‘ahu, Hawai‘i

U.S. ARMY CORPS OF ENGINEERS, HONOLULU DISTRICT

Environet, Inc.

July 13, 2012

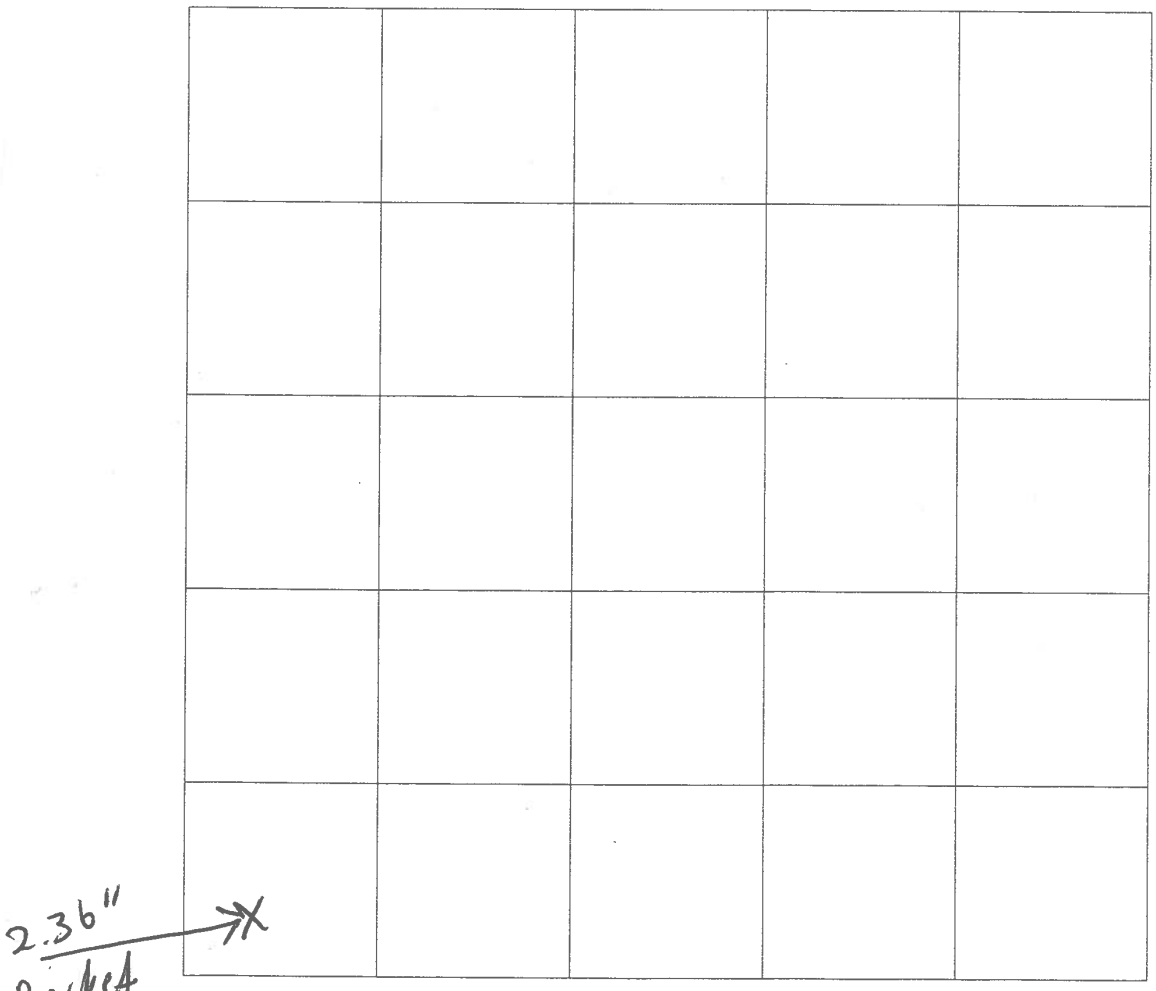
Field Notes: / Yellow Jacket nest eliminated. (1) 2.36" rocket found. PRACTICE. (45) FLAGS.

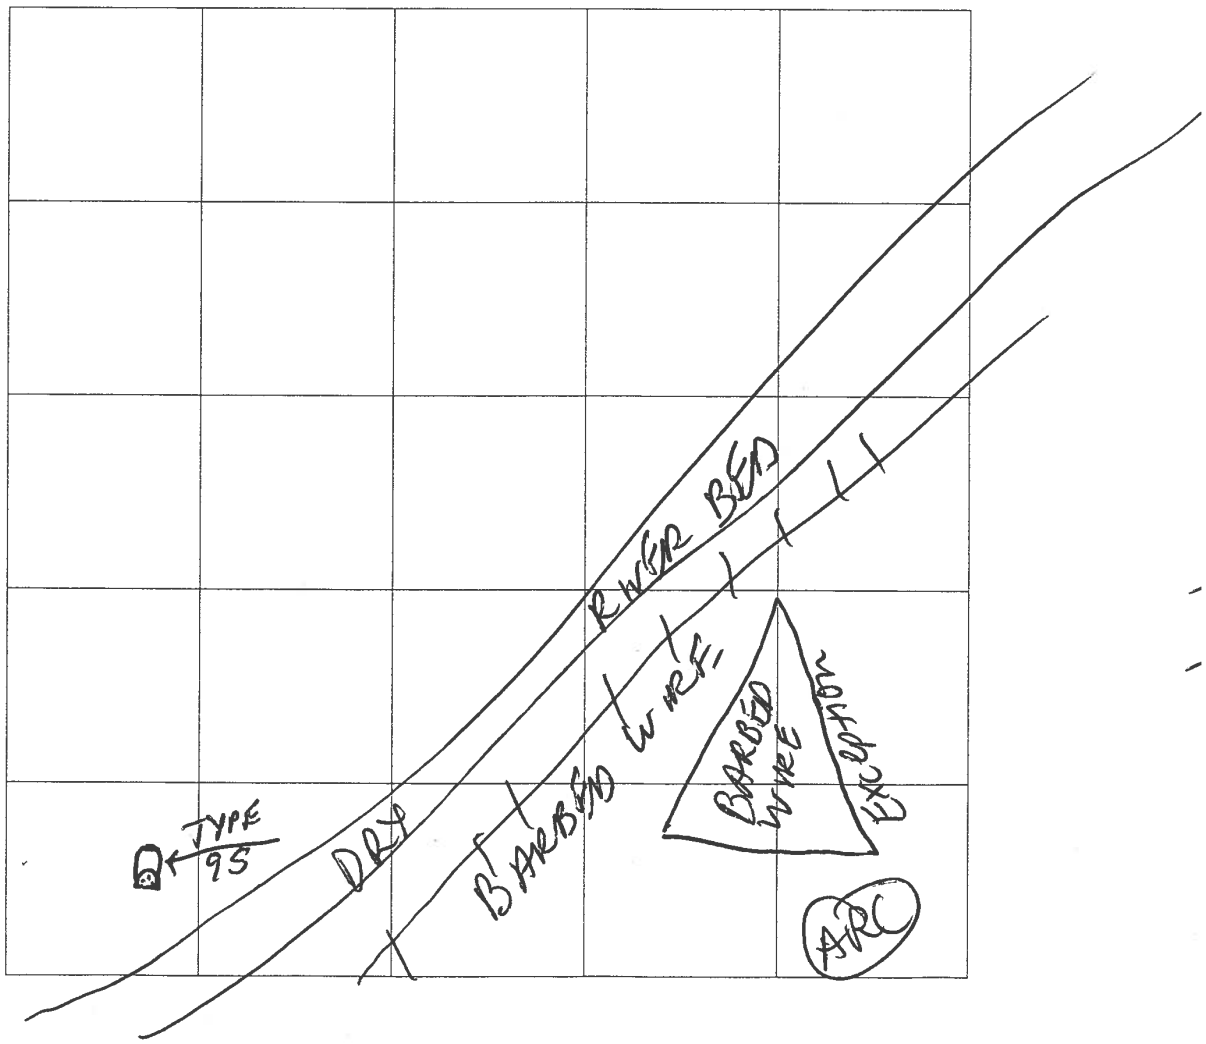
Team #: 5 Date: 10-19-11 Grid: 2250-7190

Field Notes: (78) FLAGS, (1) Type 95 Ni Mortar -

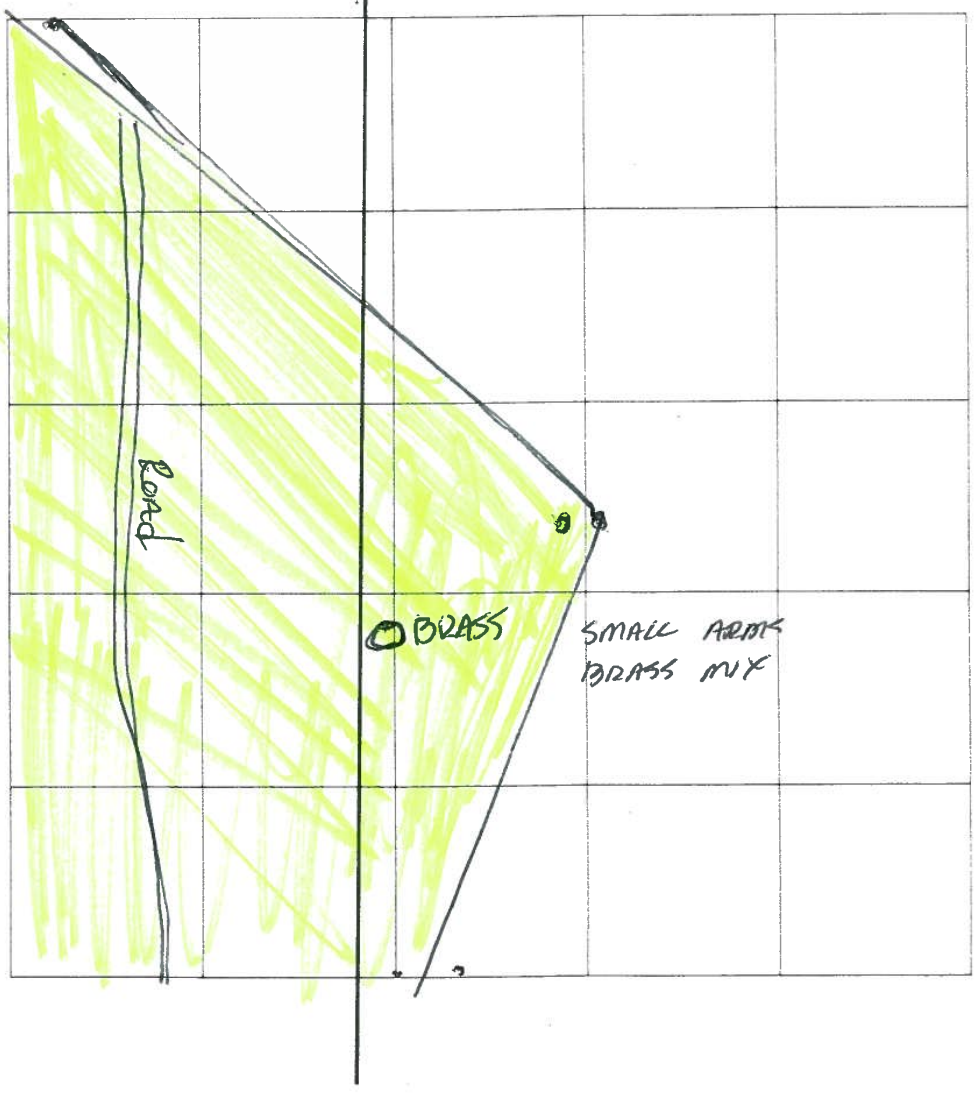
MEC Scrap Weight		3 Lbs.
Non MEC Scrap Weight		4 Lbs.
Geo Anomalies	(count)	~~22~~
Field Eliminated Anomalies	(count)	~~21~~ 43
Live Small Arms	(count)	Ø
Exception Area(s)	YES NO	
Seed Found	(count)	Ø
*MEC Found	(count)	1 m9 Rifle Grenade

Field Notes:
* Blue stake's at SW corner But Entire Grid swept
* cable still in Ground
* Trash Pile AT NE corner

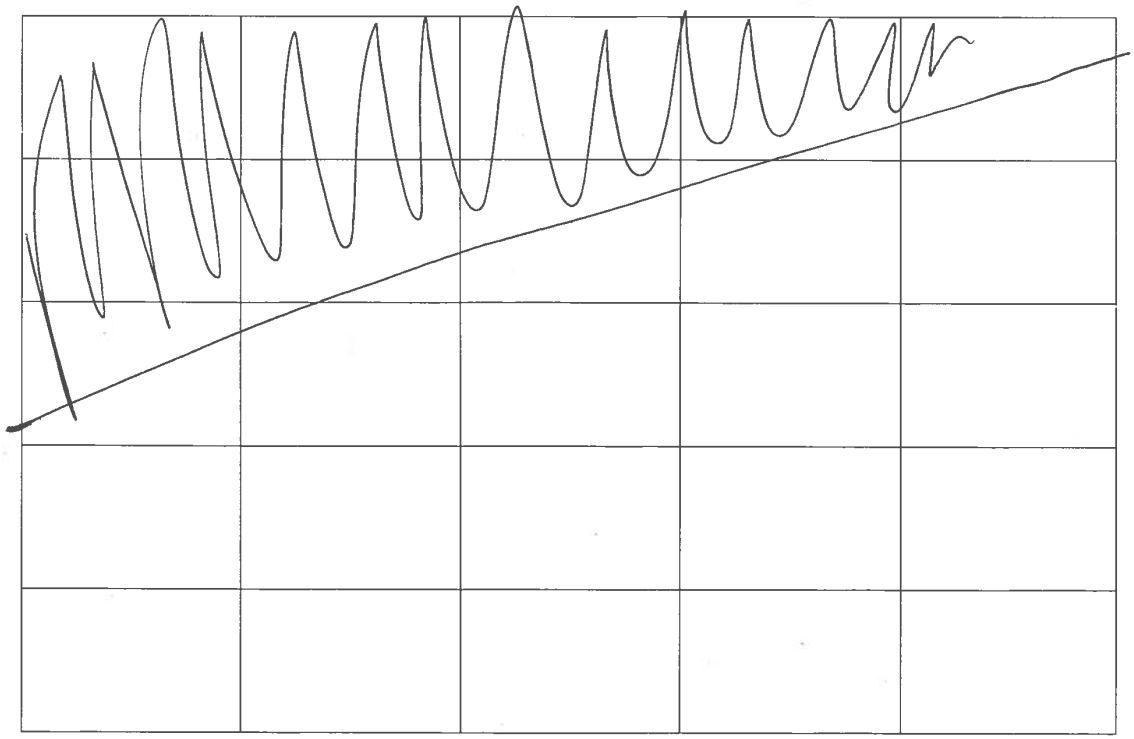
QC Note: Rework
4 large pieces of screen edging located during QC Sampling. Items were uninvestigated beneath dead grass.

Resweep

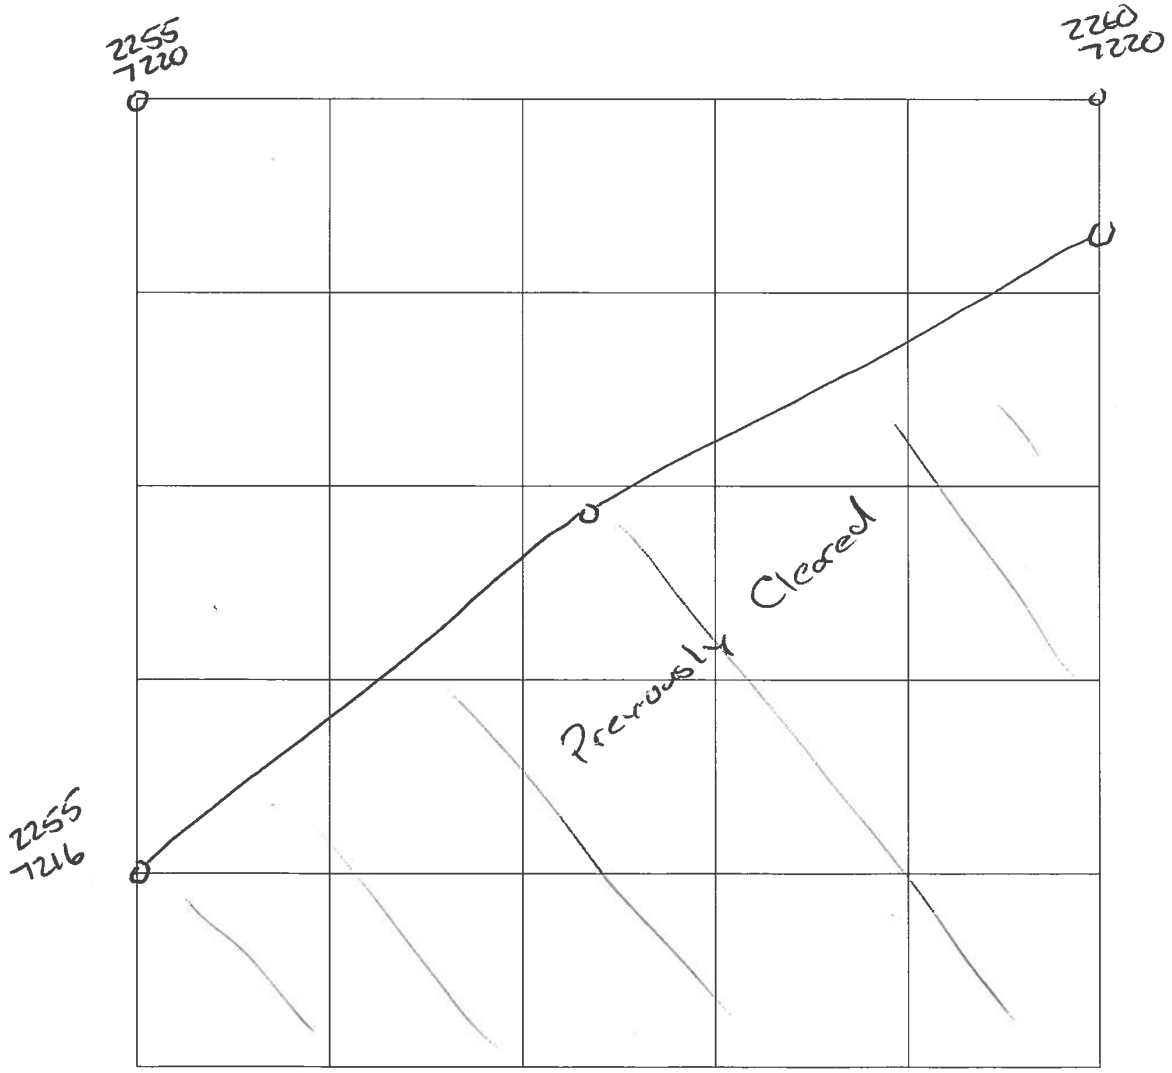
MEC Scrap Weight	45	Lbs.
Non MEC Scrap Weight	5	Lbs.
Field Eliminated Anomalies	(count) 79	
Exception Area(s)	YES (NO)	
Seed Found	(count) 0	
*MEC Found	(count) 1

Field Notes: Rope Used
① MEC Found

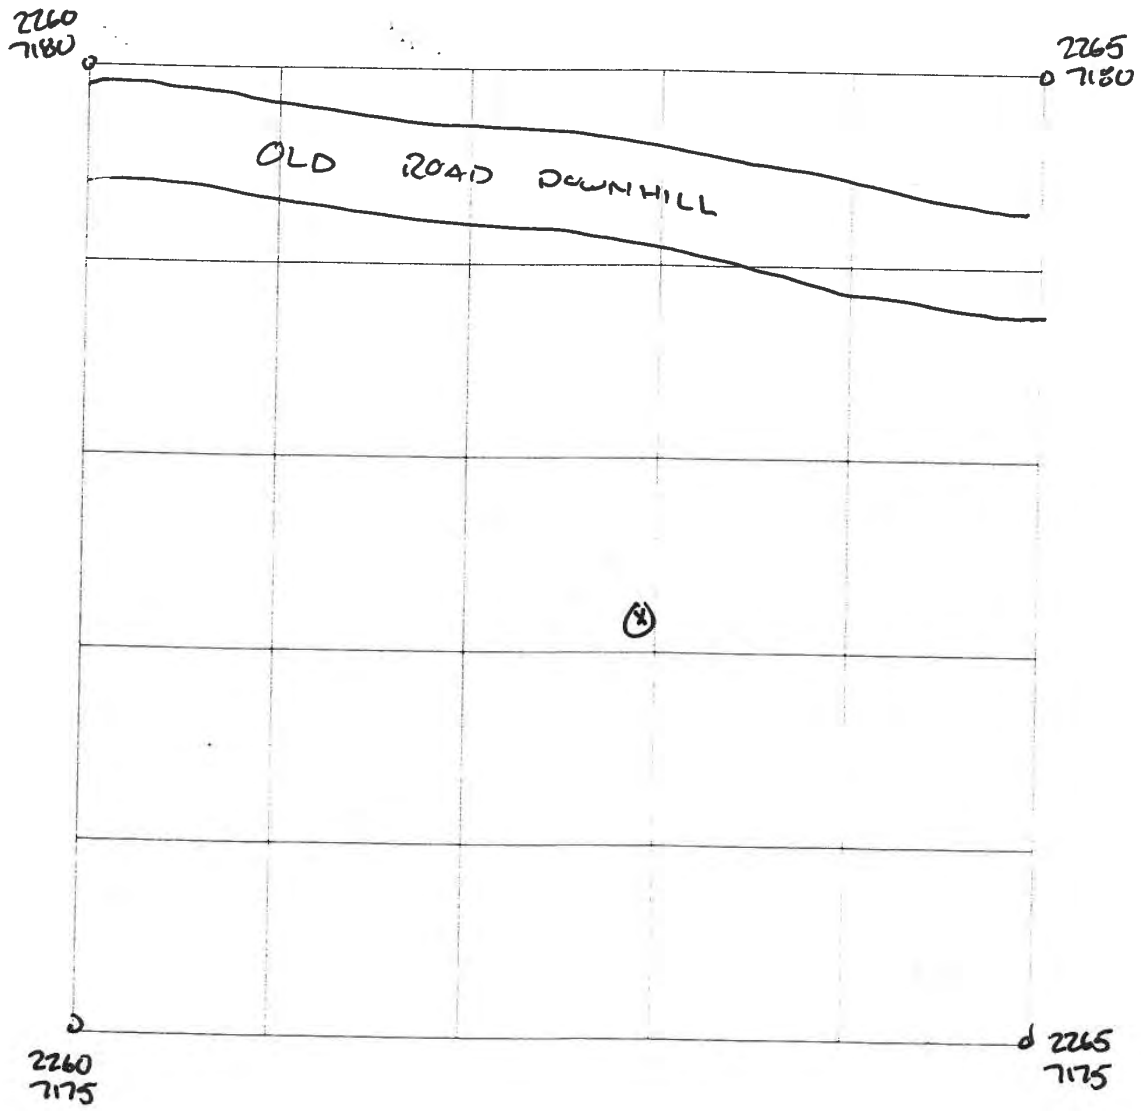
MEC Scrap Weight	12	Lbs.
Non MEC Scrap Weight	126	Lbs.
Field Eliminated Anomalies	(count) 75	
Exception Area(s)	YES NO	
Seed Found	(count) ∅	
*MEC Found	(count) 1 - Grenade Fuze

Field Notes: T Tree
1
2 Backhoe Dig
3 Backhoe Dig
4/0 4b heavy Cable
No MEC Trash
4 Backhoe Dig
mute 5 Backhoe Dig
6 ~~MK-2~~ Grenade
M1A1
Not Cleared
Cleared

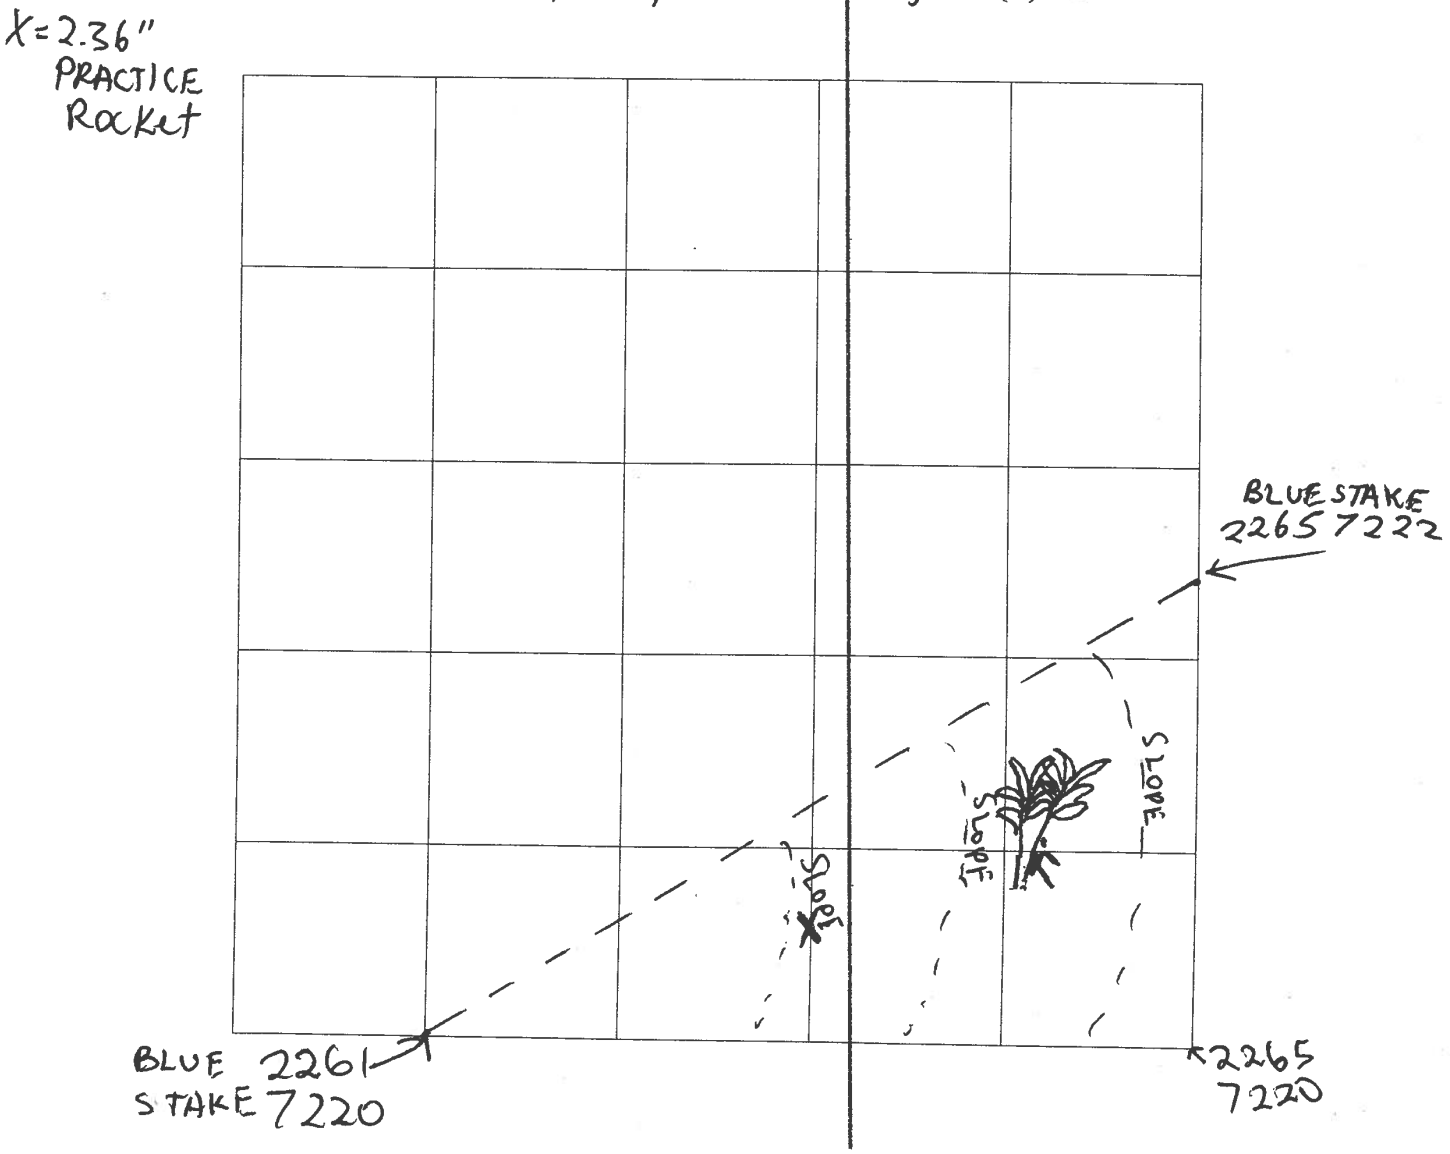
Team #: 2 Date: 9/30/11 Grid: 2260 - 7220 (B)

Field Notes: Medium trees, Grassy SLOPE 30-45 Degrees. (1) 2.36" Rocket Practice.

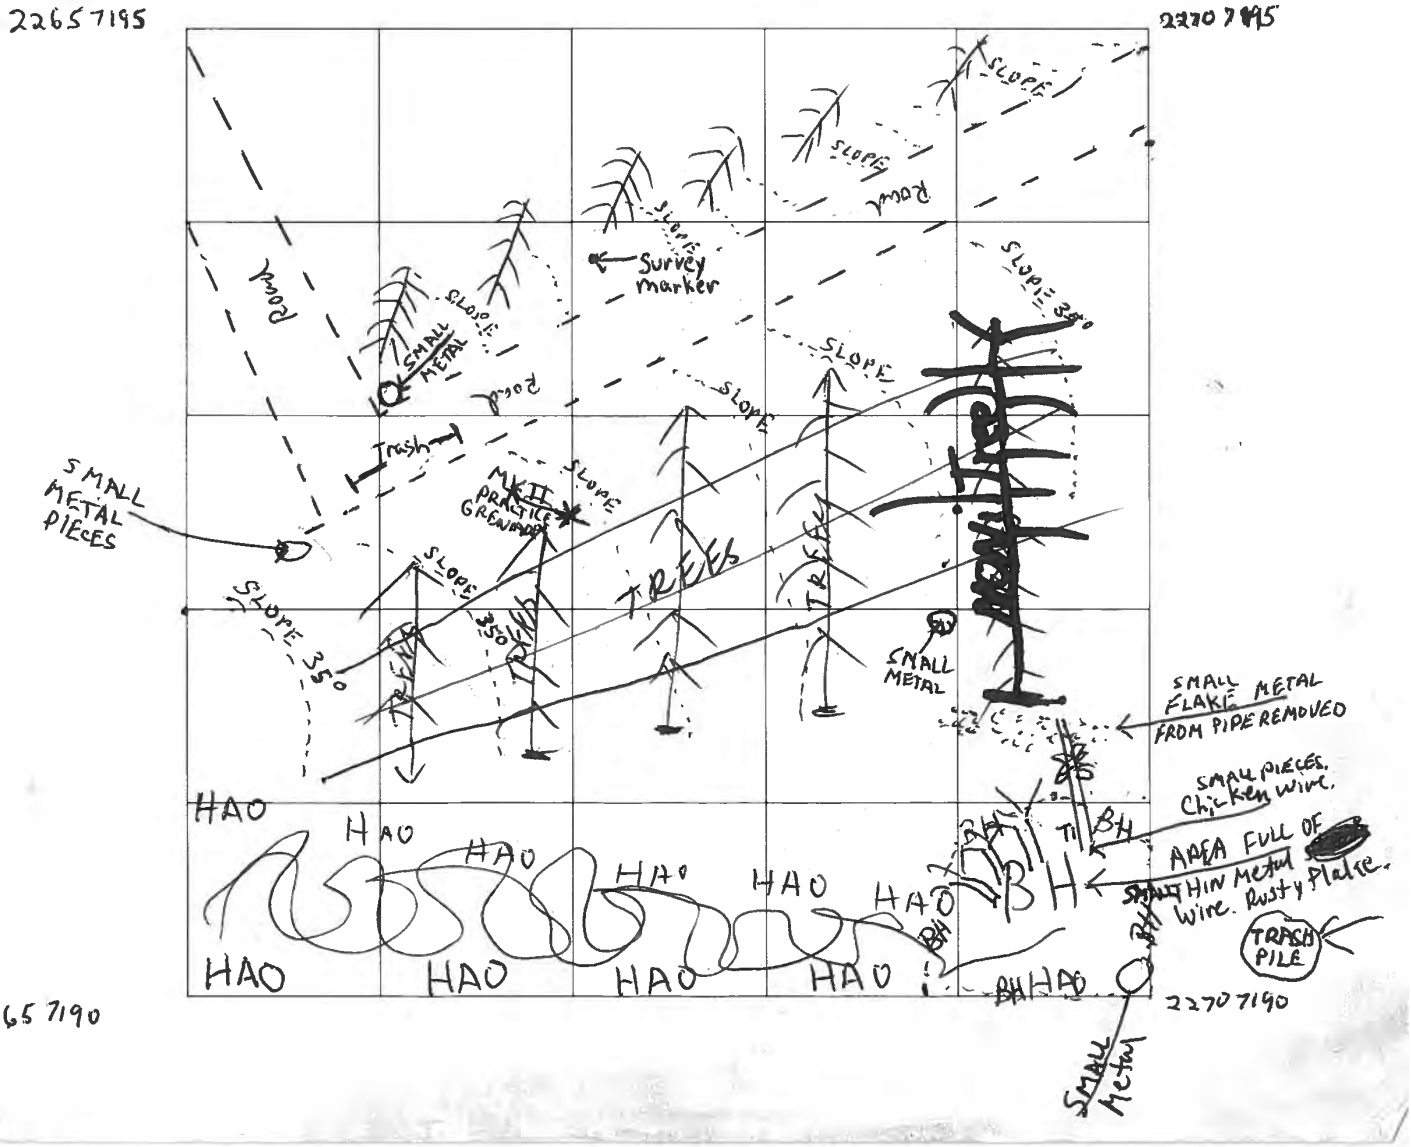
Team #: 1 Date: 8-26-11 Grid: 2265 7195

Field Notes: Heavy with HAO trees on South portion of Grid, Backhoe needed For South East Corner. Found 1 MKII PRAC. Grenade. Scraped ~~[illegible]~~ + dug backhoe area.

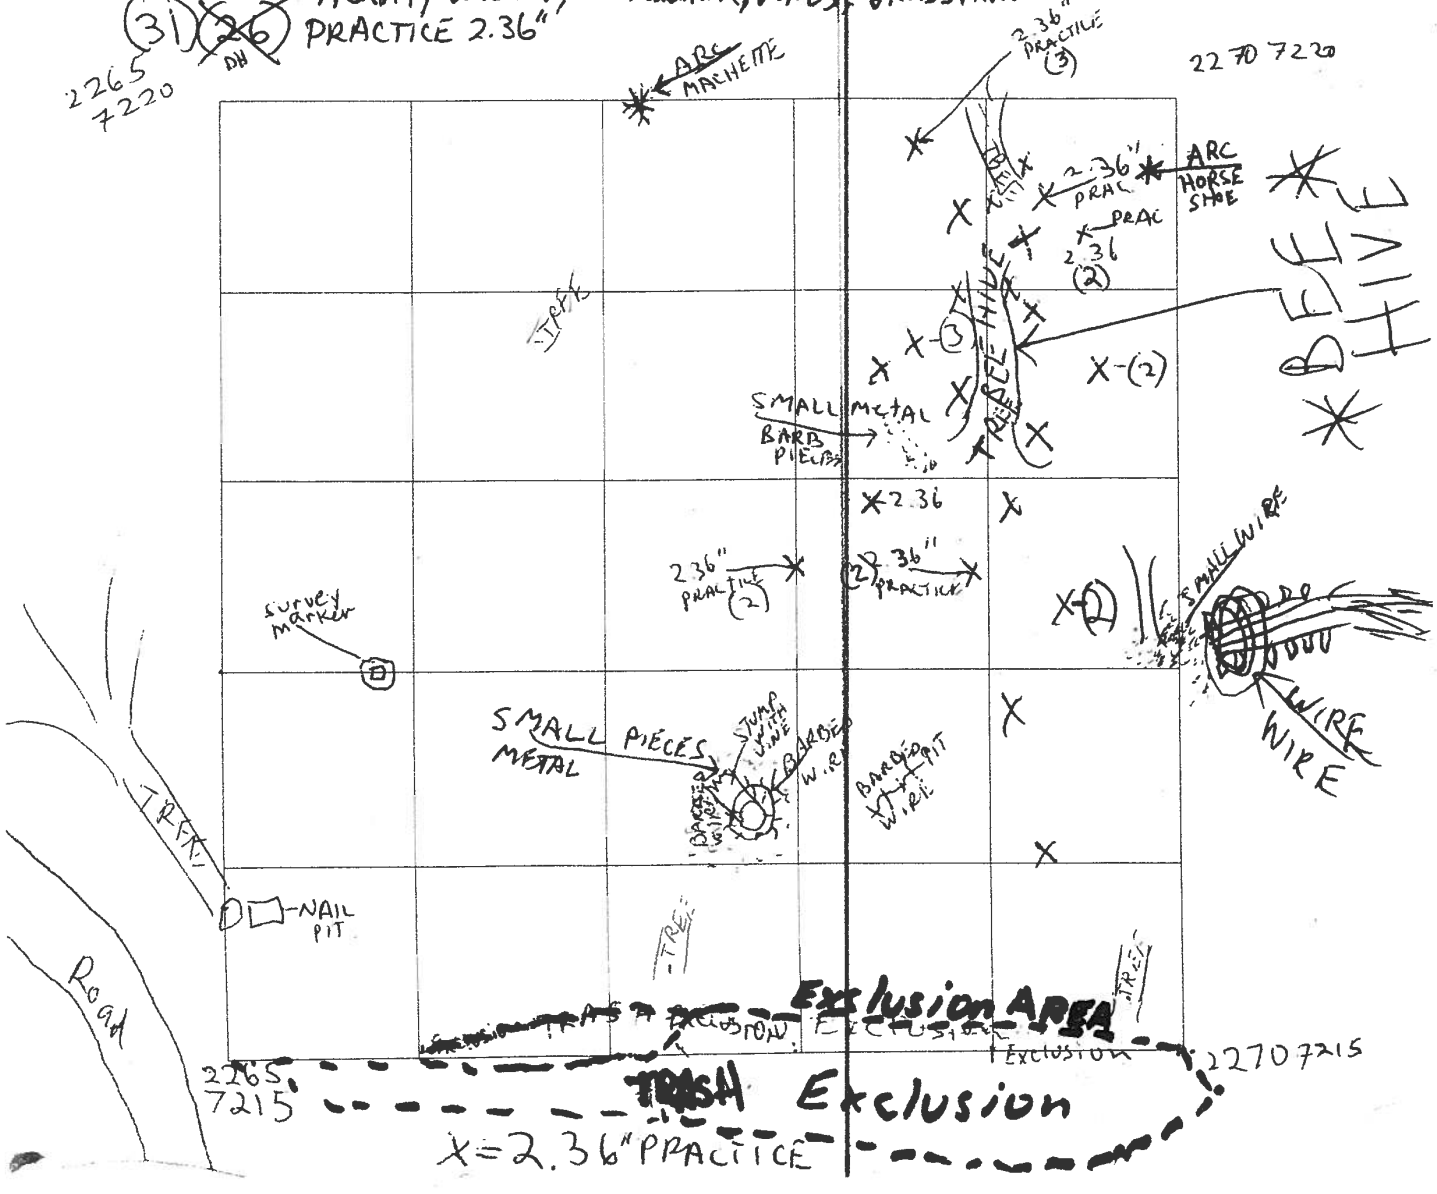
Team #: 5 Date: 9-7-11 9-8-11 Grid: 2265 7220

Field Notes: Heavily wooded, LARGE Dead Fall, VINES, GRASS THROUGHOUT
(31) ~~(26)~~ DH PRACTICE 2.36"

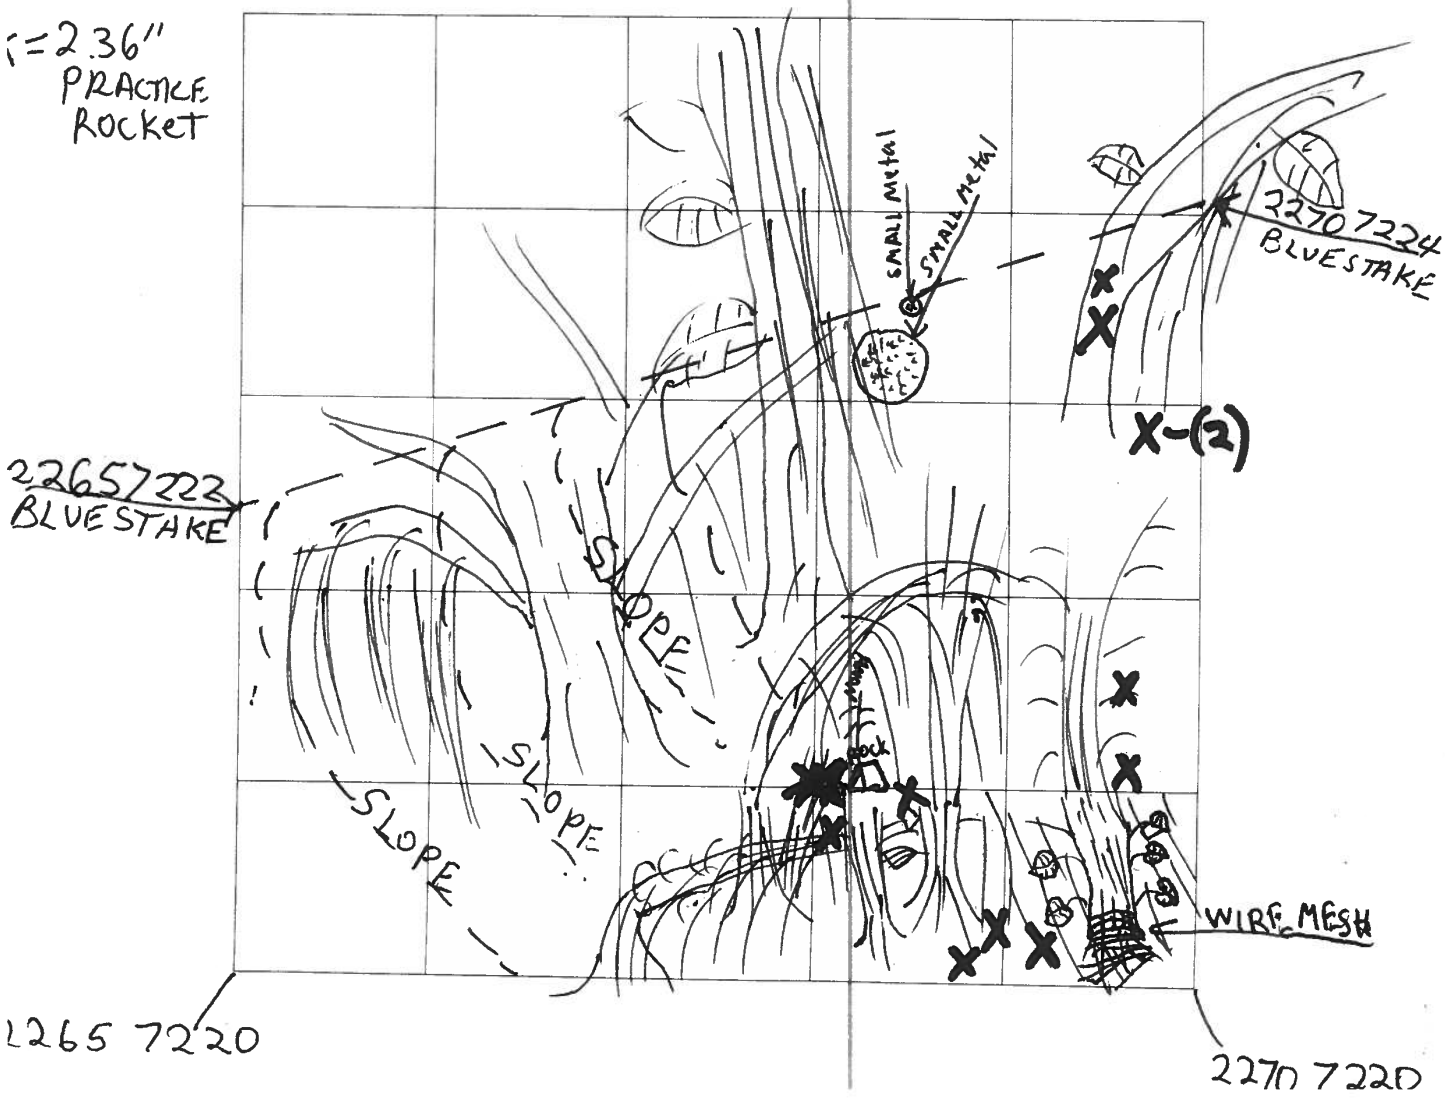
Team #: 2 Date: 9/30/11 Grid: 2265-7220 (13)

Field Notes: LARGE TREES with Vines, SLOPE 30-45 DEG. (12) 2.36" PRACTICE ROCKETS.

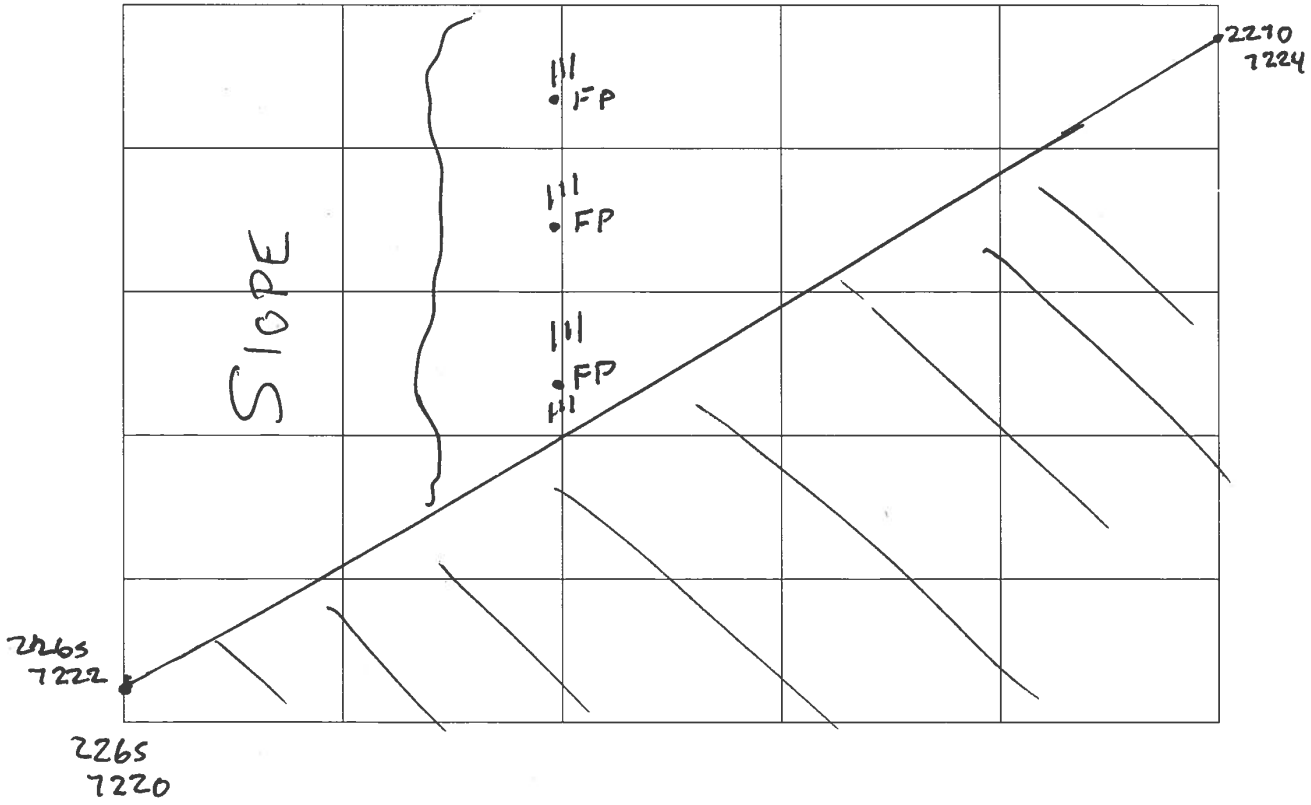
Field Notes: Ø = Practice grenade Body found

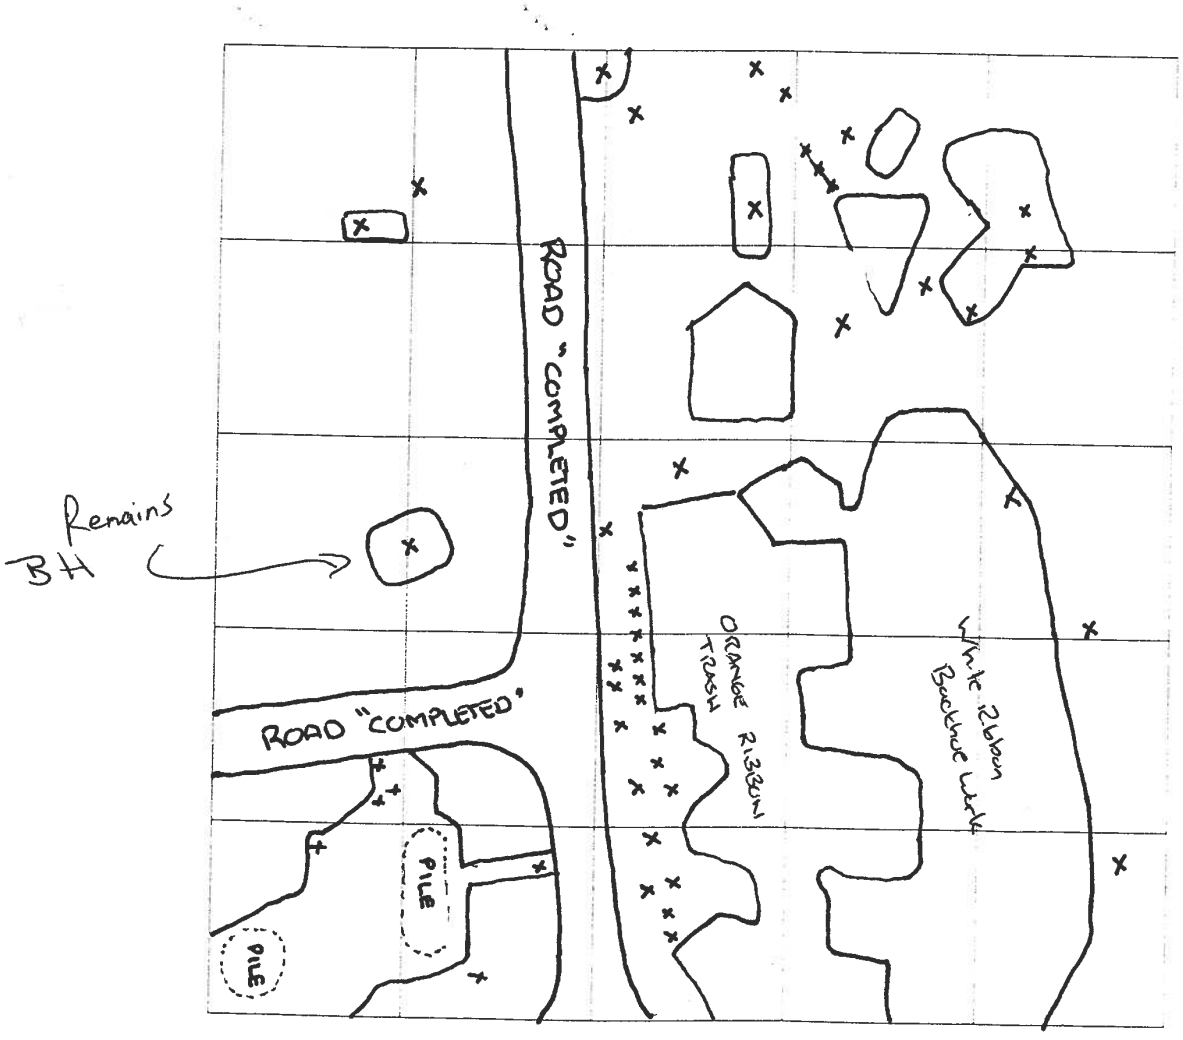
Field Notes: = Hot Backhoe Areas
(#) =(Numbered) Isolated Backhoe Digs
= Noted Areas

1) Car Parts in base of trees
2) Painted Multi-hole Rusted Scrap
3) Scrap
4) Scrap
5) Scrap
6) Scrape
7) Rebar
8) Wire Mesh
9) Angle Iron
10) Angle Iron
11) Pipe (Rusted)
12) Painted Area "Scrape"
13) Two holes
A = Vertical Pipe
B = Grease Tubes
14) Scrap
15) Scrap
16) Scrap
17) Pipe
18) Pipe
19) Pipe
20) Deep Scrap
21) Roofing Material
22) Hot H.E. in Scrape

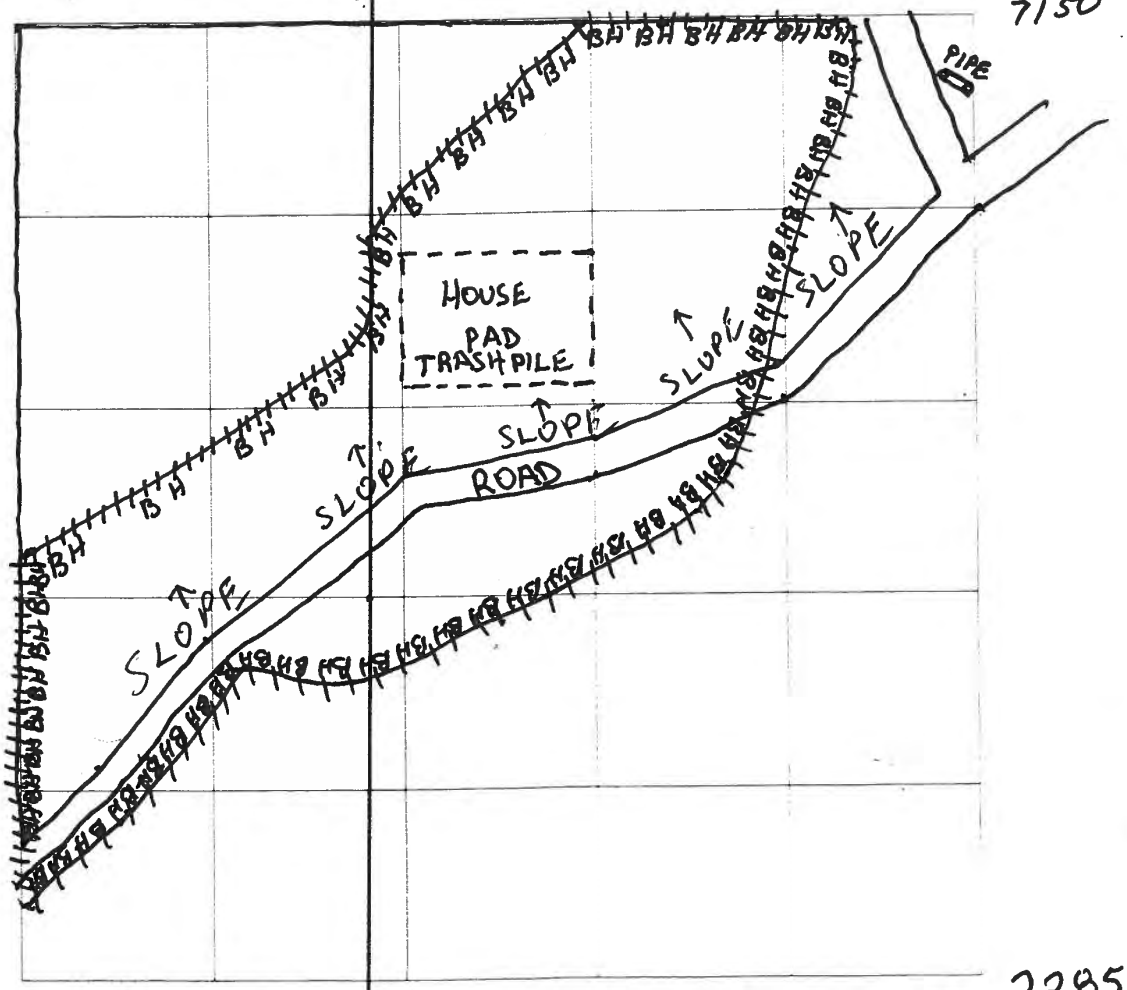
Field Notes: (2) LARGE NAIL PITS (1) SEPTIC HOLE, PIPE BURIED. ARC-LAWNMOWER, LARGE NAILPITS, (1) ARC.

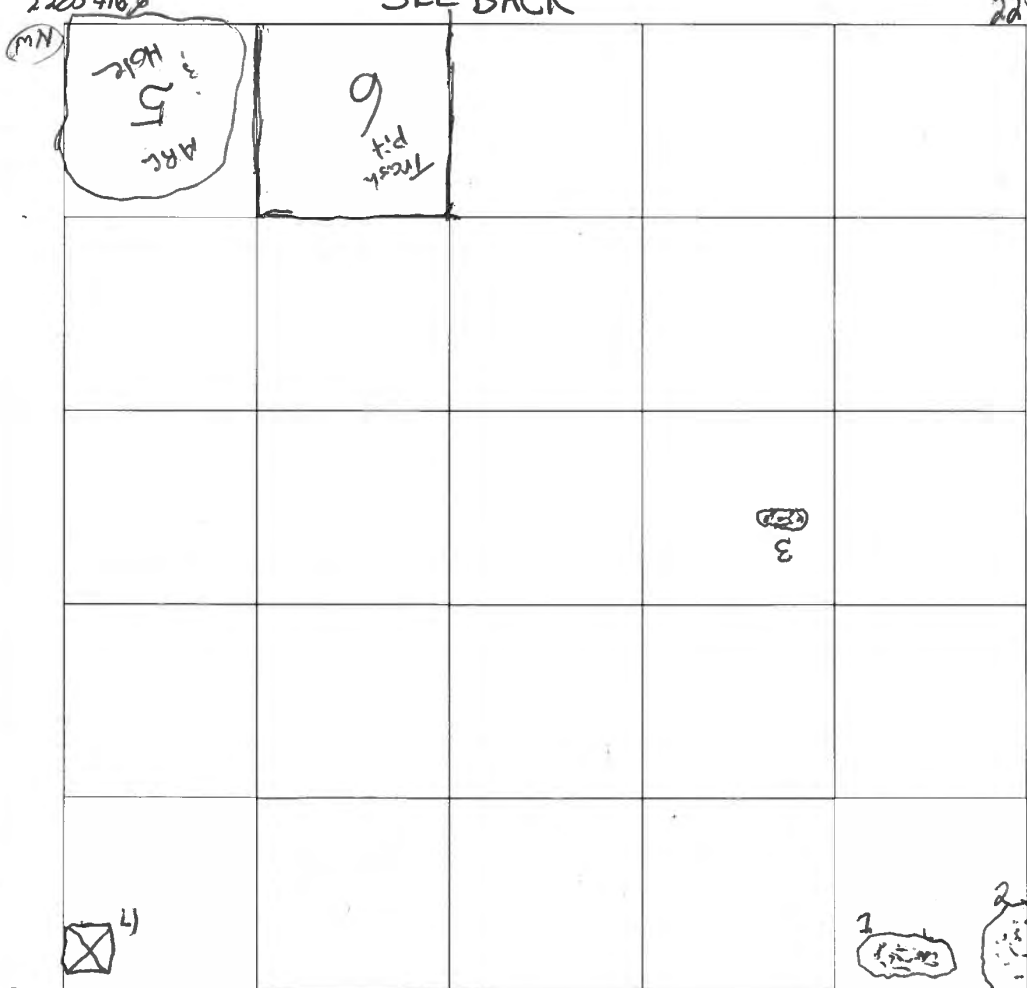
MS 22857155 QC Note: Fail - Resweep 22907155

MK II Practice body Near Eastern Boundary 3" depth uninvestigated

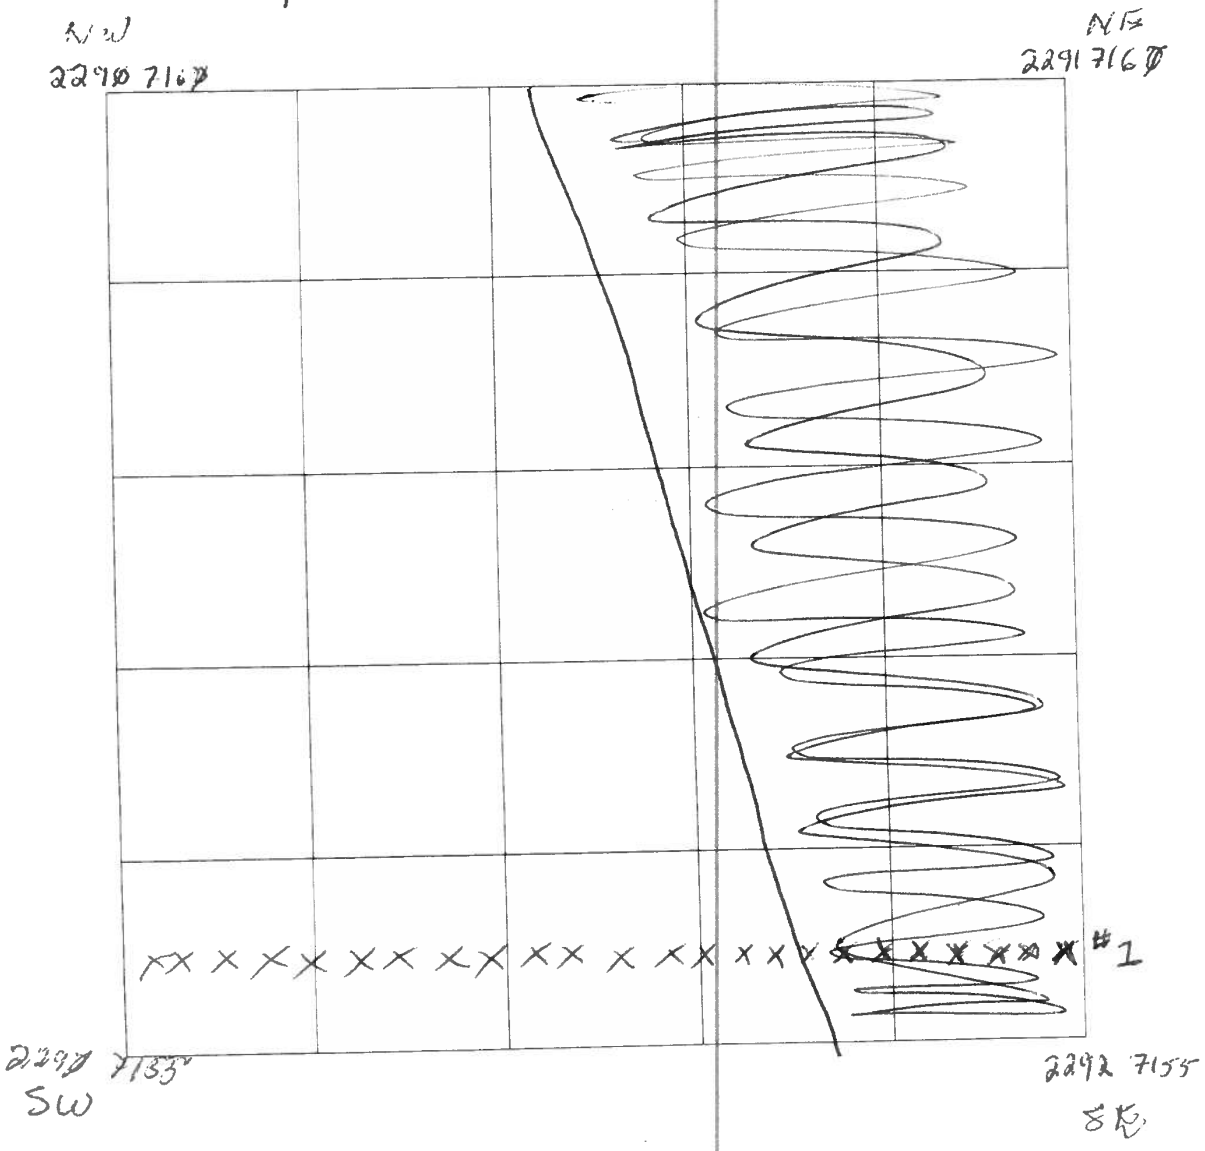
Field Notes: found practice grenade

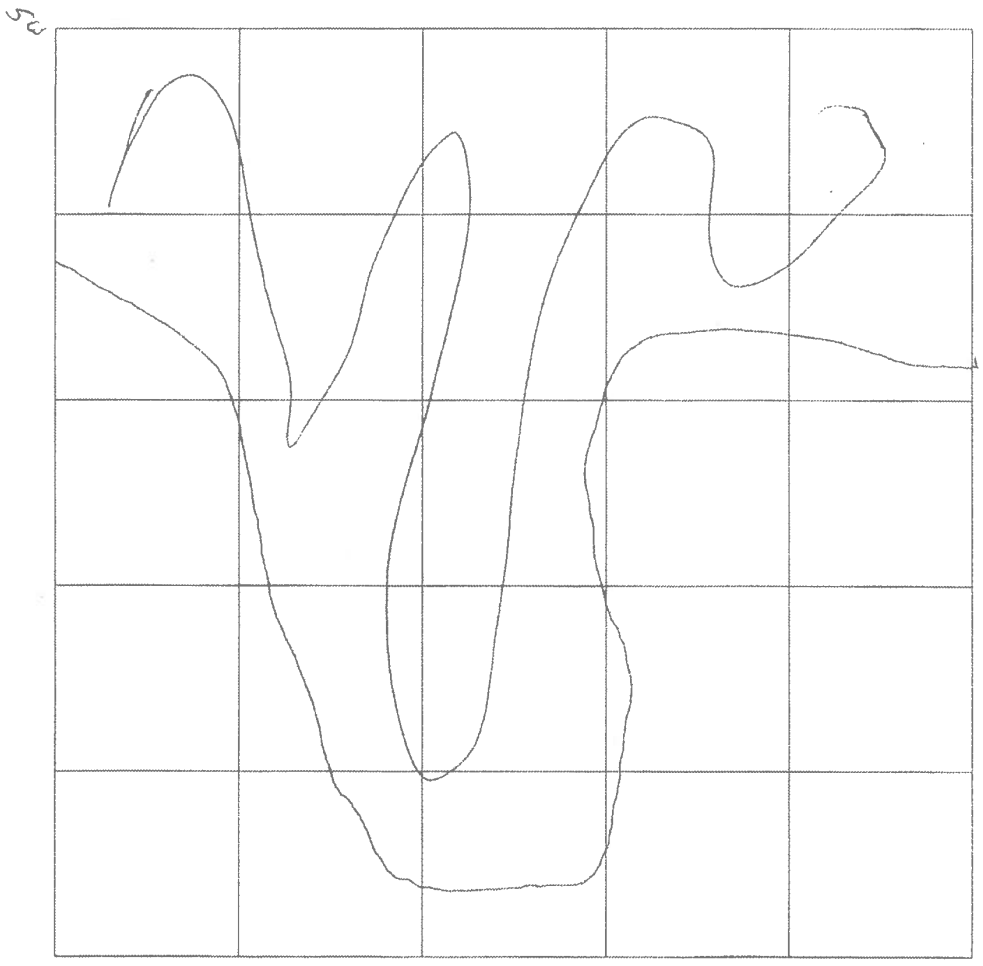
CHECK NEW MAP BOUNDARIES

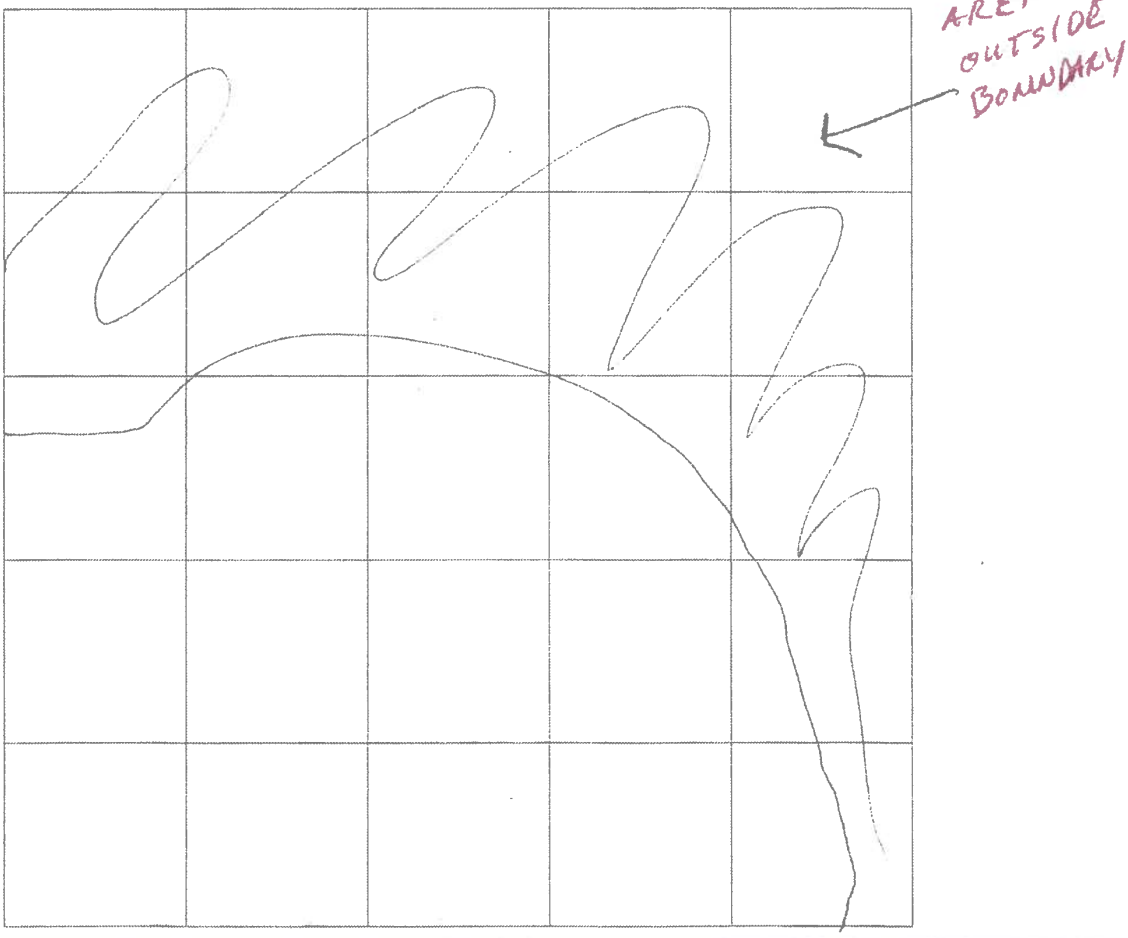
CHECK BOUNDARY
DOESN'T RESEMBLE MAP

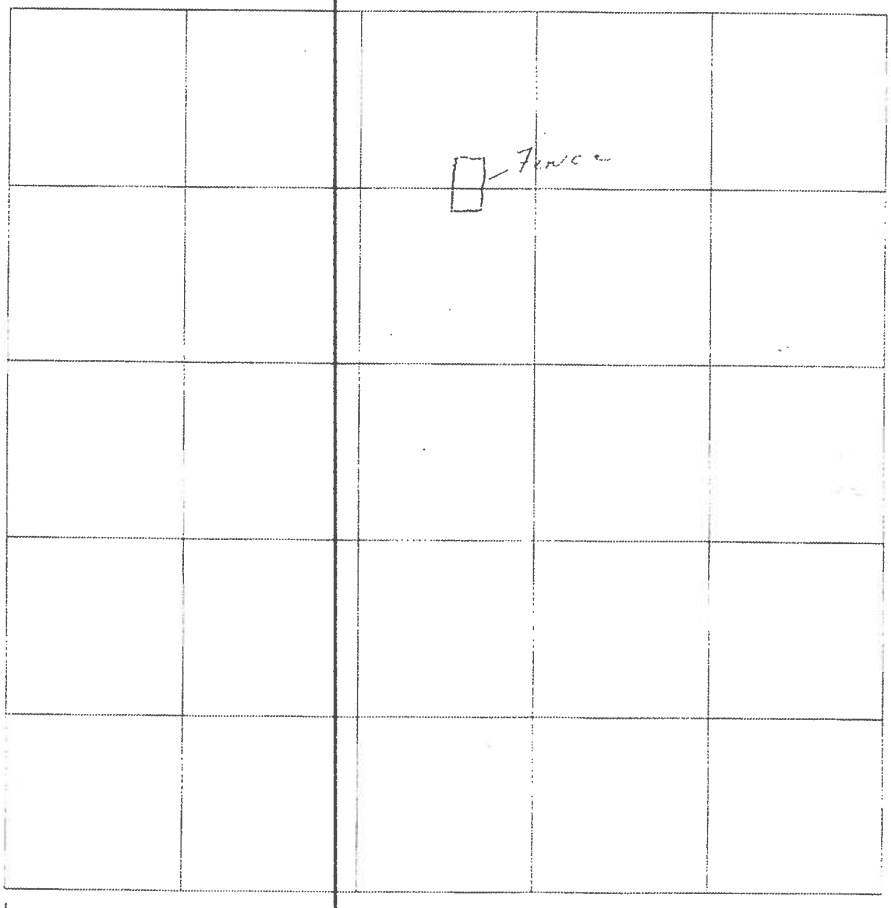
Field Notes: Left Fence in grid Approx 5'x15'
