SITE SPECIFIC FINAL REPORT
Munitions and Explosives of Concern (MEC) Removal Action and Supporting Functions
Former He‘eia Combat Training Area and Former Pali Training Camp, Island of O‘ahu, Hawai‘i

U.S. ARMY CORPS OF ENGINEERS, HONOLULU DISTRICT

Environet, Inc.

July 13, 2012

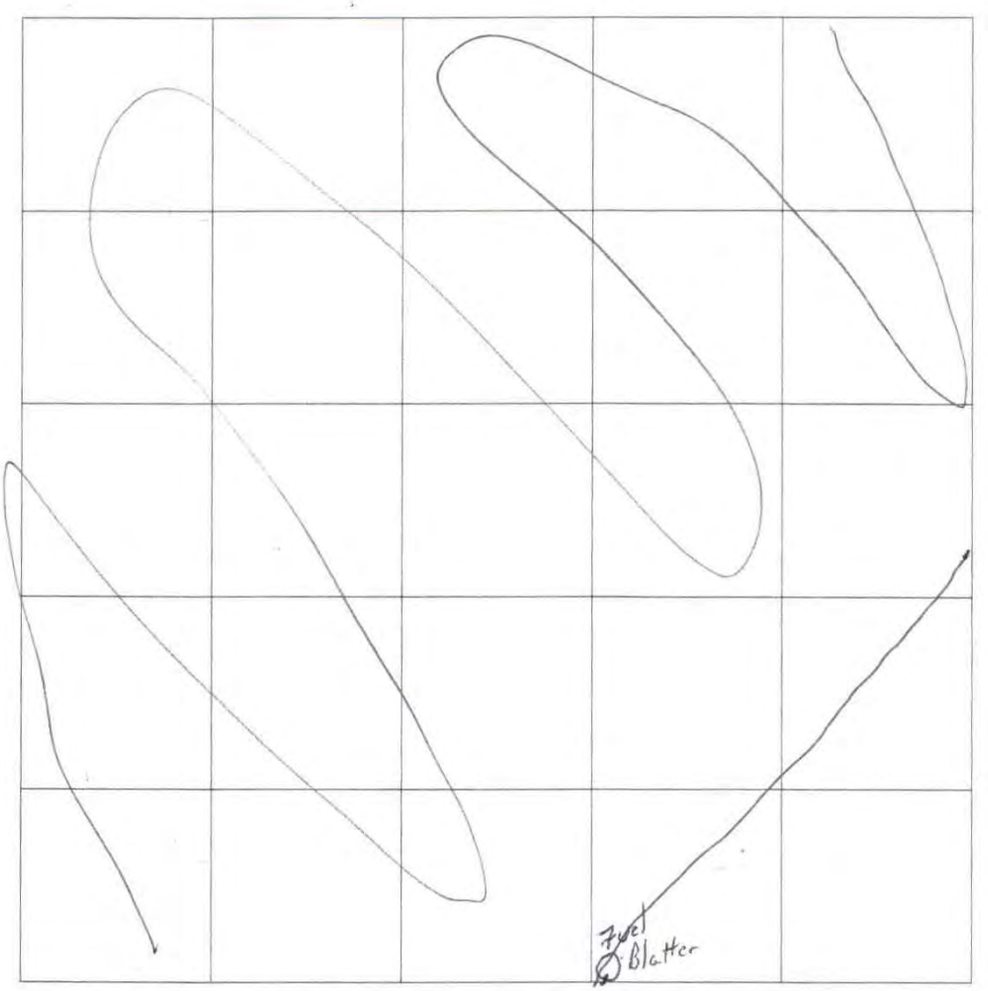
Field Notes: Fuel blatter left in place

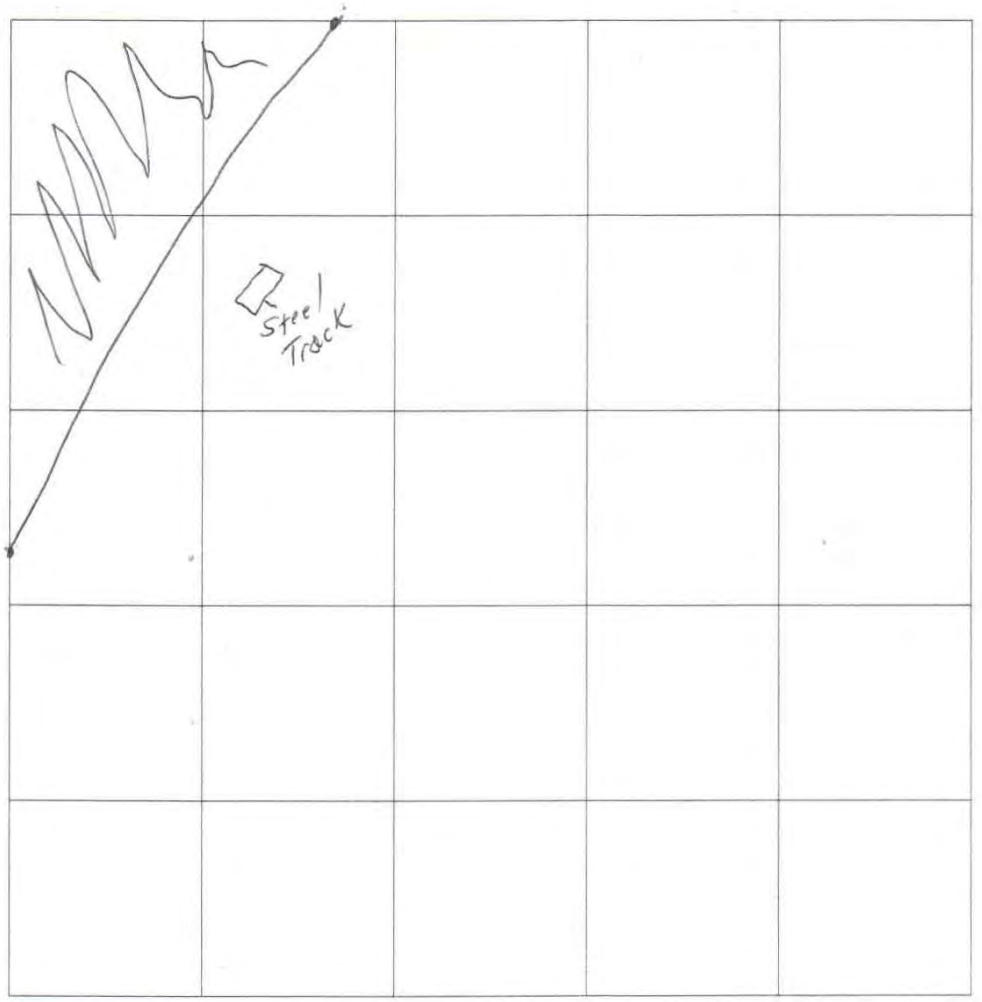
Field Notes: Steel track left in grid, have been moved and cleared under

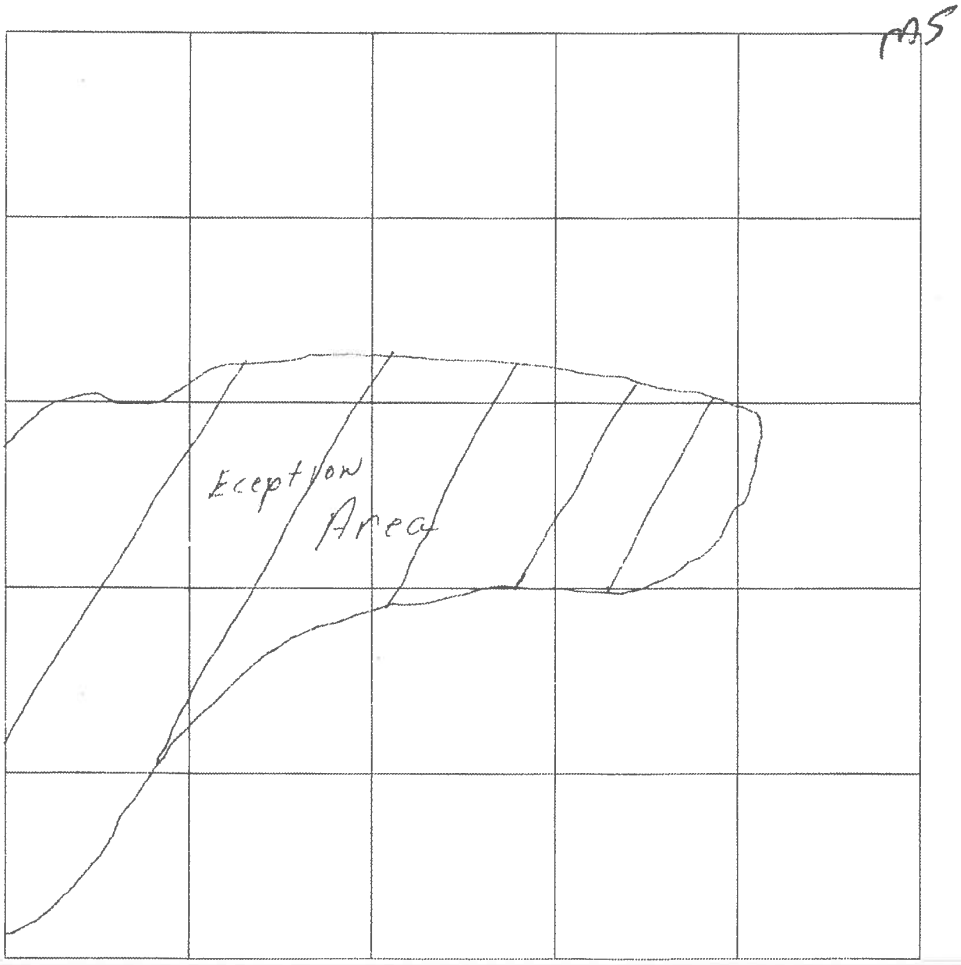
Field Notes: Exception Area cliff & trees

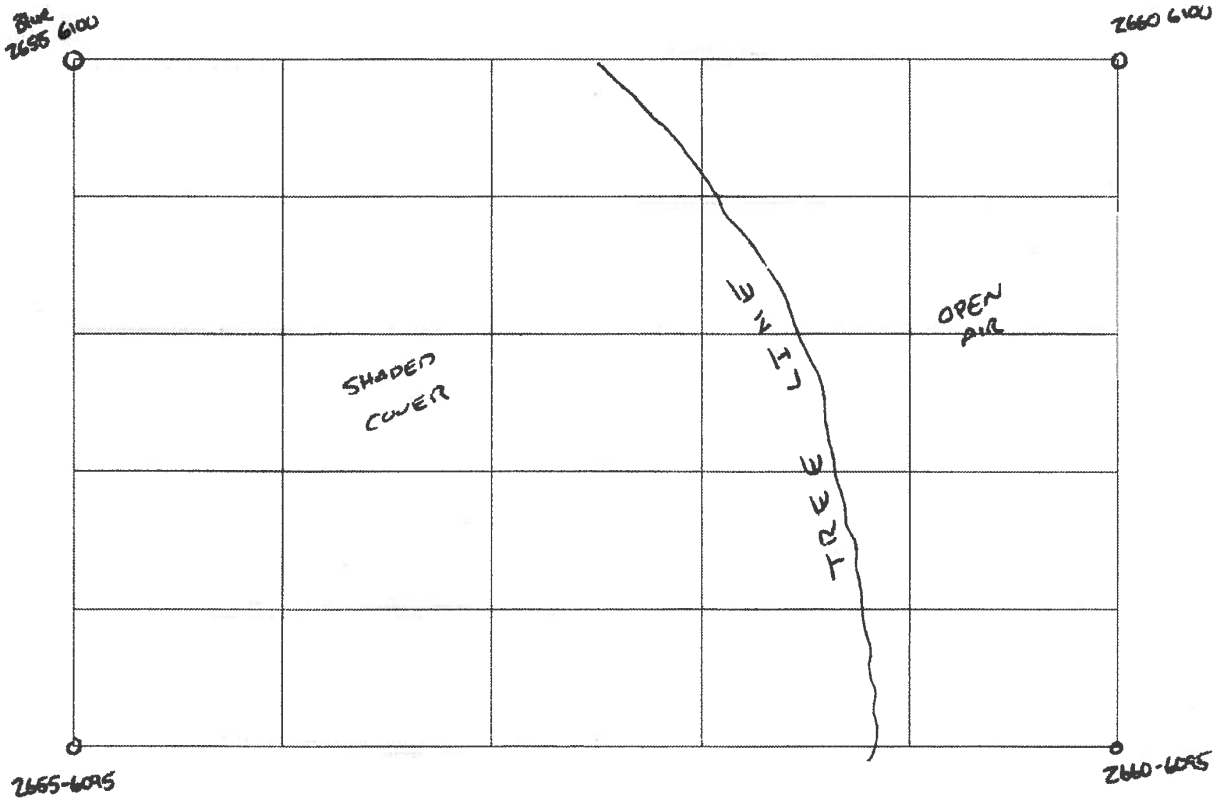
Field Notes: *60mm Mortar Fuzed under tree
*20mm Complete practice

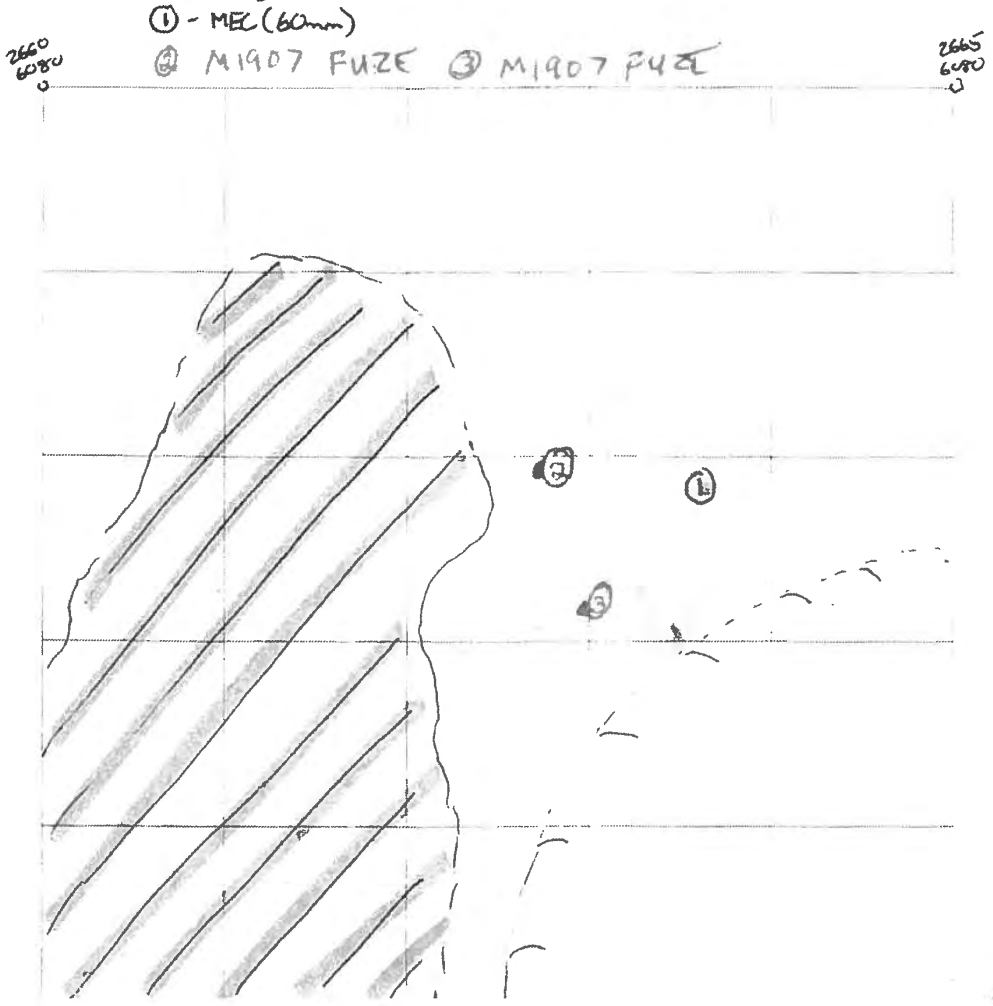
Field Notes: Tm 3 - Mag & Flag / Grid Sheet ☐ = Not Surveyed
Tm 4 - D.J
① - MEC (60mm)
② M1907 FUZE ③ M1907 FUZE

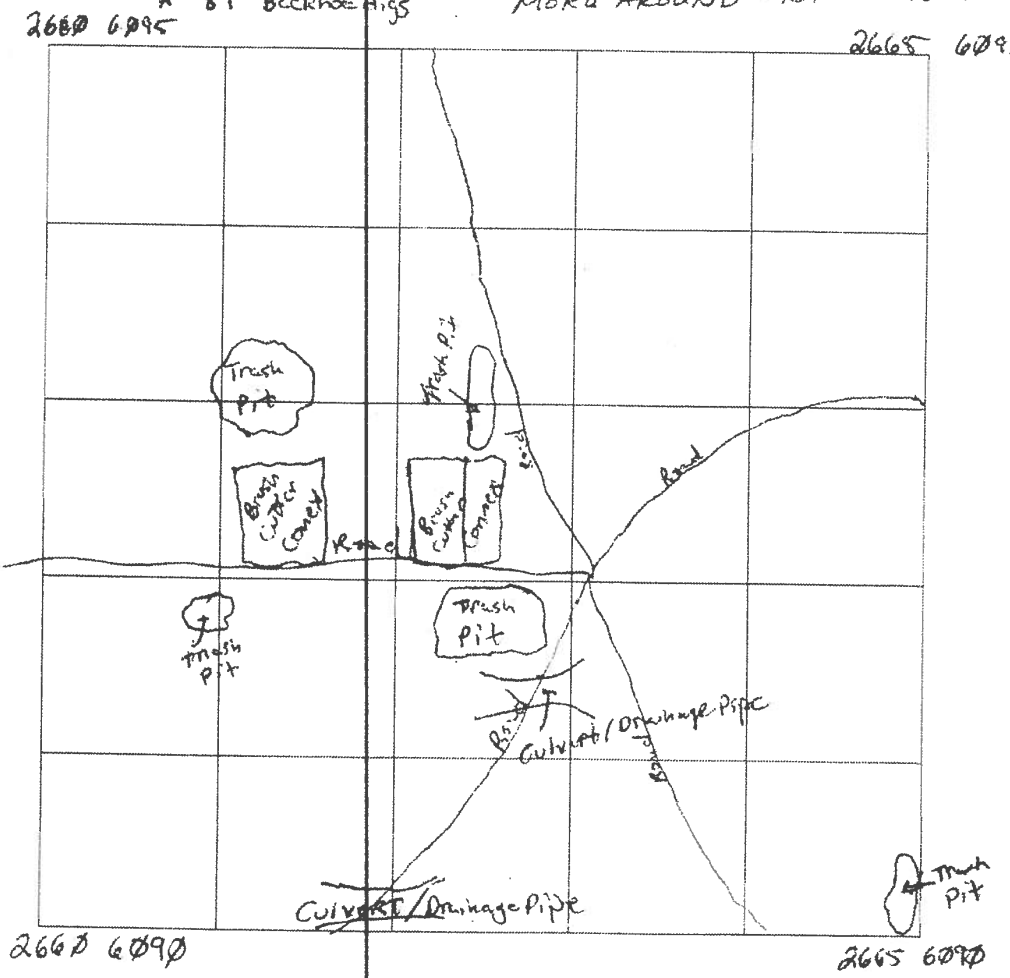
NEEDS SURVEY

See Back on Trash Pits

AS PER QC WILL SURVEY A LITTLE MORE AROUND TRASH PIT ON 9-23

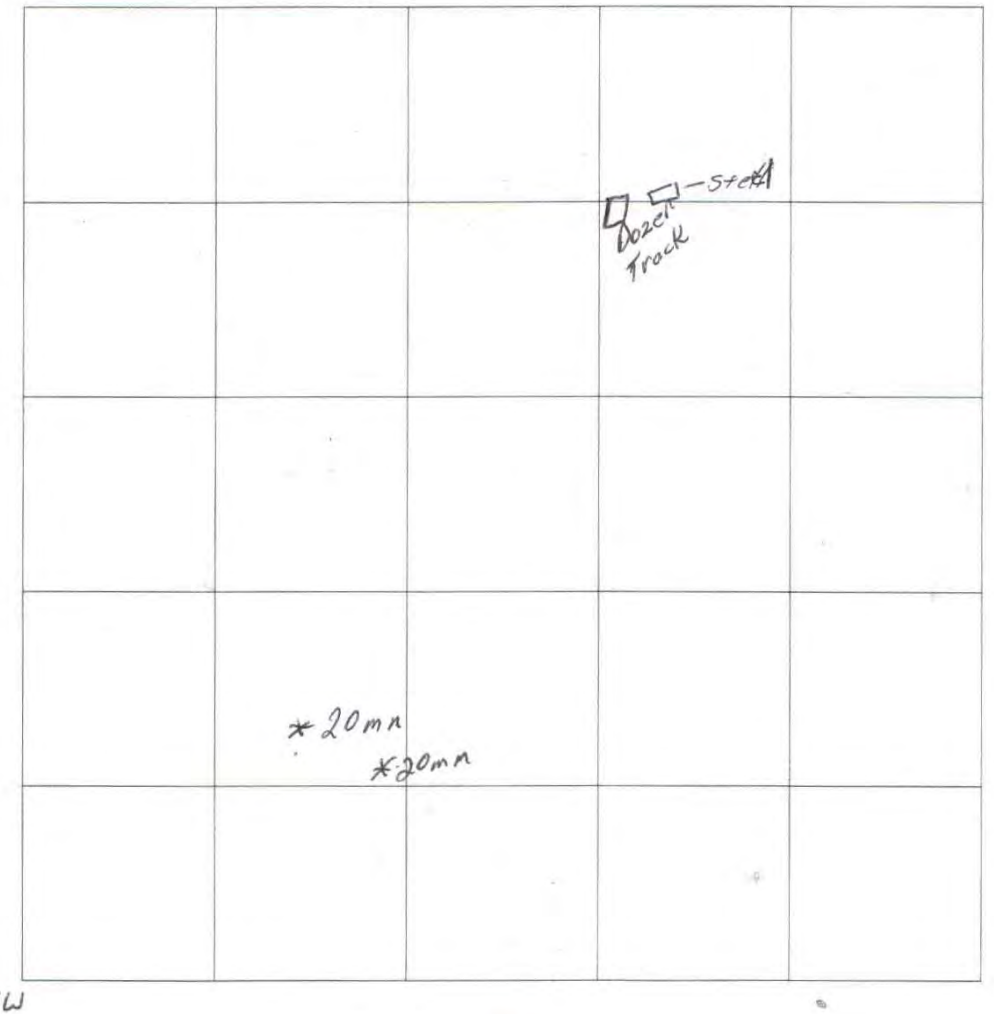
Field Notes: 20mm Prac 2ea
Dozer Frame + Steel left in grid

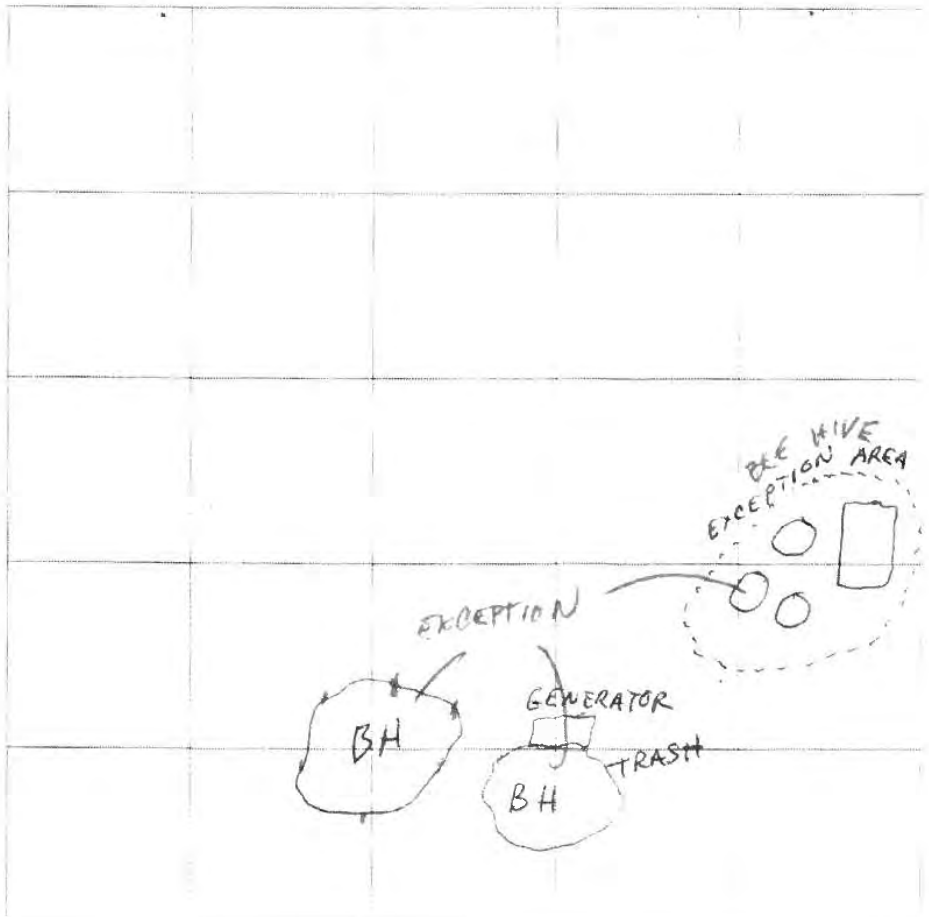
Team 3 Grid Sheet 3 A

MEC Scrap Weight	10	Lbs.
Non MEC Scrap Weight	100	Lbs.
Geo Anolmalies	(count) 0	
Field Eliminated Anomalies	(count) 101	
Live Small Arms	(count) 0	
Exception Area(s)	YES (NO)	
*UXO Found	(count) 2 1	
*Seed Found	(count) 0

Field Notes: P: Pig Trap / Backhoe scrap (80lbs)
① = UXO 60mm
② = UXO 20mm

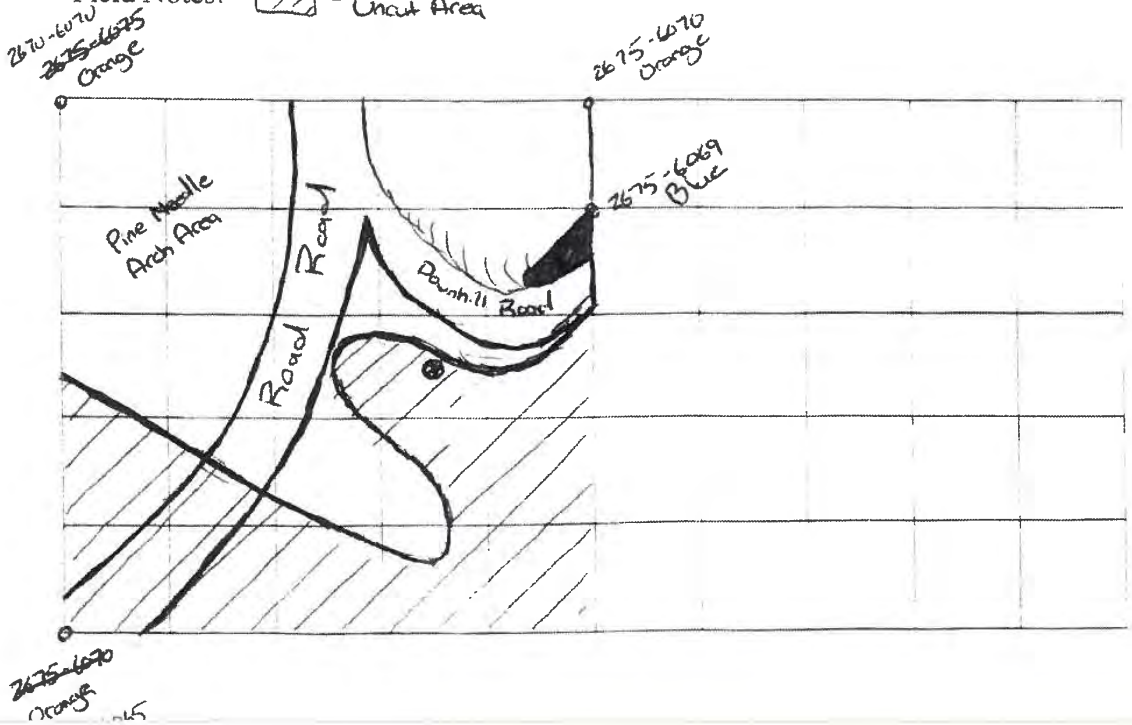
AREA: P-1

MEC Scrap Weight	5	Lbs.
Non MEC Scrap Weight	210	Lbs.
Field Eliminated Anomalies	(count) 101	
Exception Area(s)	(YES) NO	
Seed Found	(count) 1	
*MEC Found	(count) 0

Field Notes:
(1) Trash Pile "Cleared"
(2) Trash Pile "Cleared"
(3) Torch Ginger "Patch Uncleared"
(4) SEED "P10"

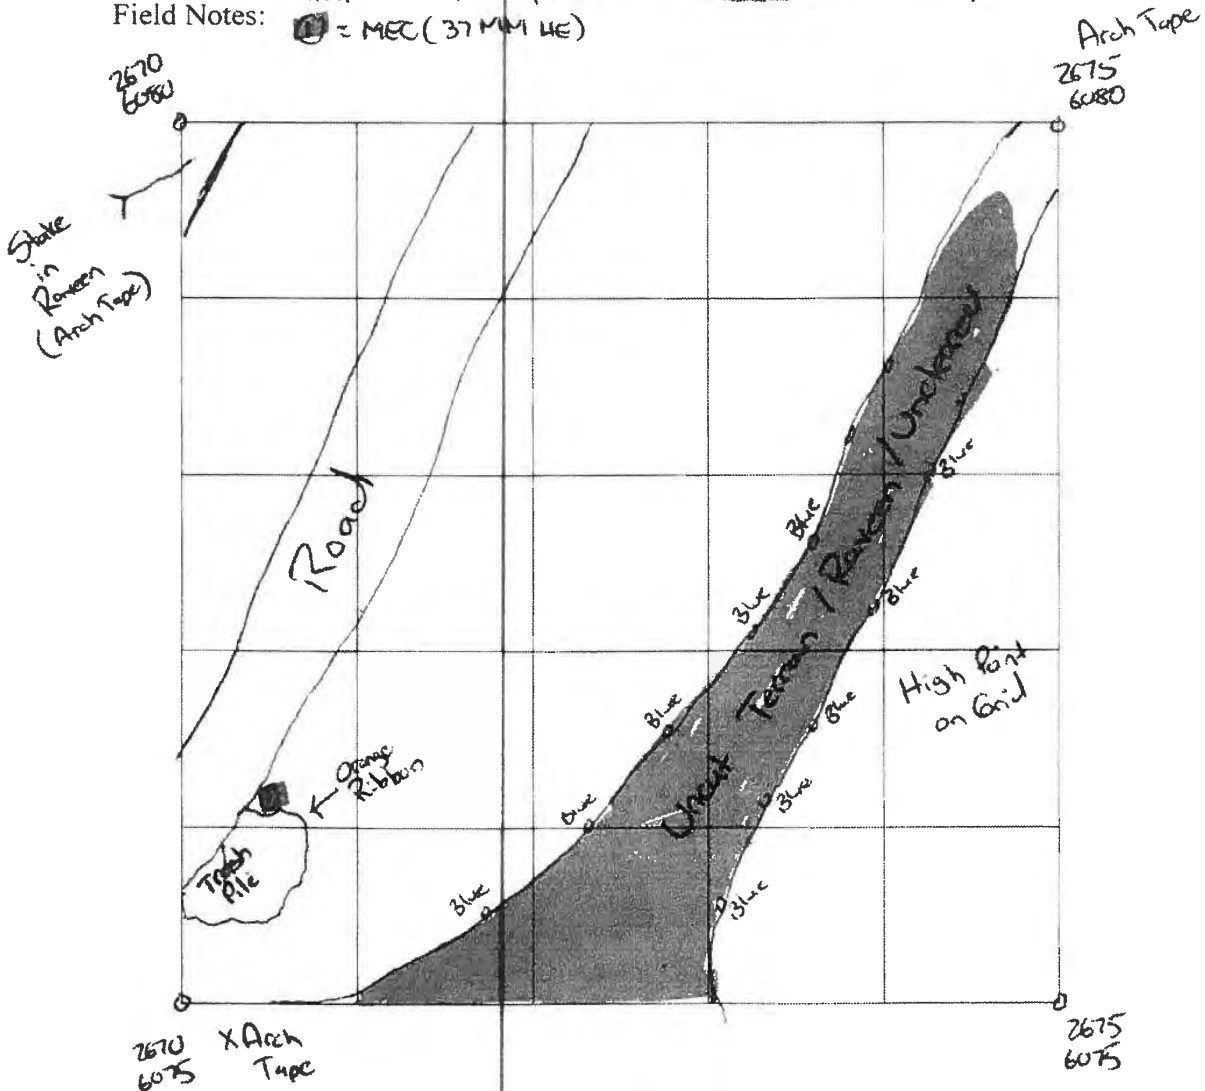
Team #: 3 Date: 9/20/11 Grid: 2670 - 6080

Field Notes: 9/20/11 Survey took points for [redacted] and trash pile
1 = MEC (37 MM HE)

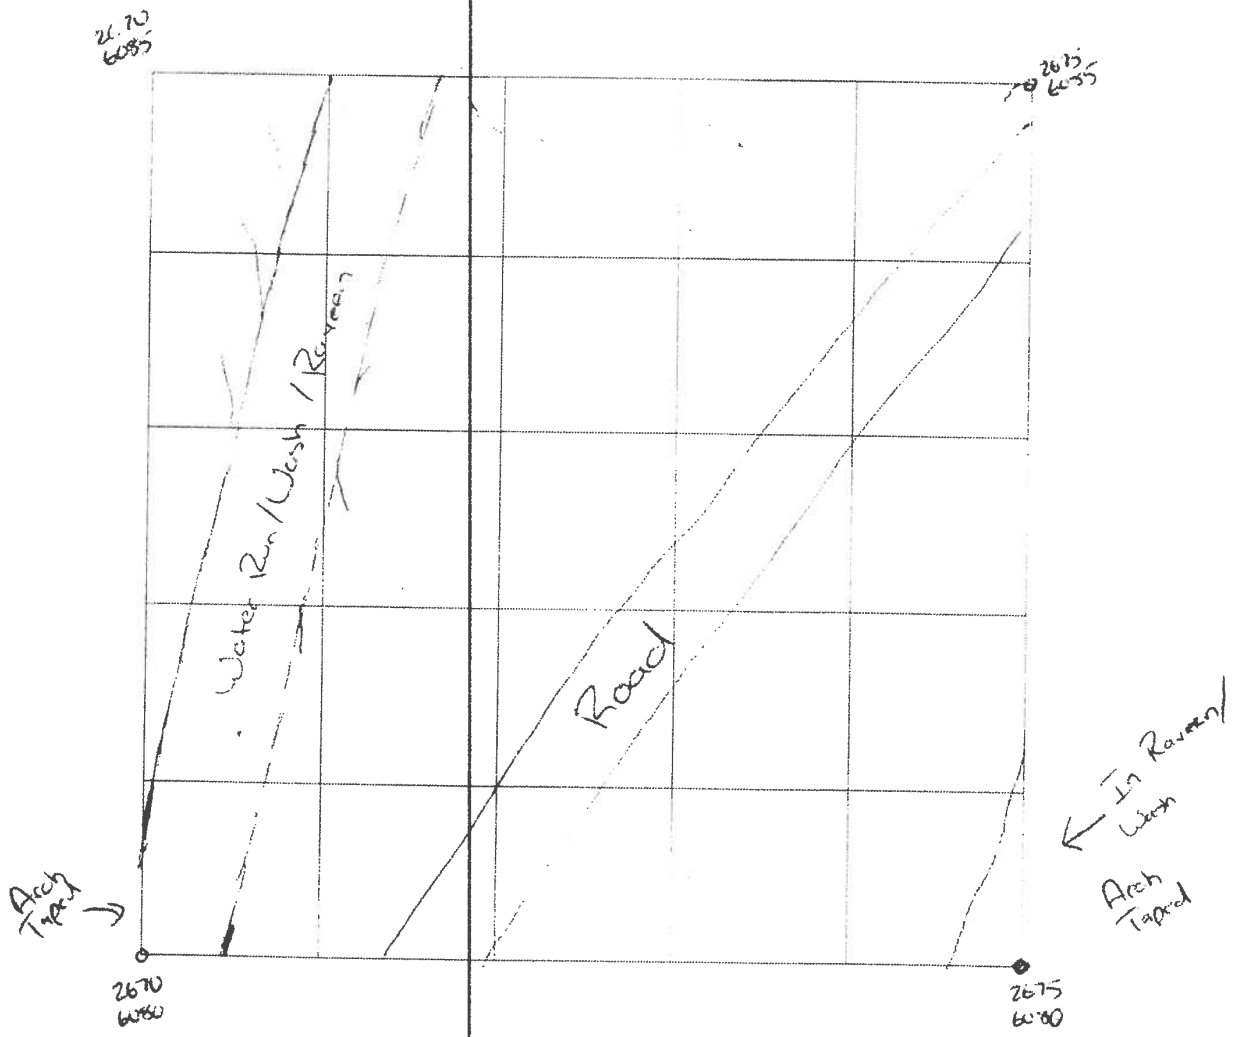
AREA: Pal

MEC Scrap Weight	5	Lbs.
Non MEC Scrap Weight	20	Lbs.
Field Eliminated Anomalies	(count) 25	
Exception Area(s)	YES (NO)	
Seed Found	(count) 0	
*MEC Found	(count) 1 (81MM)

Field Notes: ■ Uncleared (High Ridge Unit)

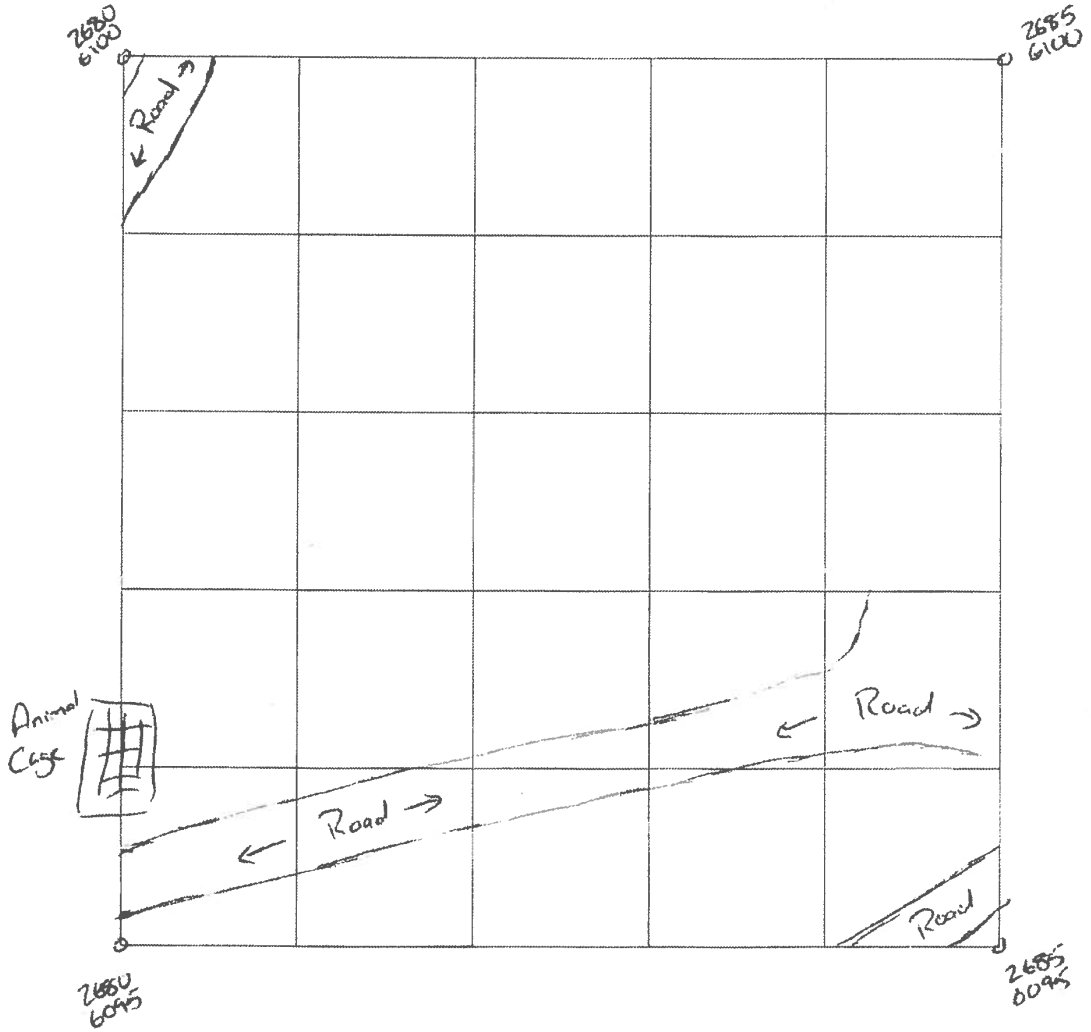
Team #: 2 Date: 9-13-11 Grid: 2680-6100

MEC Scrap Weight		60 Lbs.
Non MEC Scrap Weight		10 Lbs.
Geo Anomalies	(count)	~~112~~
Field Eliminated Anomalies	(count)	~~105~~ 217
Live Small Arms	(count)	∅
Exception Area(s)	YES NO	
Seed Found	(count)	∅
*MEC Found	(count)	1

Field Notes: - BH-1 concrete Road Bed
- BH-2 Trash Pit
- Exception Area ~~Due To Dead Fall - Slope, and, Crevase.~~ 9/21/11 JKB
- 75mm Schrapnel Removed By Demo 9-13-11

- 9/21/11 Dead fall Removed Area Swept Found 4 BackHoe Digs & MEC W/WP

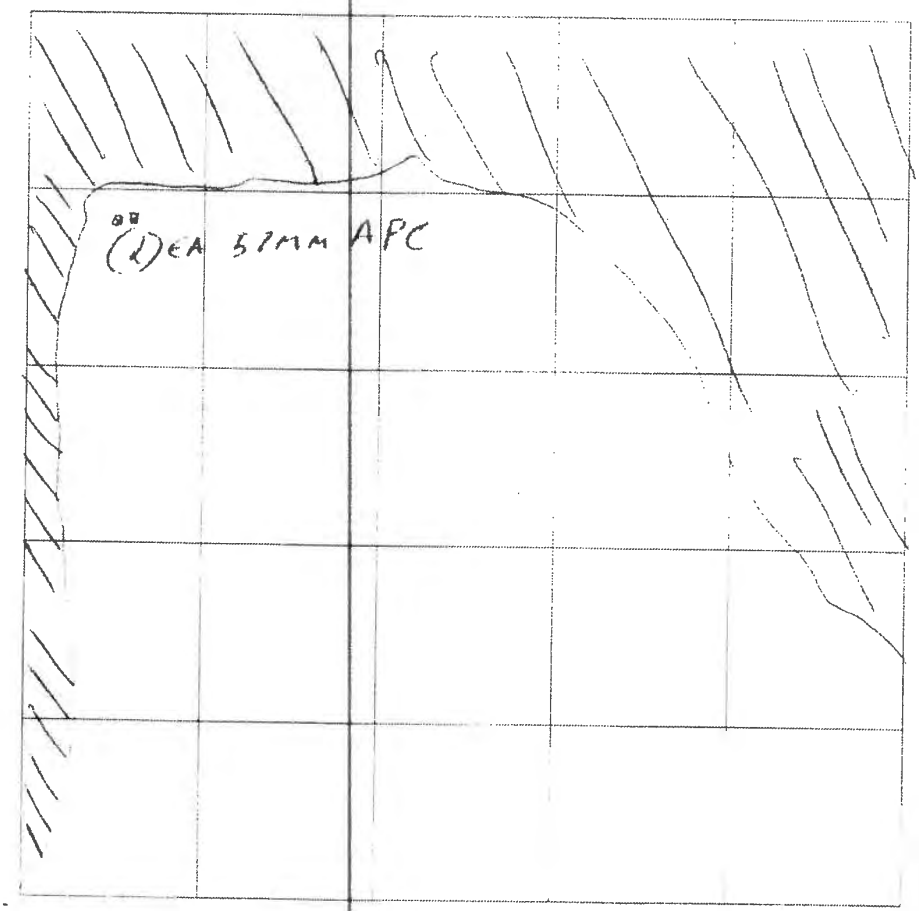
AREA: Pal

MEC Scrap Weight	2	Lbs.
Non MEC Scrap Weight	70	Lbs.
Field Eliminated Anomalies	(count) 124	
Exception Area(s)	(YES) NO	
Seed Found	(count) ∅	
*MEC Found	(count) 6

Field Notes: found 37mm practice

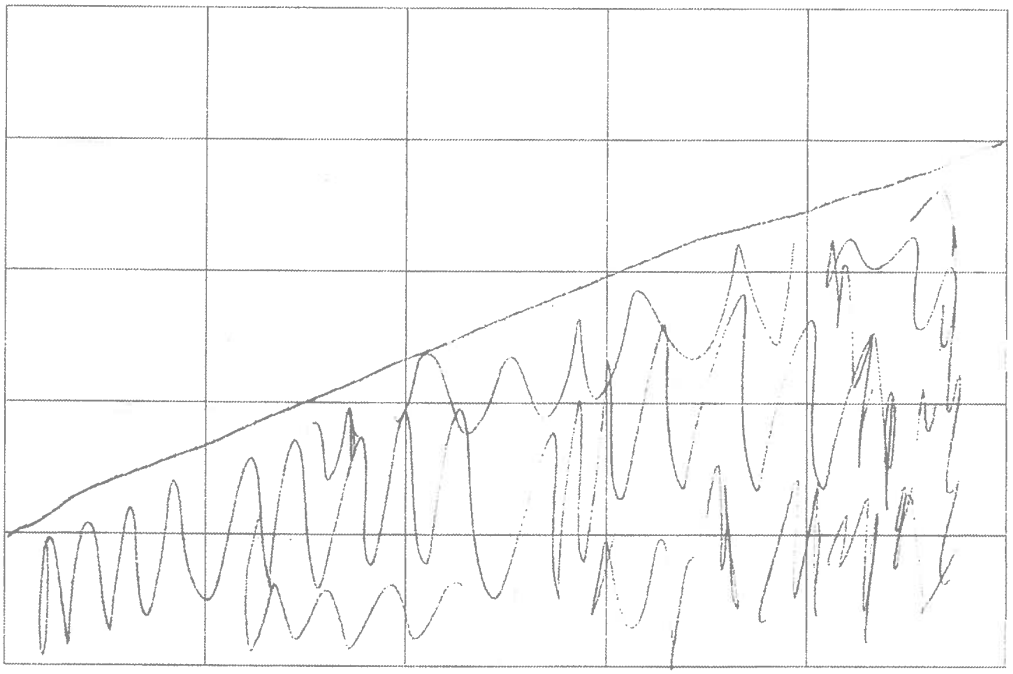
AREA: PALI

Field Notes: * 37MM 1 HE FARM + ROAD EQUIP. WILL BE SURVEYED IN

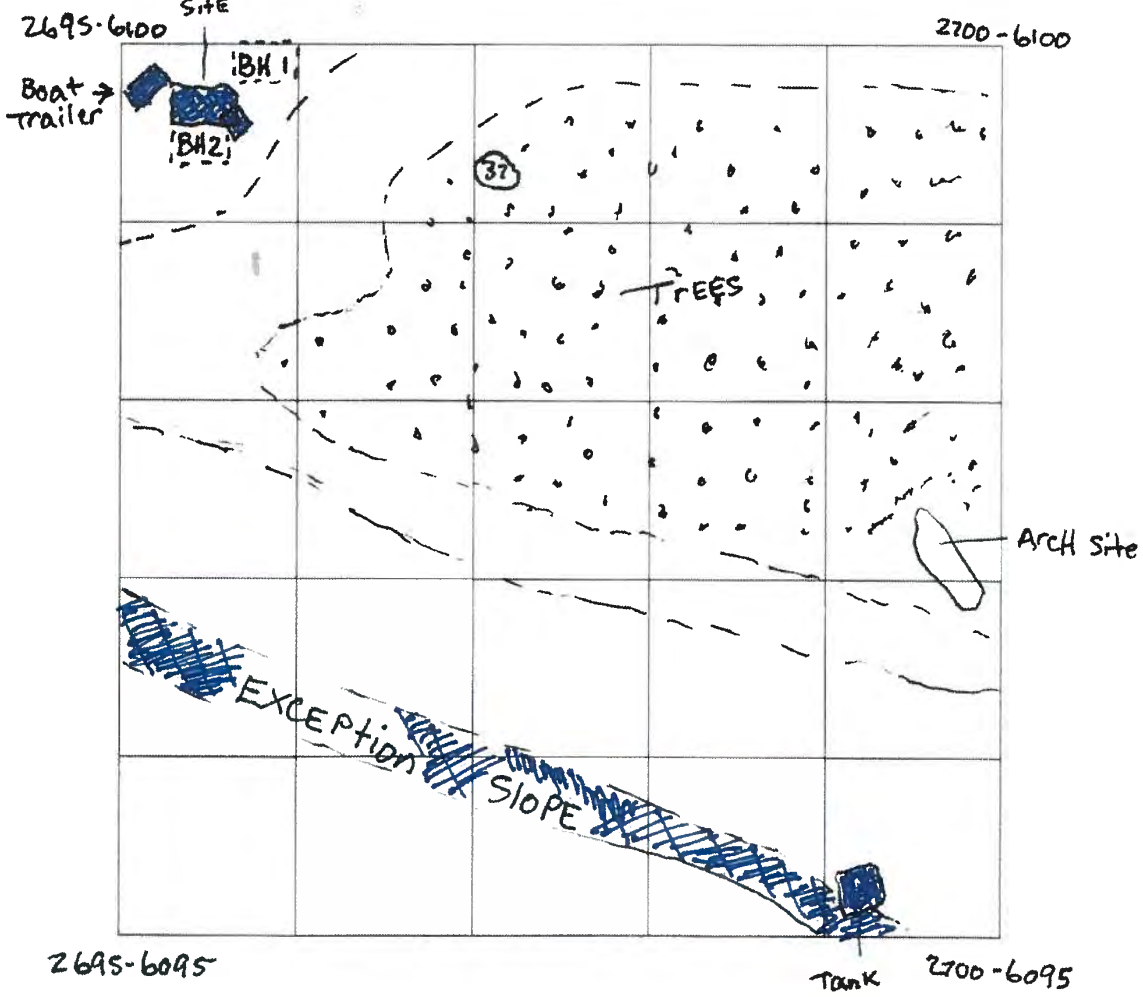
Team #: 2 Date: 9/21/11 Grid: 2695-6100

Field Notes: * Exception Area For VEHICLES
Arch * 37 mm Removed By Demo 9/21/11
