1. Project Name: Honokohau SBH
2. Date of Inspection: 4 May 2005
3. Inspection Personnel:

The project consist of:

HONOKOHAU SMALL BOAT HARBOR, HAWAII, HAWAII

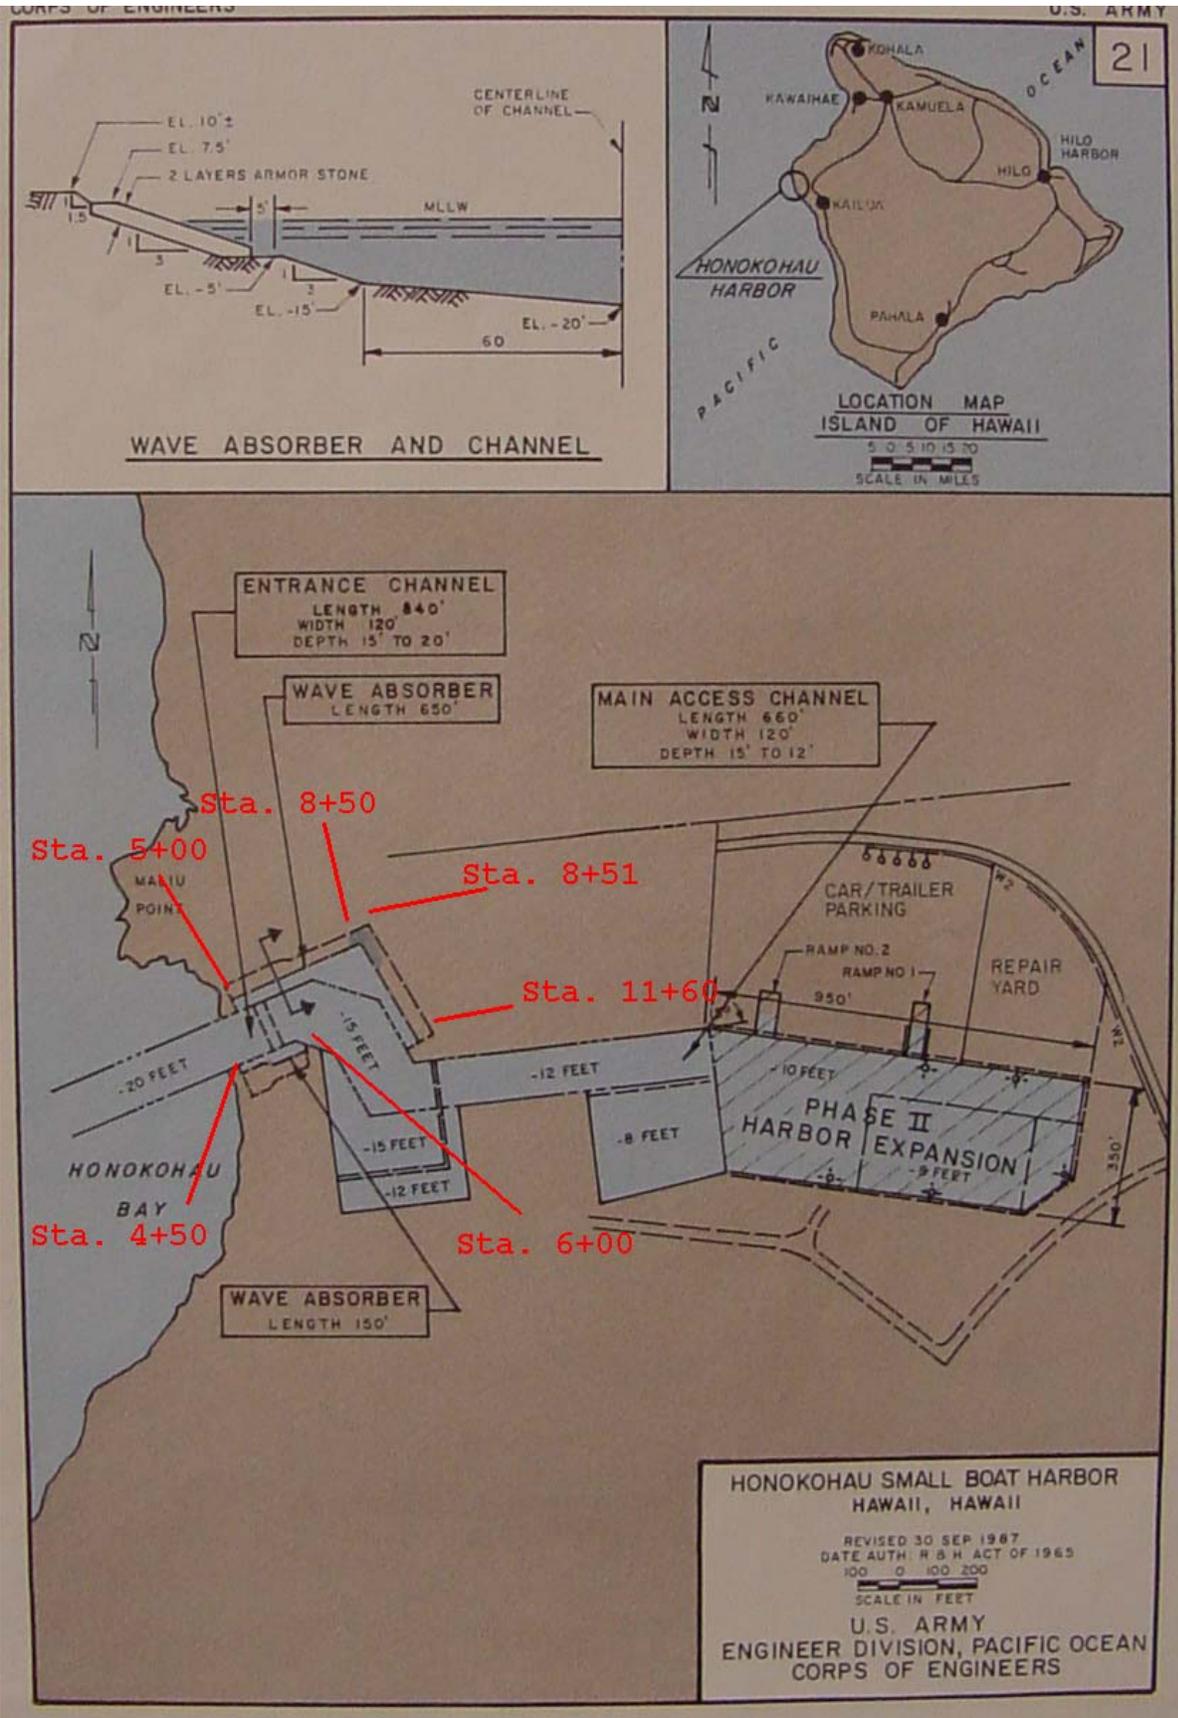
Attached:
Project Index Map
Info Sheet

Wave Absorber (South) - 150' long adjacent the south-side of the entrance channel. The project begins at Sta. 4+50 (Oceanside) to Sta. 6+00 as shown on the attached Project Index Map.

Wave Absorber (North) - 650' long adjacent the north-side of the entrance channel. The project begins at Sta. 5+00 (Oceanside) thru Sta. 8+50 then transitions east at Sta. 8+51 to Sta. 11+60 as shown on the attached Project Index Map.
