1. Project Name: Pohoiki Bay Navigational Improvements
2. Date of Inspection: May 4, 2005
3. Inspection Personnel:

4. General Note:

Overall, the head and oceanside of the structure are experiencing some settling.

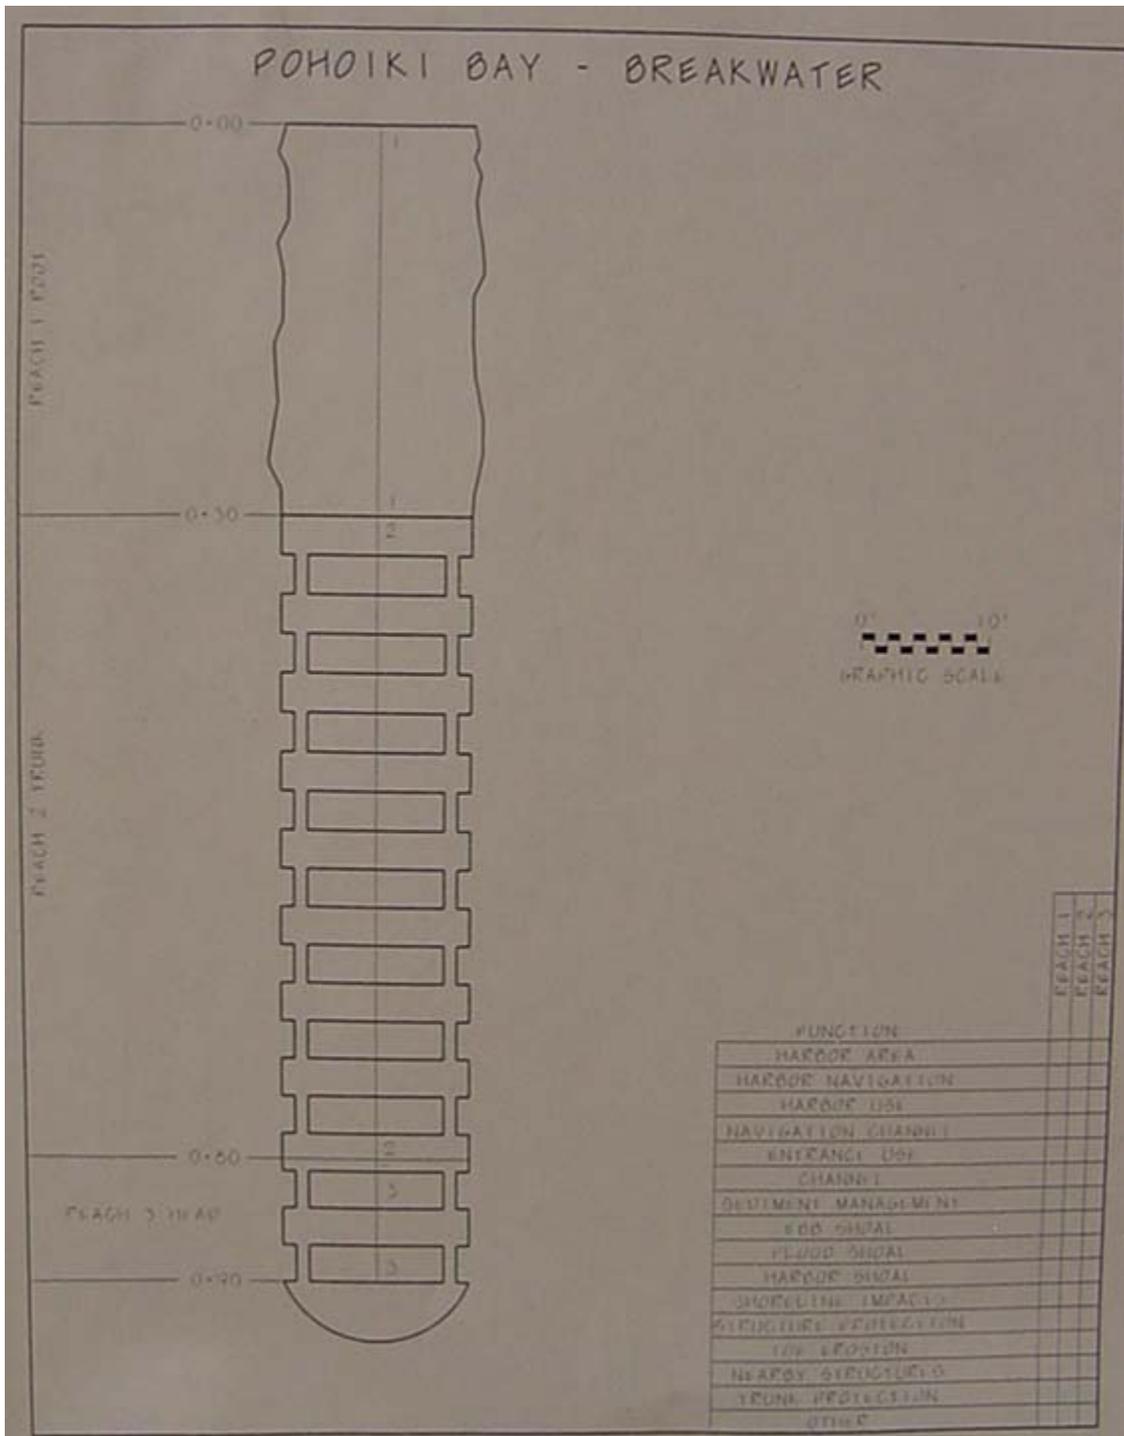
The breakwater structure is in MARGINAL condition, and should be monitored closely. The center cells of the ribcaps 1-4 (starting at the root) are filling in up to 50%; all other cells have no cinders. Settling of dolos noted primarily on oceanside of the structure.
