1. Project Name: Kawaihae Deep Draft Harbor
2. Date of Inspection: June 28, 2007
3. Inspection Personnel:

KAWAIHAE DEEP DRAFT HARBOR, HAWAII

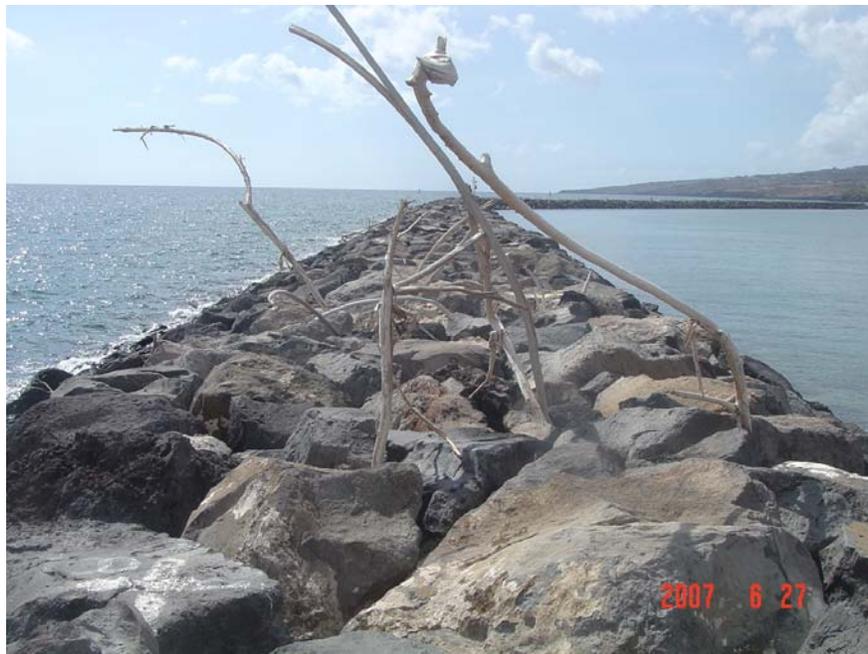
q. Sta. 7+90, CL, settlement.

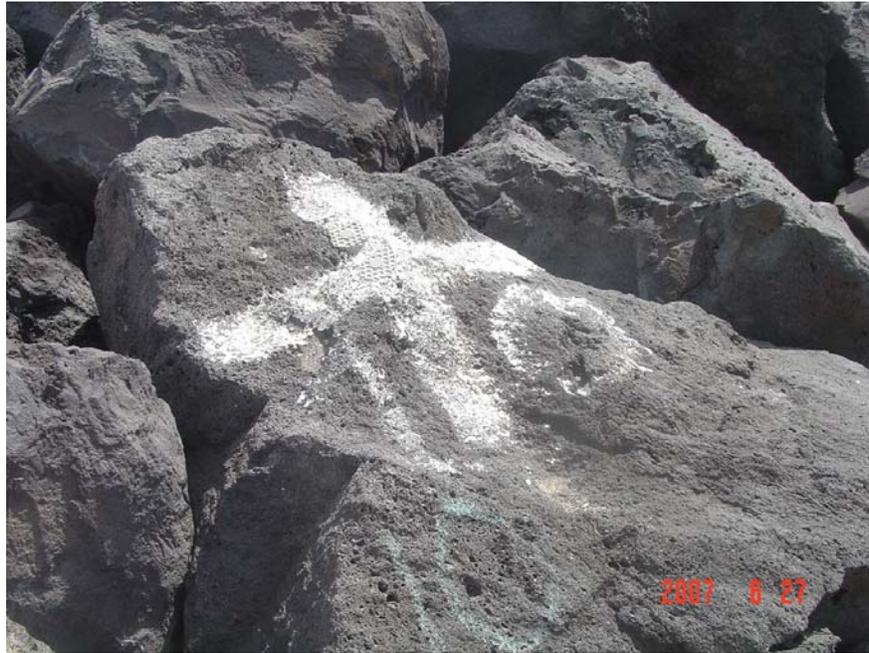
u. Sta. 9+71, OS, three armor stones have rolled off of the structure and into the water. Likely from structure sideslope at waterline.

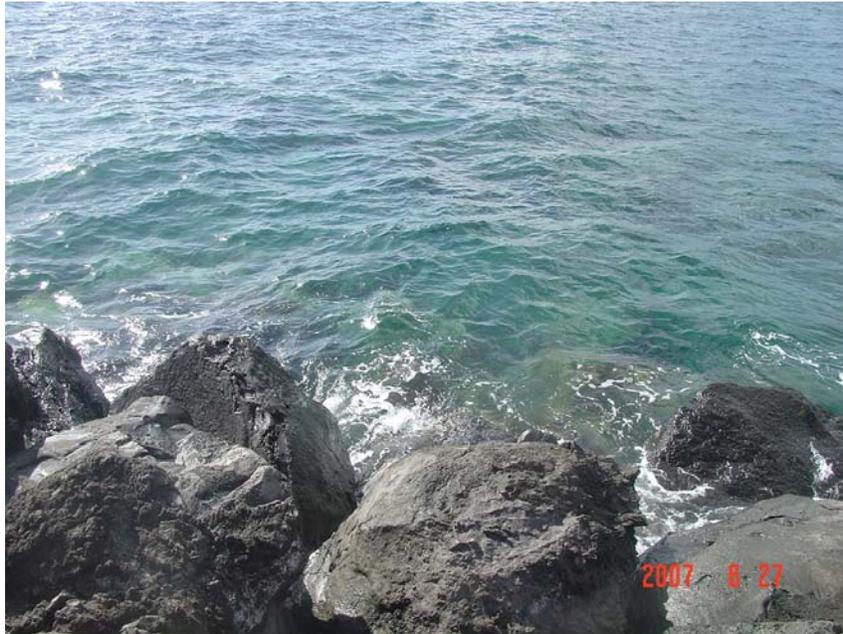
ww. Sta 26+54, OS, Missing toe armor stone (6 ea.), monitor.

5. Findings / Conclusions: The primary damages at this structure are at the head, as shown in photographs. Several cracked stones and dislodged toe stones indicate wave action is continuing to deteriorate structure. Continue to monitor. The overall condition of the breakwater is FAIR, and functionality is GOOD. Navigation aids are in good condition.

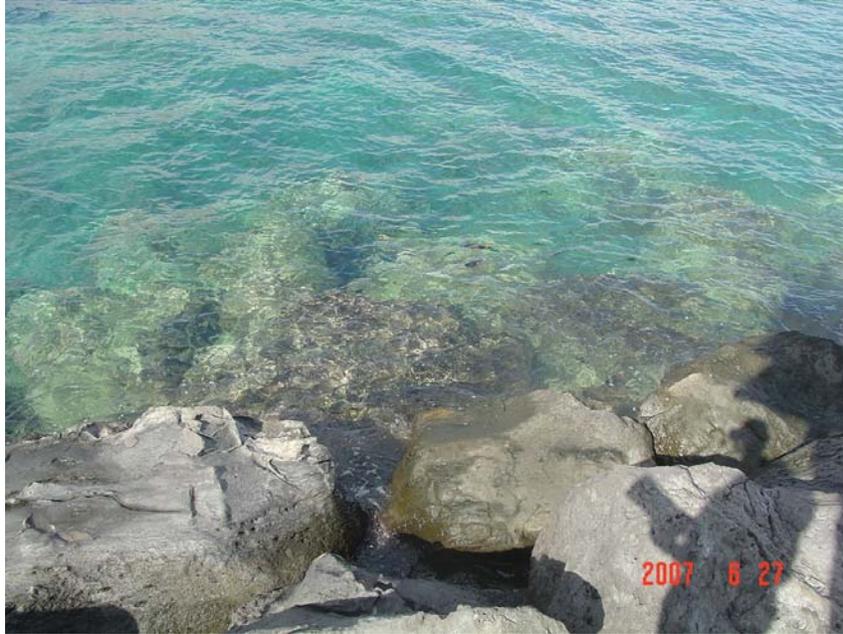
yy. Sta. 26+64, Head, missing armor stones at the waterline.
