1. Project Name: Kihei Beach SPP
2. Date of Inspection: June 16, 2004
3. Inspection Personnel:

CONTINUING ELIGIBILITY INSPECTION (CEI) REPORT
FOR HURRICANE & SHORE PROTECTION PROJECTS

KIHEI BEACH, MAUI, HAWAII

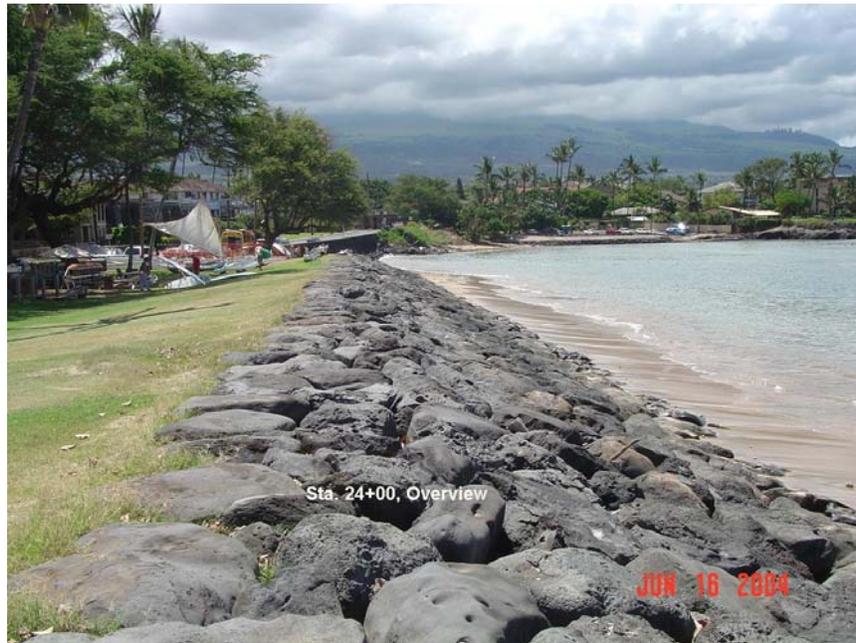
- p. Sta. 24+00, Overview, photo for reference.
- q. Sta. 25+14, Monitor area for settling.
- r. Sta. 26+06, Monitor sideslope settling in this area.

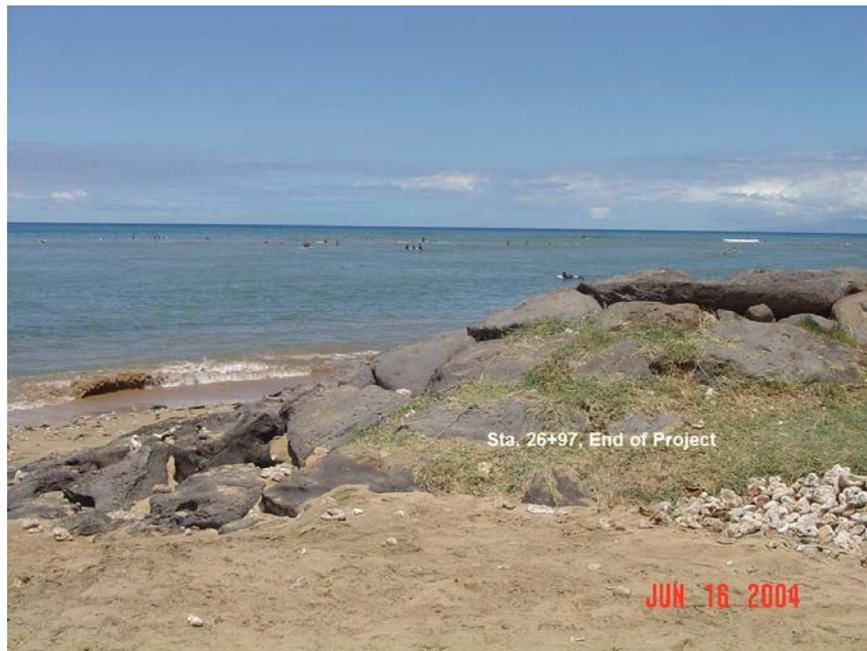
- s. Sta. 26+97, End of project (south), reference photo.
