O & M INSPECTION REPORT
FOR NAVIGATION AND SHORE PROTECTION PROJECTS

1. Project Name: Laupahoehoe Navigational Improvements
2. Date of Inspection: May 1, 2002
3. Inspection Personnel:

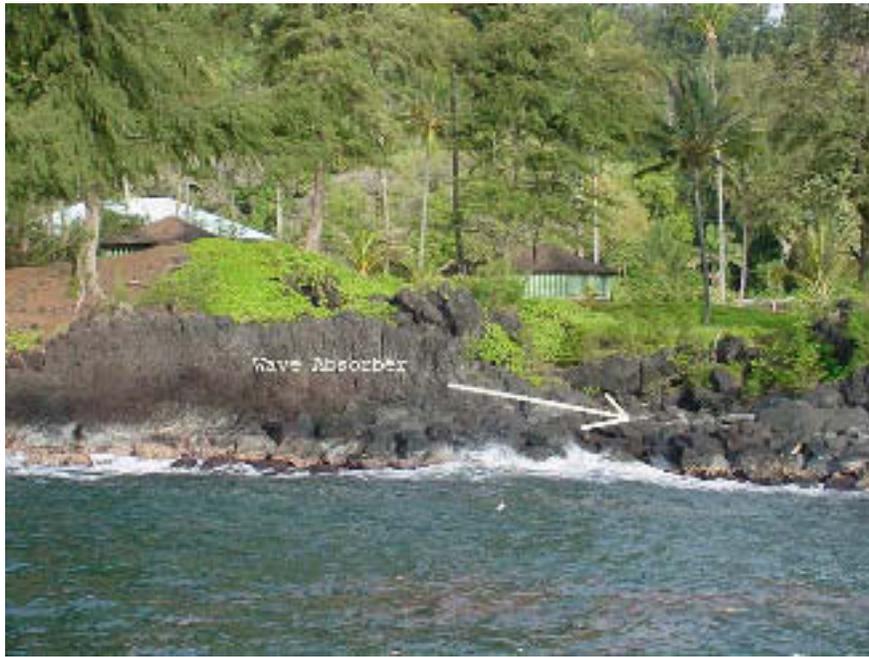
a. Wave Absorber (60 LF): The wave absorber is in good condition. There appears to be minimal change in the structure since our last inspection.
