**CONTINUING ELIGIBILITY INSPECTION (CEI) REPORT
FOR HURRICANE & SHORE PROTECTION PROJECTS**

1. Project Name: Pago Pago Int'l Airport Shore Protection Project
2. Date of Inspection: April 10, 2002
3. Inspection Personnel:

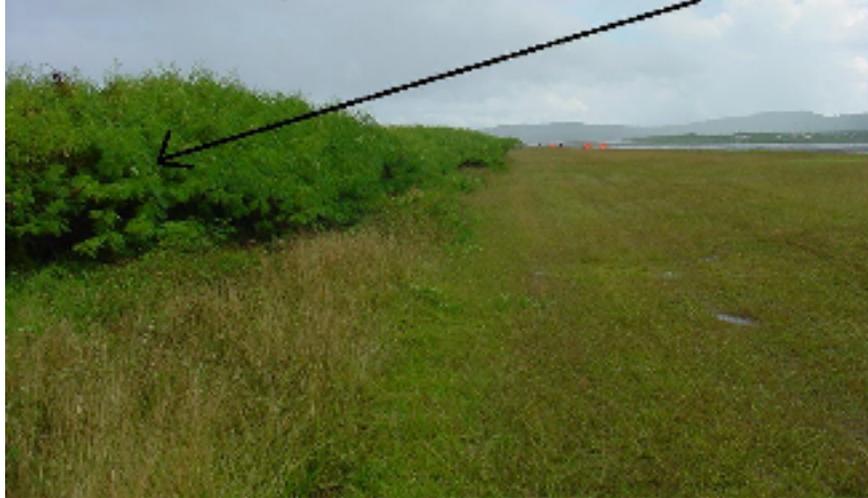
Sta. 73+00, Runway Side of Revetment

Remove Vegetation from Revetment's Splash Apron

The focus of the maintenance required should be directed at vegetation control. Removal or herbicides are recommended in lieu of cutting.
