**CONTINUING ELIGIBILITY INSPECTION (CEI) REPORT
FOR HURRICANE & SHORE PROTECTION PROJECTS**

1. Project Name: Poloa Shore Protection Project
2. Date of Inspection: April 10, 2002
3. Inspection Personnel:

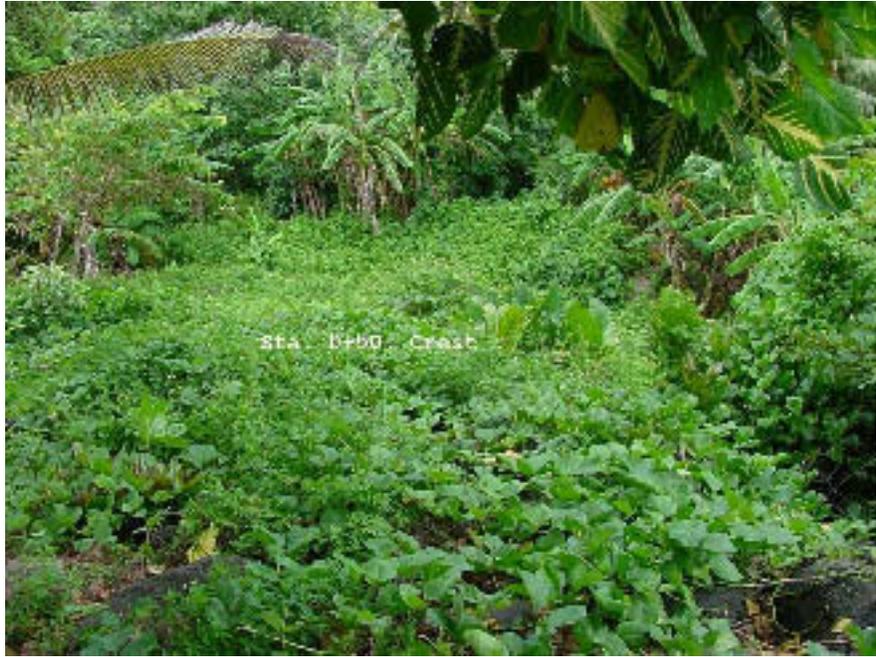
a. Sta. 0+10 to Sta. 1+00, is area was covered with too much vegetation (vines) to properly inspect.

The focus of the maintenance required should be directed at vegetation control. Removal or herbicides are recommended in lieu of cutting.
