1. Project Name: Rota SBH
2. Date of Inspection: January 28, 2004
3. Inspection Personnel:

4. Discussion:

Revetted Mole - 535 LF:

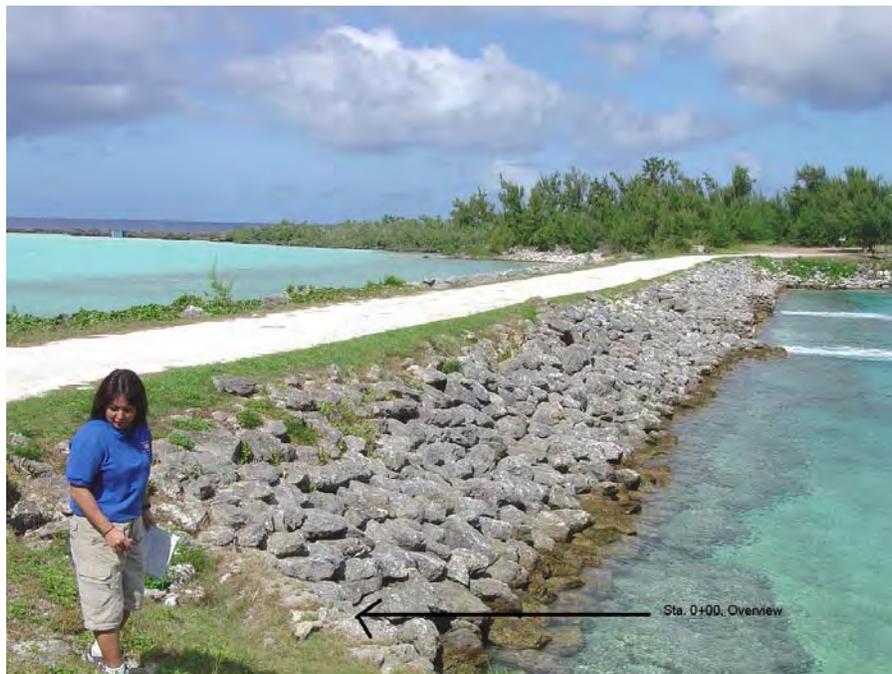
The Revetted mole is approximately 535 LF. The overall condition of the project is poor. There has been some on-going deterioration, at Sta. 1+80, (1st Set of Culverts) and Sta. 2+70, (2nd Set of Culverts) which was damaged during Typhoon Pongsona. Additional deterioration has occurred since the June 5, 2003 inspection. Repairs are required to ensure the continuing functionality of the structure.

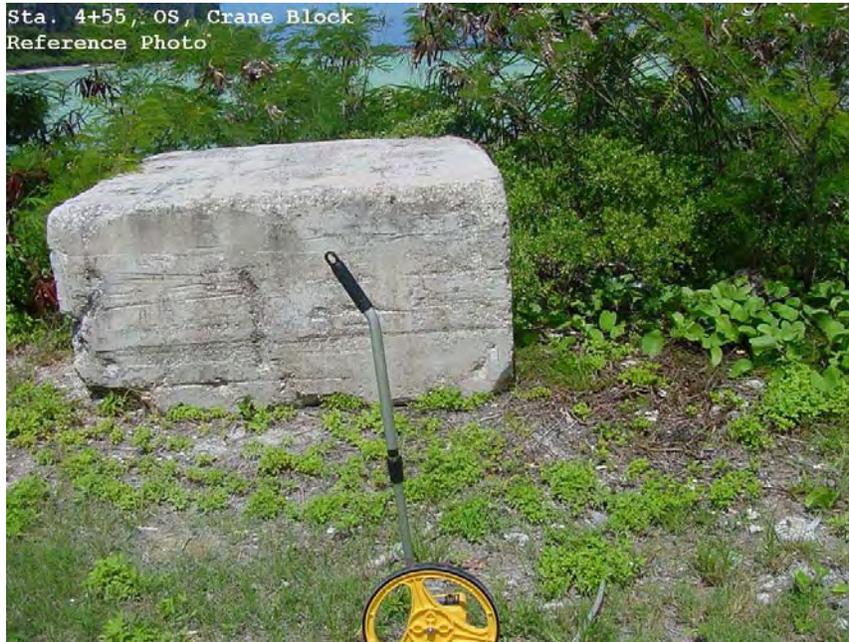
u. Sta. 4+55, OS, (FY03 reference photo).
