**CONTINUING ELIGIBILITY INSPECTION (CEI) REPORT
FOR HURRICANE & SHORE PROTECTION PROJECTS**

1. Project Name: Afono Shore Protection Project
2. Date of Inspection: April 9, 2002
3. Inspection Personnel:

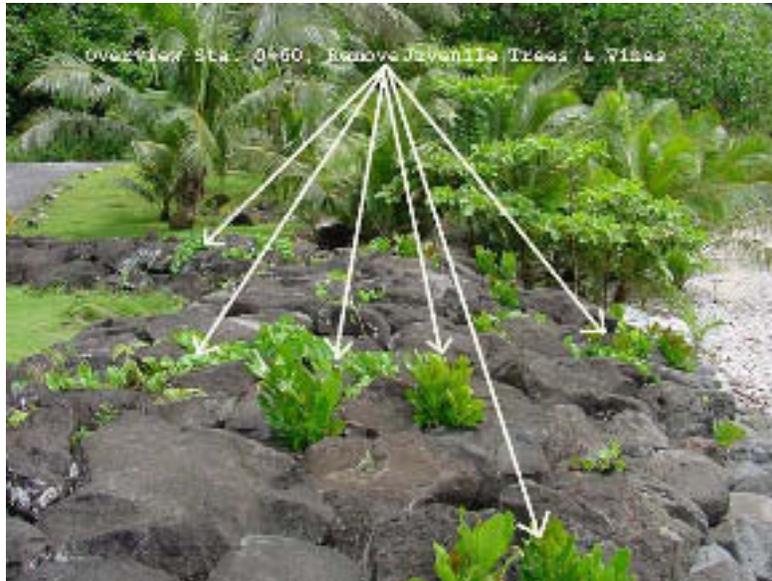
- a. Sta. 0+60, Remove juvenile trees and vines from the revetment.

The focus of the maintenance required should be directed at vegetation control. Removal or herbicides are recommended in lieu of cutting.

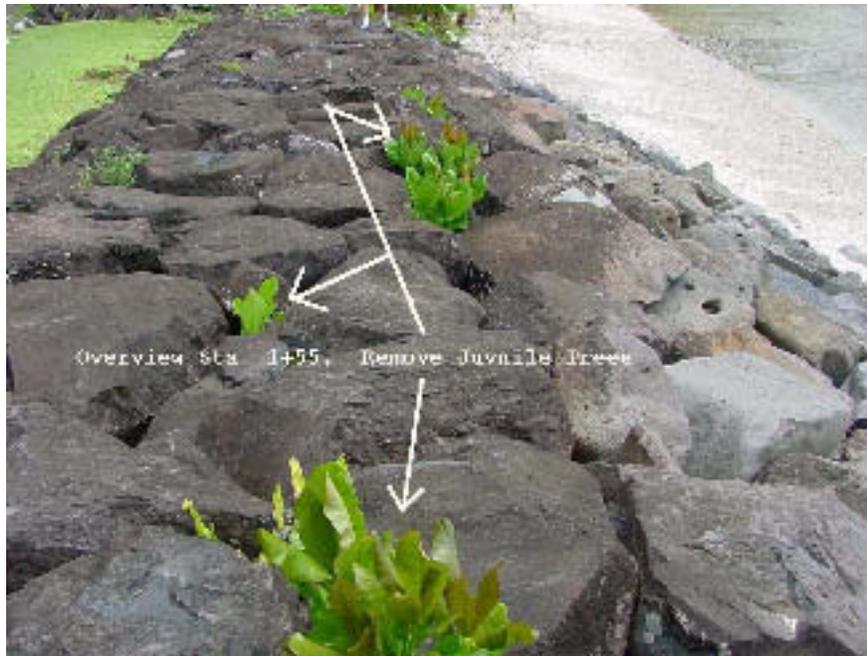
b. Sta. 1+55, Remove juvenile trees and vines from the revetment and monitor one rocking armor stone at the crest.

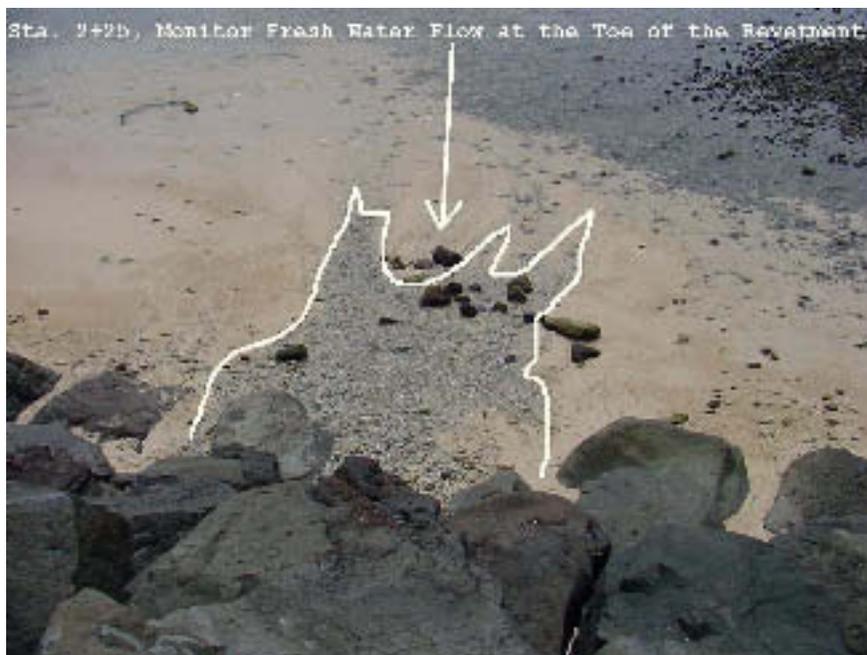
c. Sta. 2+25, There appears to be a fresh water leak "day-lighting" at the toe of the revetment, monitor this area for piping / settling. On past inspections we verified with the schoolteachers that there was no recent loss of water pressure.

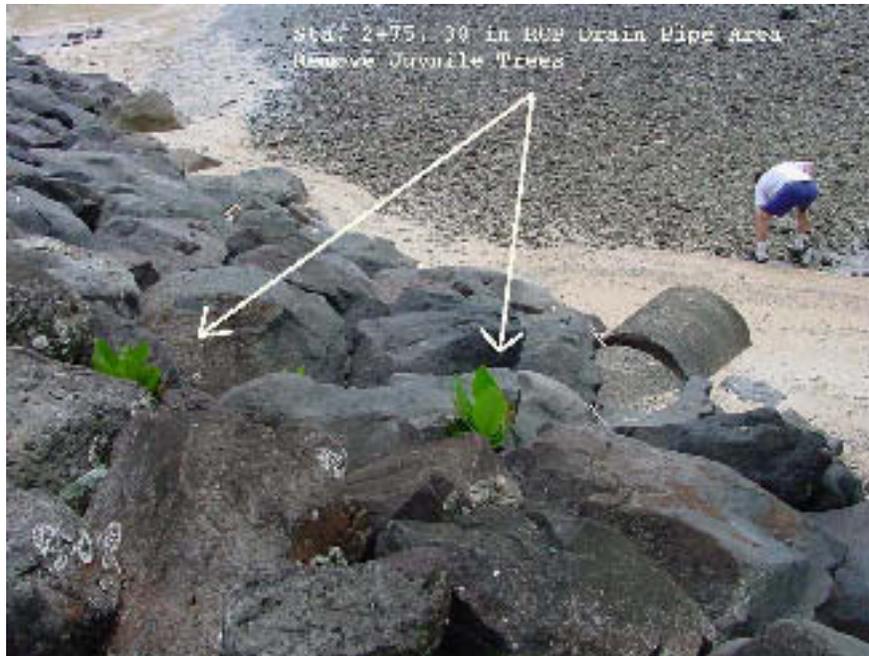
- d. Sta. 2+75, Patch the RCP pipe at the joint separation.
- e. Sta. 2+55, one split armor stone on the sideslope.
- f. Sta. 3+40, one split armor stone on the sideslope.

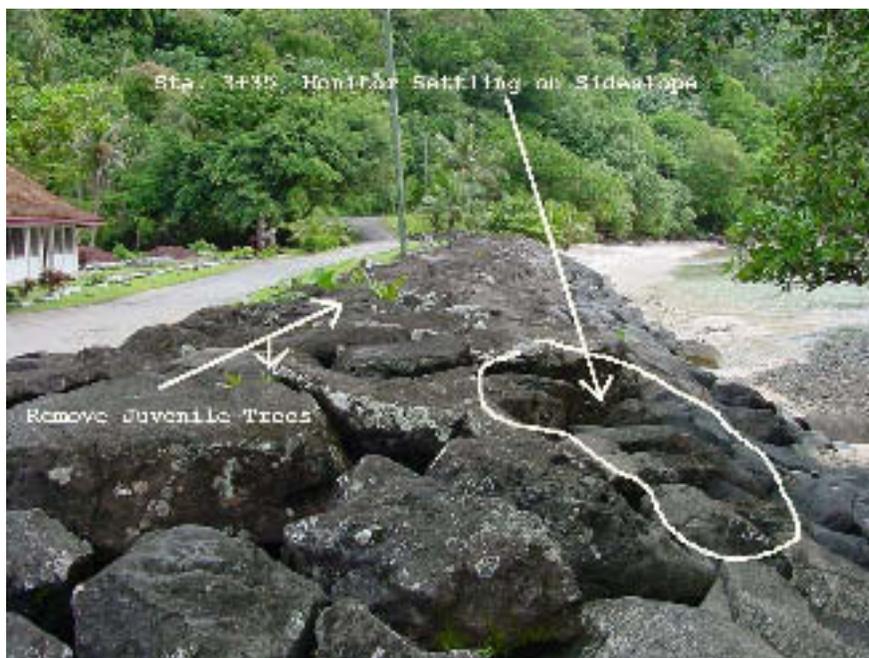
- g. Sta. 3+35, the one split armor stone on the sideslope, now has flipped. Monitor sideslope depression.

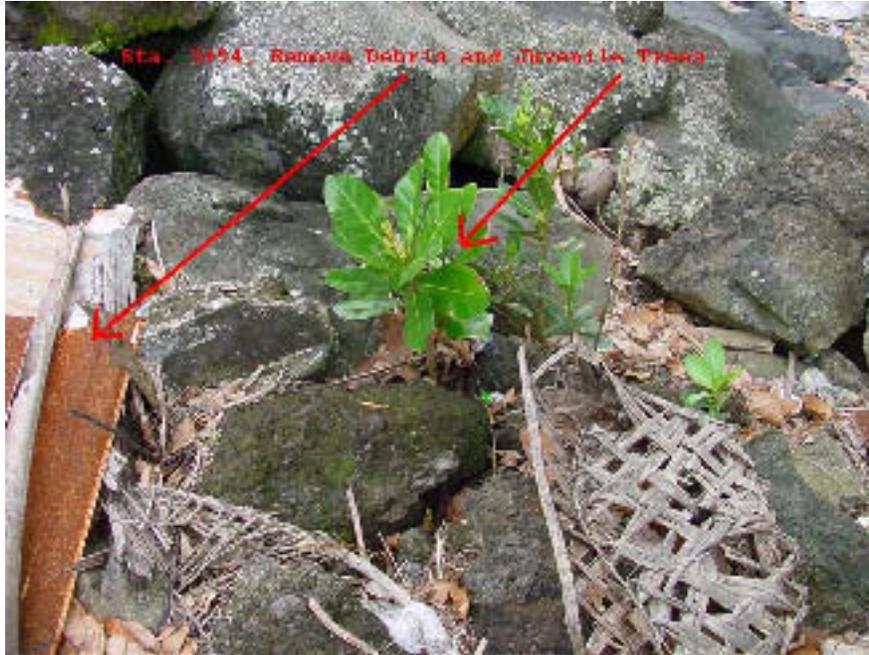
h. Sta. 3+55, Remove juvenile vegetation and debris from revetment.
