1. Project Name: Hilo Deep Draft Harbor

2. Date of Inspection: May 2, 2005

O&M INSPECTION REPORT FOR NAVIGATION PROJECTS
HILO DEEP DRAFT HARBOR
Honolulu Engineer District
CEPOH-EC-T

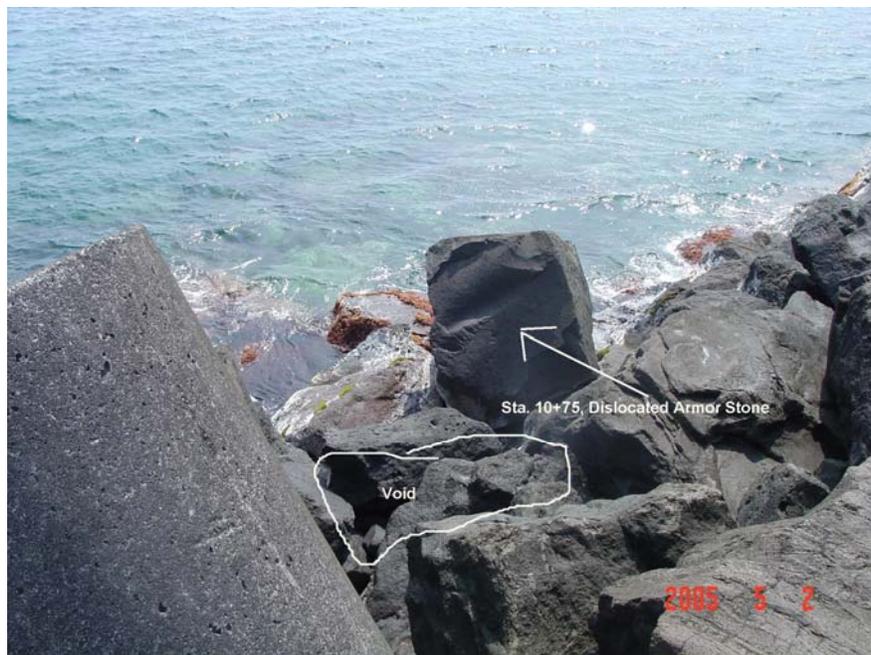
h. Sta. 10+75, OS, Monitor dislocated armor stone resting on the sideslope.

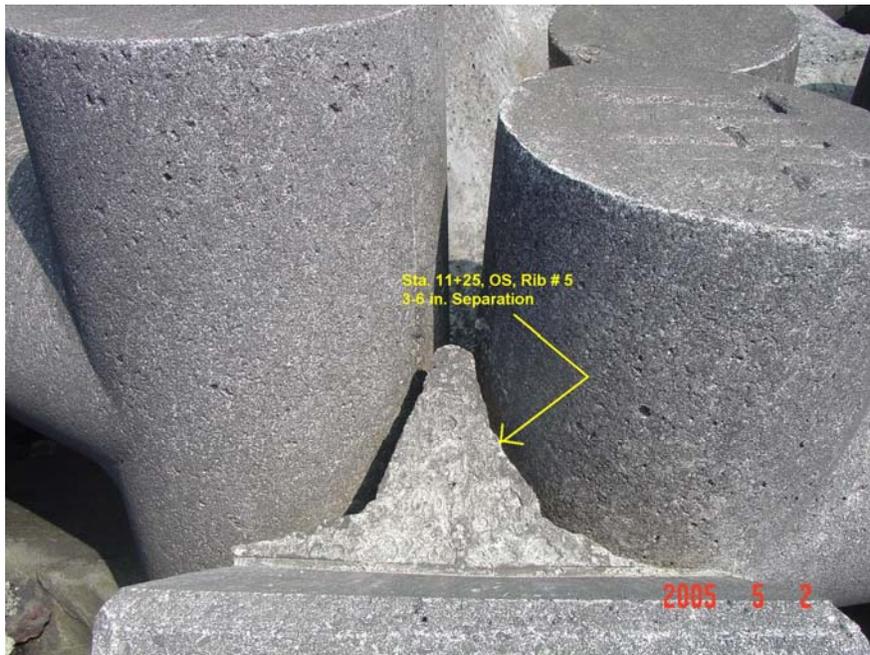
k. Sta. 11+25, OS, 3-6" separation (tribar #740 and #744), Rib # 5.

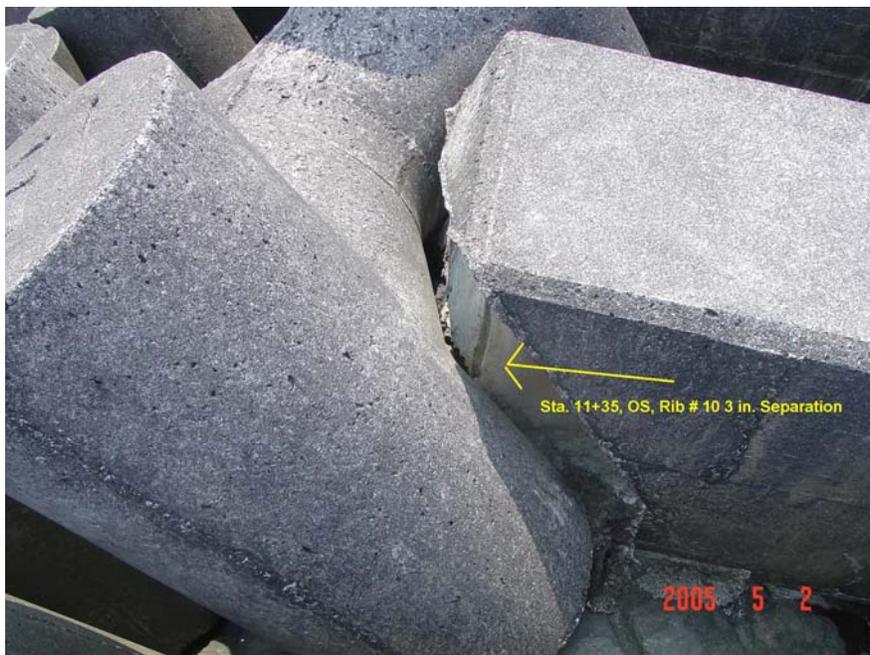
l. Sta. 11+35, OS, 3" separation (tribar #851). Rib # 10, Sideslope steepening.

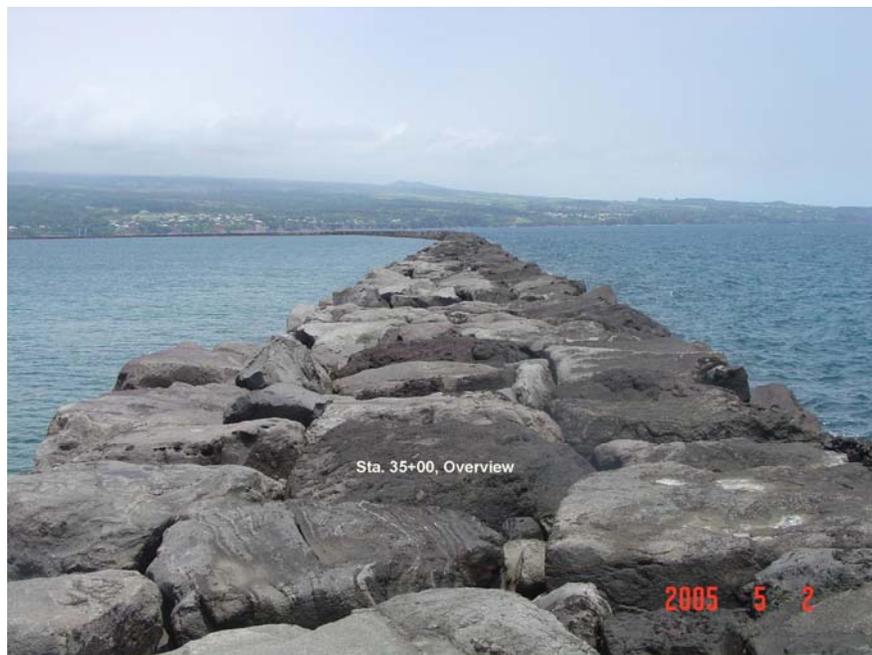
kk. Sta. 33+66, Void on crest.

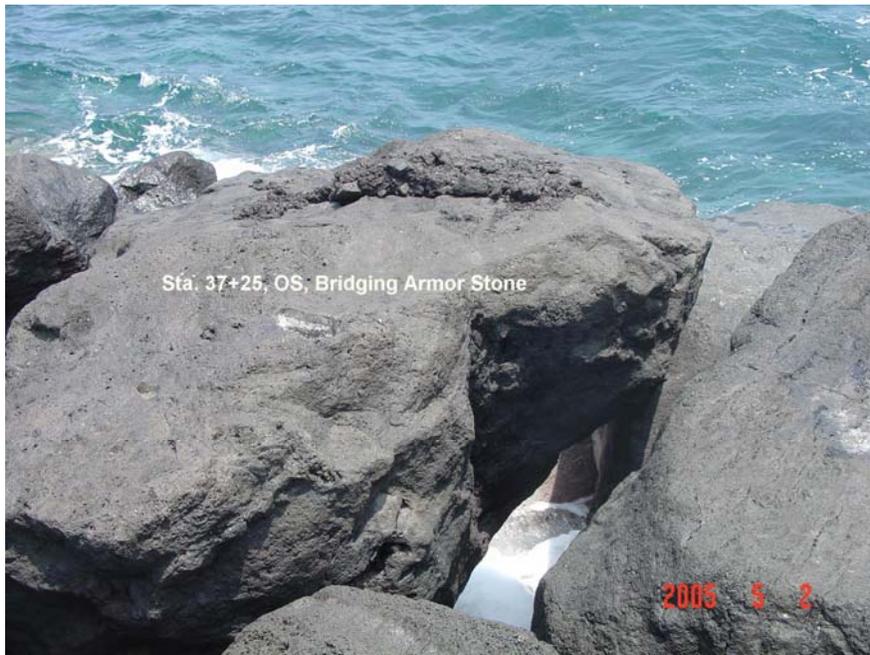
oo. Sta. 37+25, OS, bridging armor stone.

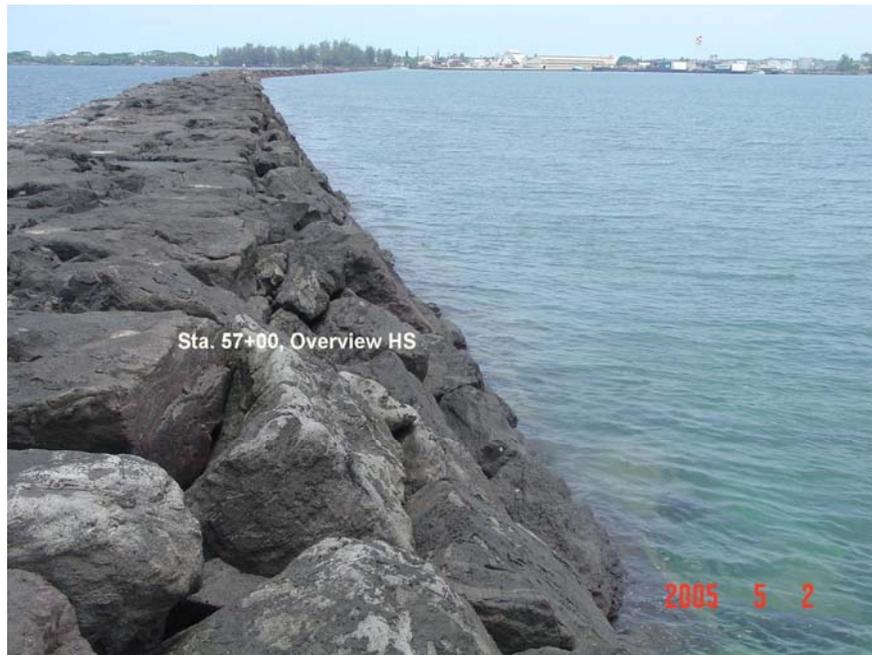
bbb. Sta. 57+35, void at crest, CL of OS, 4' deep 3' wide 4' deep.

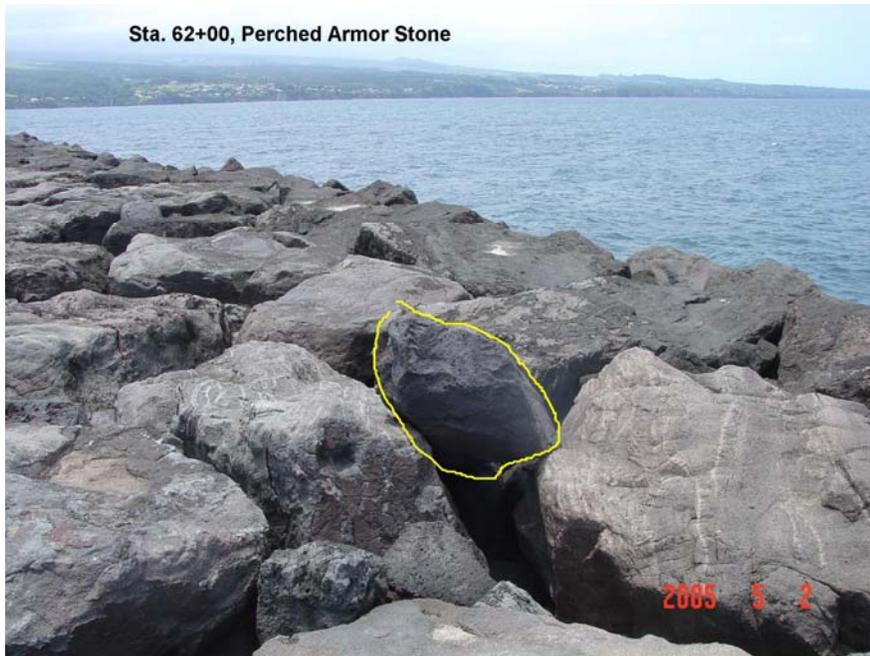
hhh. Sta. 62+00, perched armor stone, no obvious void.

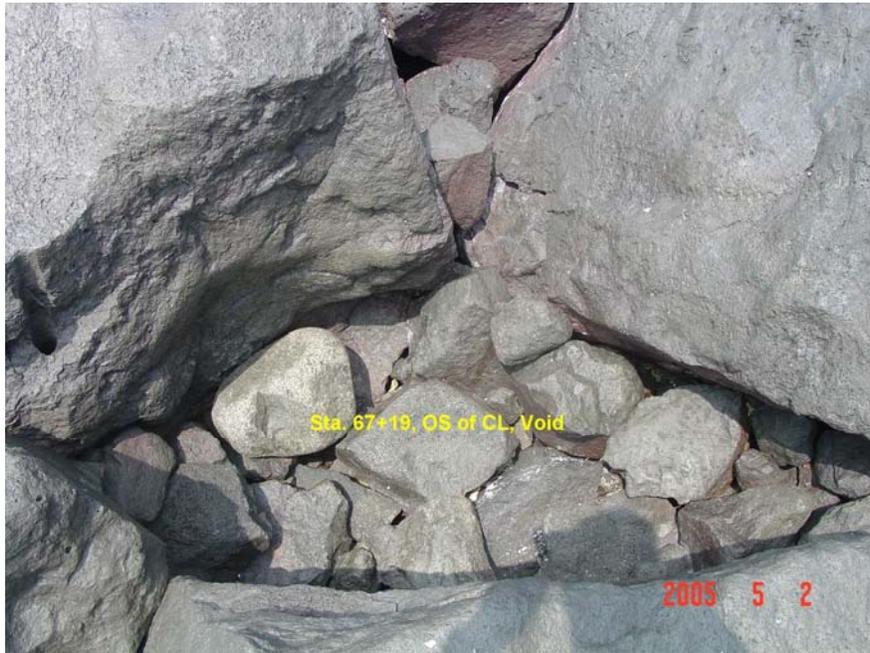
mmm. Sta. 67+19, OS, 2'Wx3'Lx4'D, void at hinge.

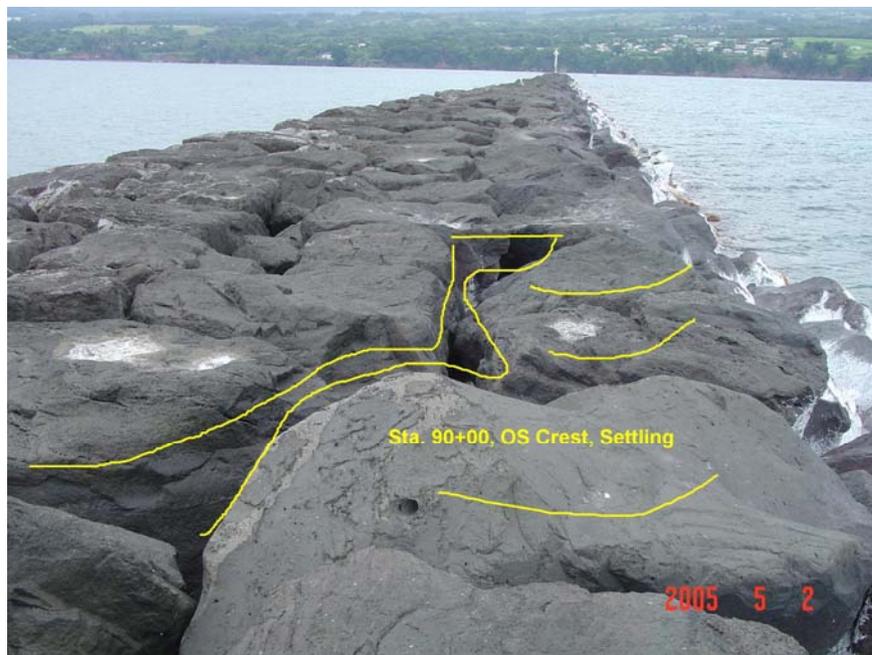
xxx. Sta. 90+00, OS, crest settling and gap.

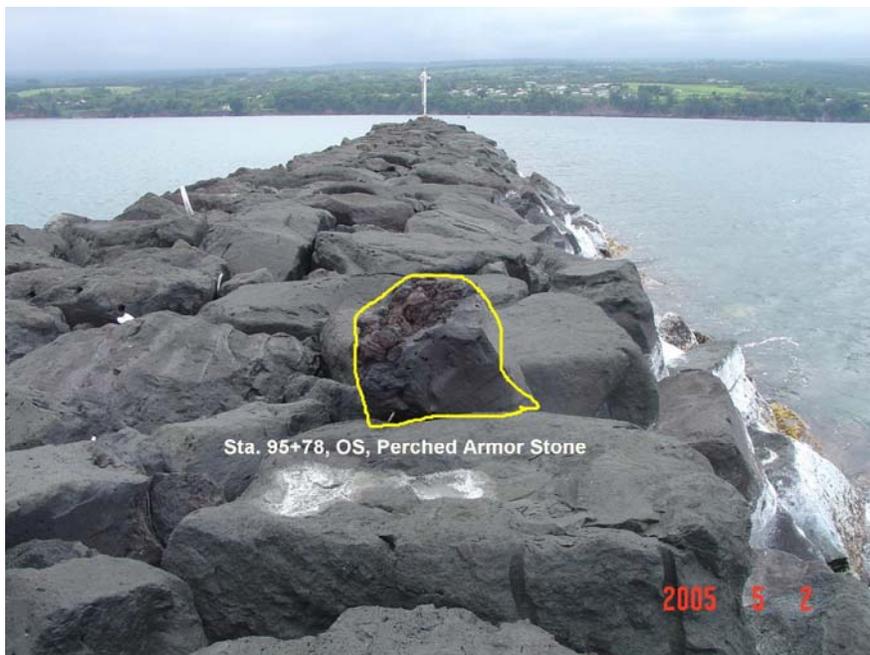
zzz. Sta. 95+78. OS, perched armor stone.

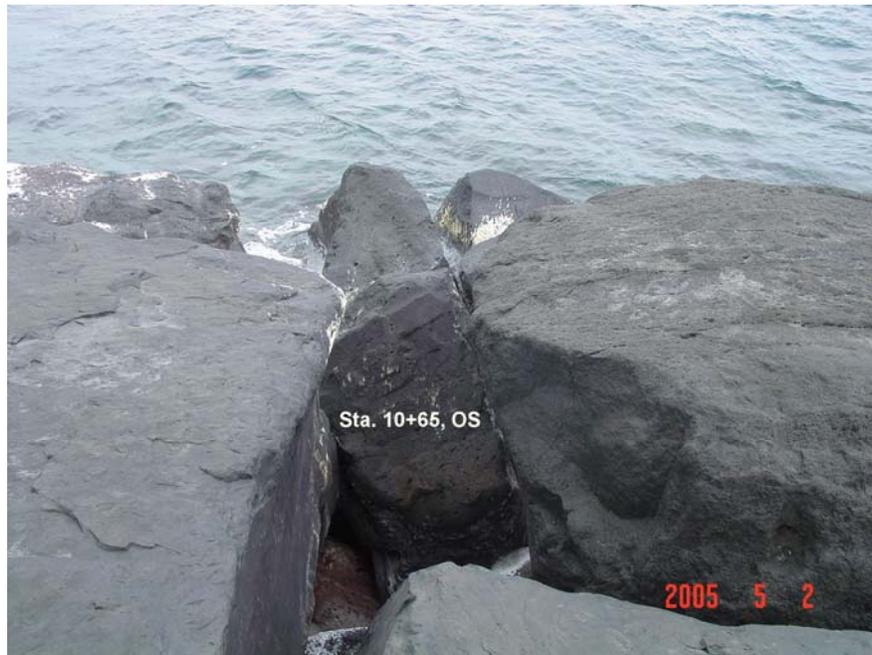
aaaa. Sta. 100+65, OS, void at hinge.
