**CONTINUING ELIGIBILITY INSPECTION (CEI) REPORT
FOR FLOOD CONTROL WORKS
Honolulu Engineer District
CEPOH-EC-T**

1. Project Name: Kawainui Marsh Flood Control Project
2. Date of Inspection: November 7 & 14, 2007
3. Inspection Personnel:

4. Ratings for FY08
Project Rating: **"MS, Marginally Satisfactory"**
Project Condition Code: **"MA, Minimally Acceptable"**
Project Status: **"Active"**
5. Discussion:

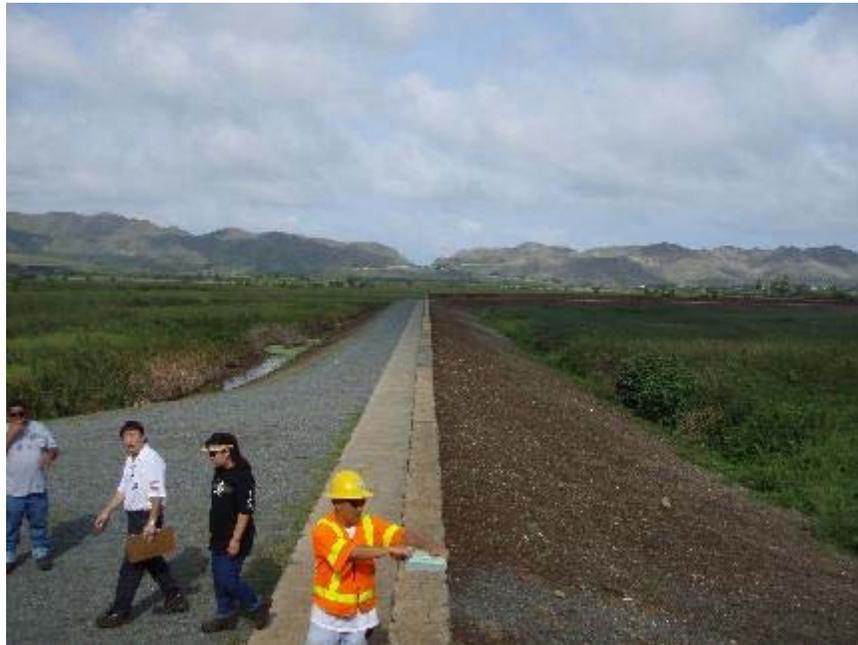
a. Sta. 0+00, Overview, cut back woody vegetation 15' back from the toe of the levee (town side).

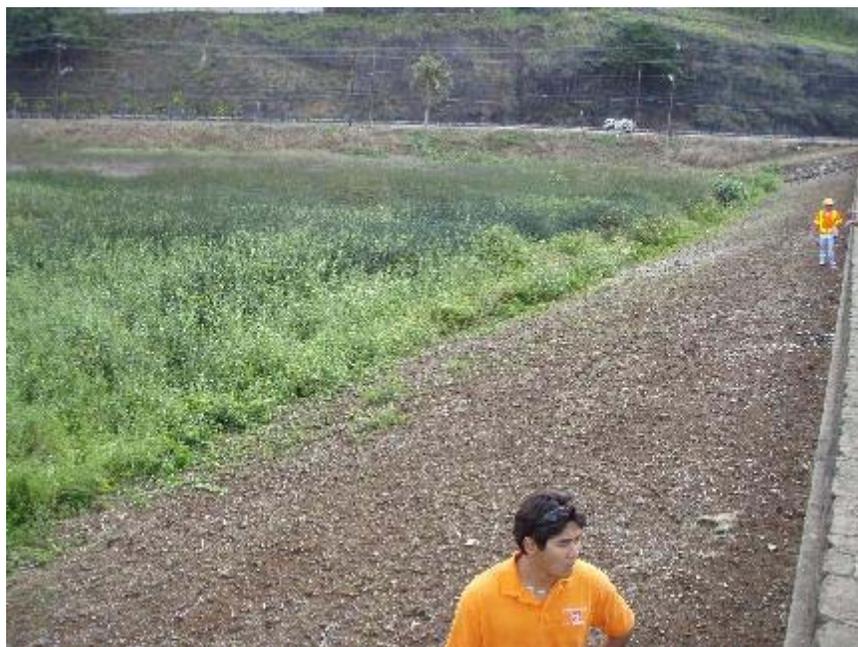
b. Sta. 5+00, town side (TS), remove woody vegetation from levee.

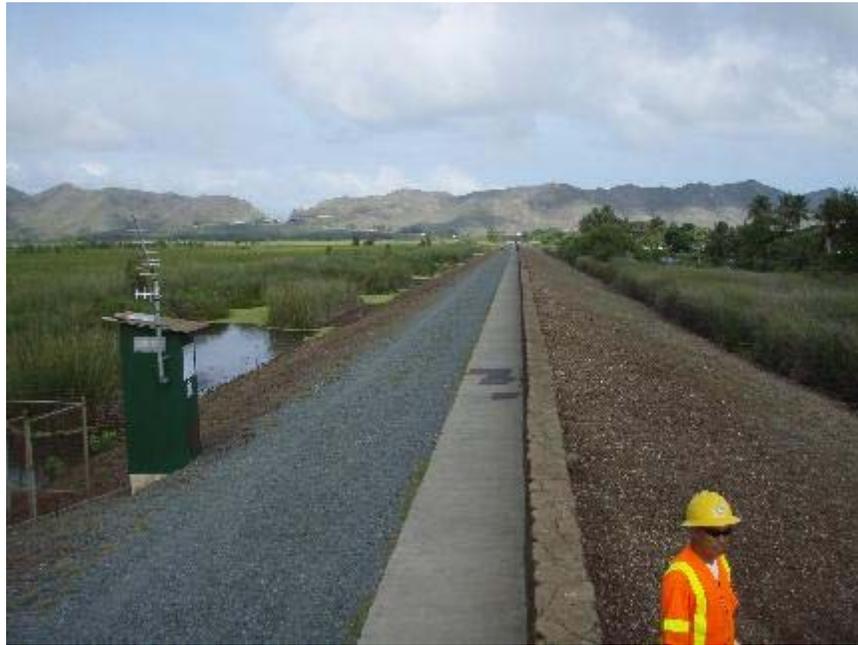
c. Sta. 15+50, overview, USGS stream gauge (marsh side).

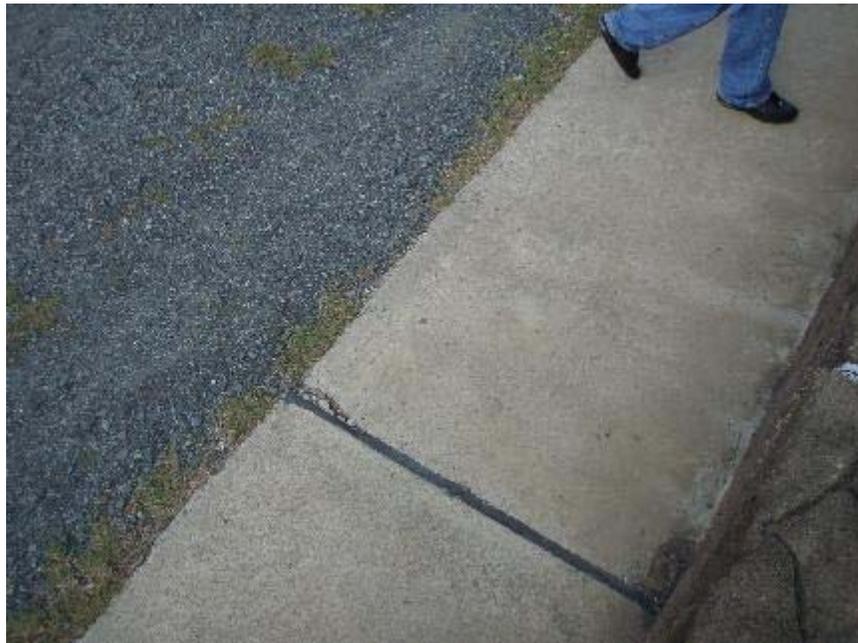
d. Sta. 23+30, marsh side (MS), patch concrete.

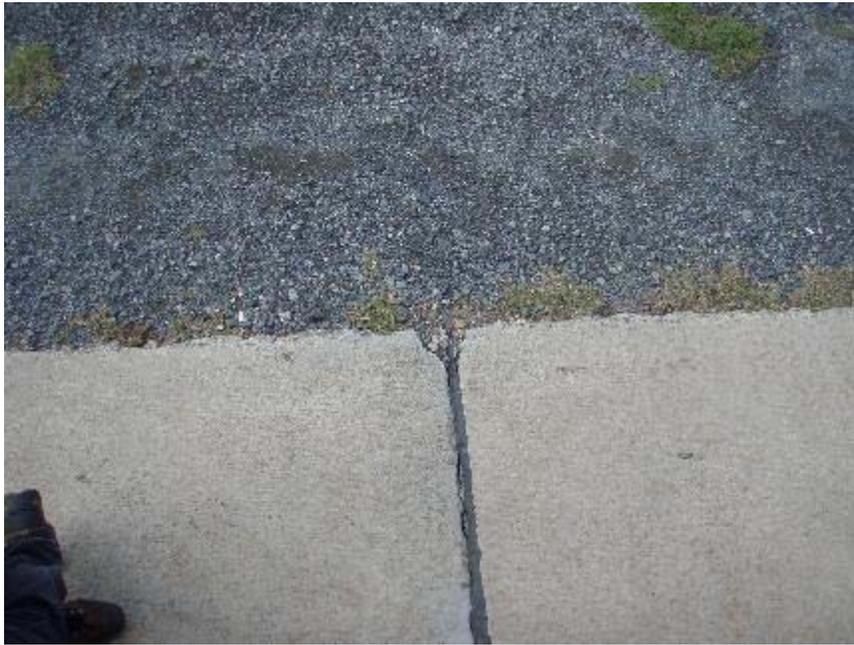
e. Sta. 29+15, MS, patch concrete.

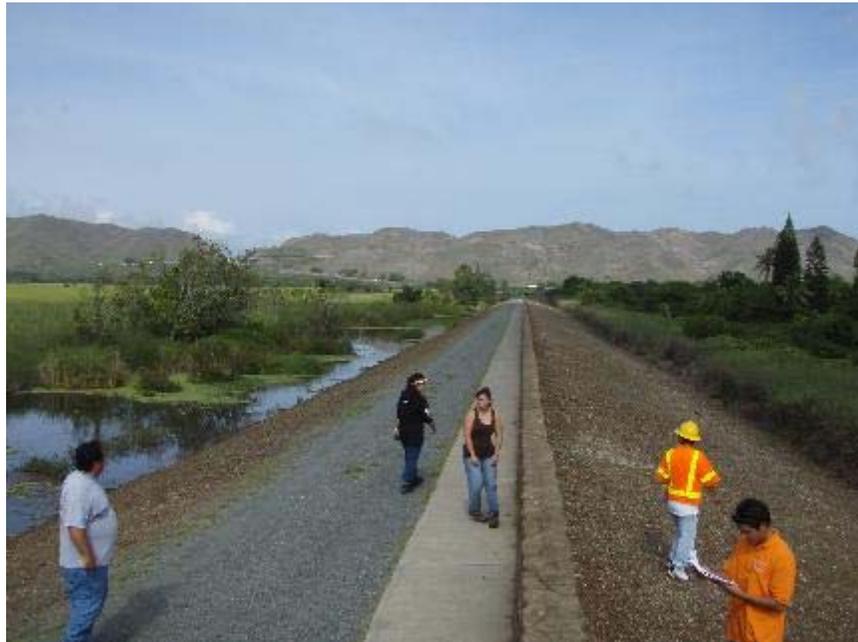
f. Sta. 30+00, Overview of levee, minimal vegetation.

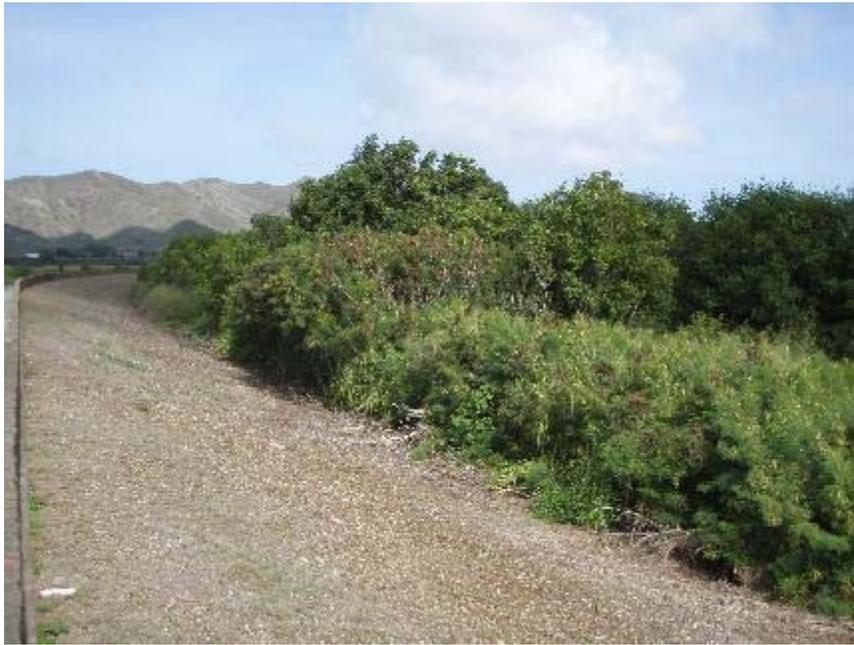
h. Sta. 43+00, TS, cut back woody vegetation 15' from toe.

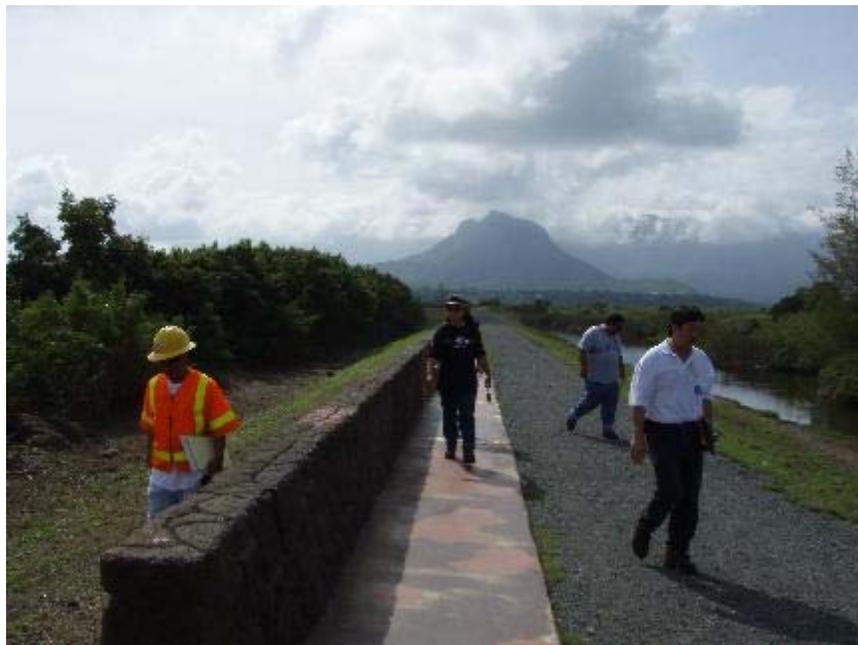
m. Sta. 64+00, MS, looking south, Overview.

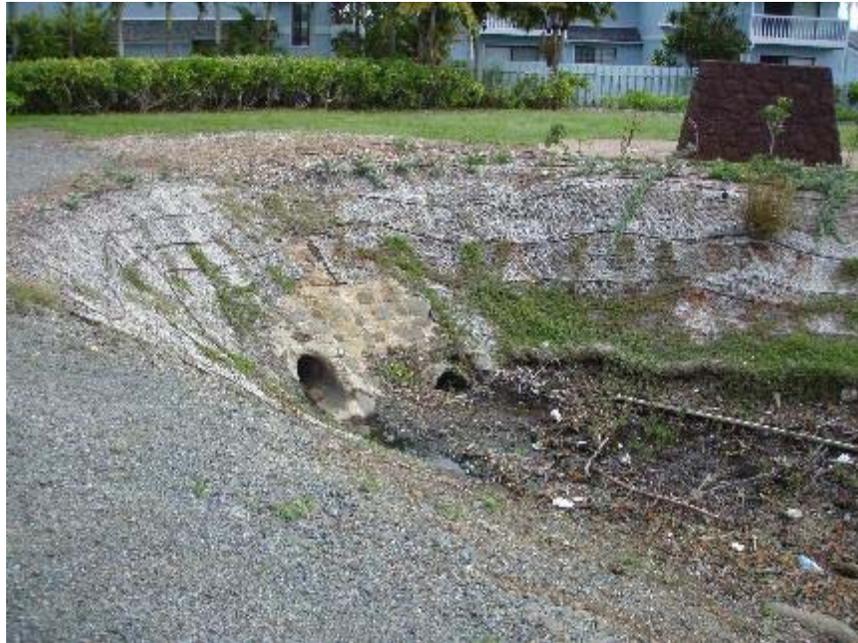
a. Sta. 91+25, Interior drain line outlets.

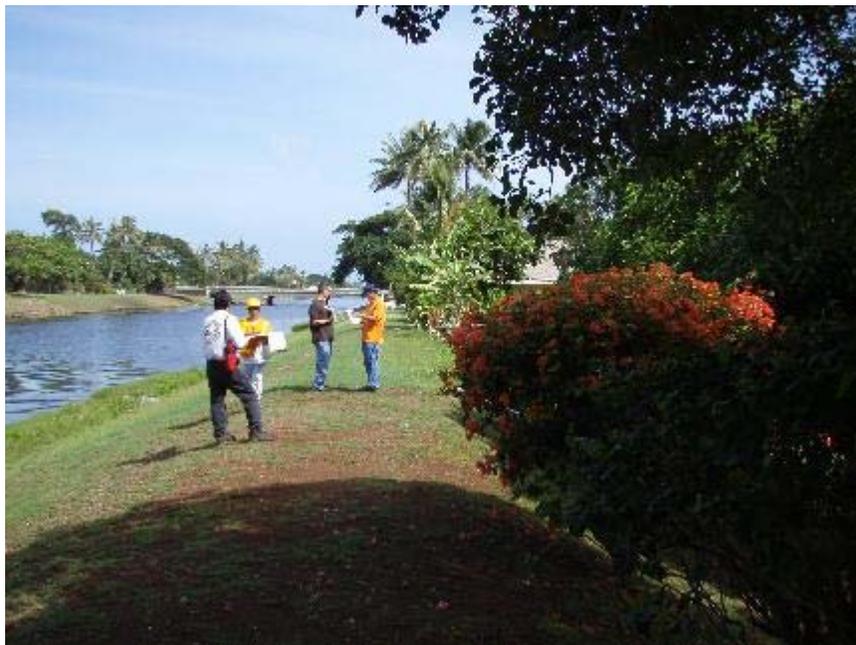
d. Sta. 89+00 - 88+00, RB, remove waddy vegetation on town side (TS) side slope.

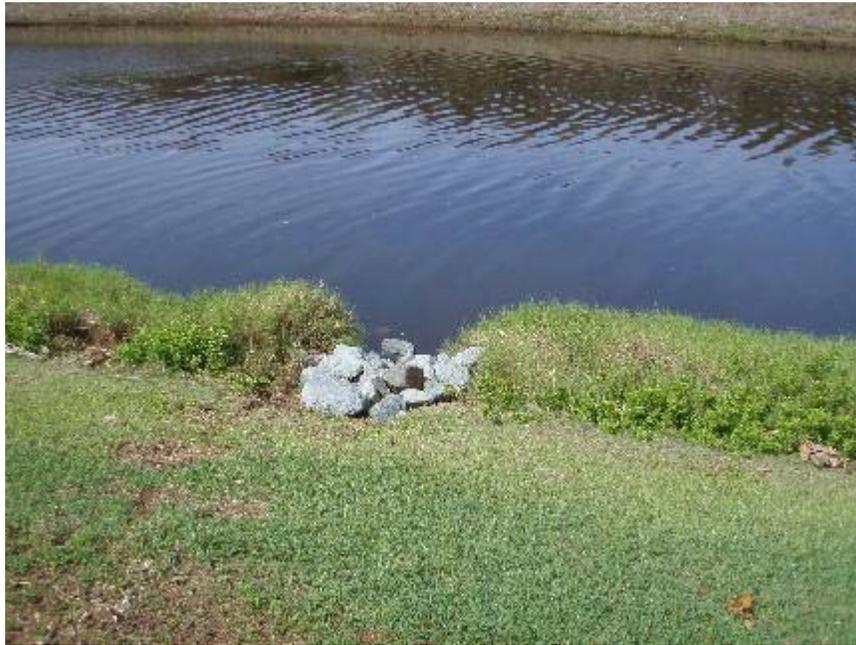
e. Sta. 89+77, RB, boat roller removed and side slope restored.

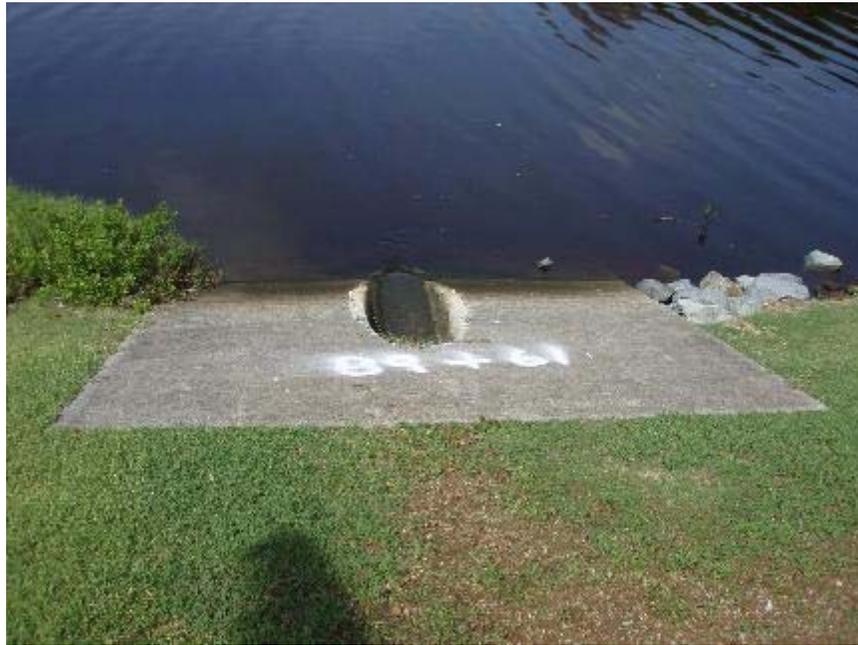
g. Sta. 89+61, RB, 24" Pipe outlet.

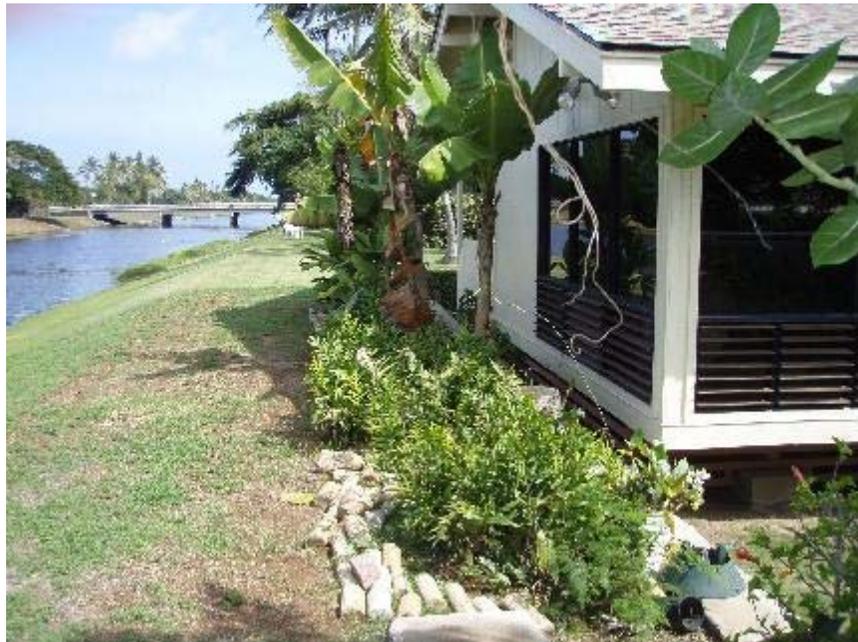
h. Sta. 89+50, RB, remove all unauthorized encroachments, woody vegetation and CRM wall, on TS side slope.

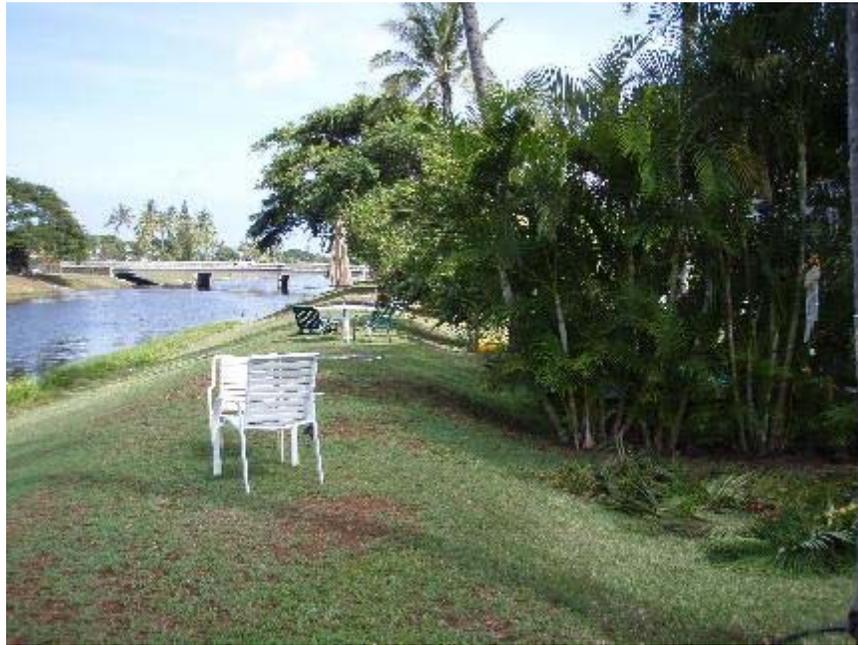
i. Sta. 88+00, RB, remove woody vegetation within maintenance easement.

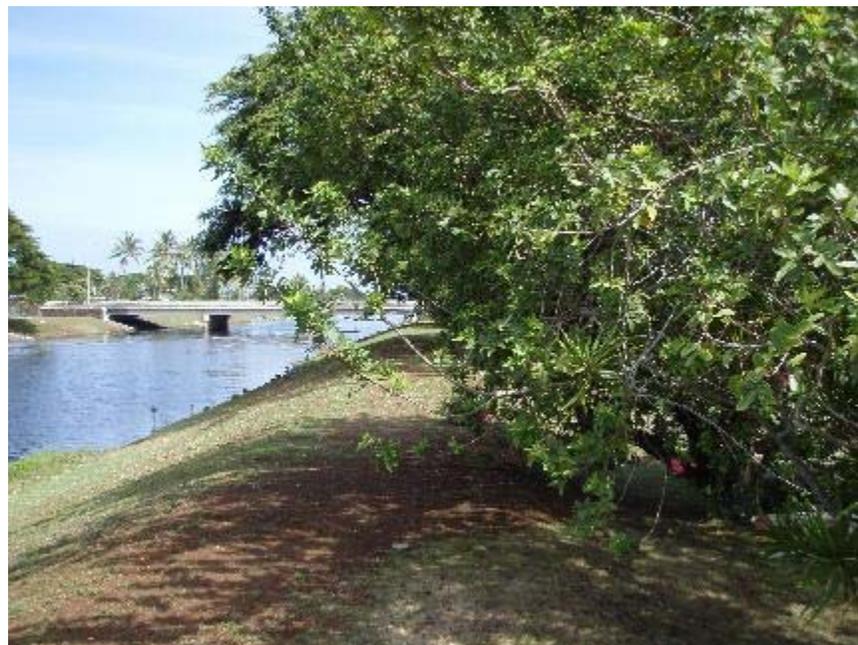
j. Sta. 86+30, RB, remove woody vegetation within maintenance easement.

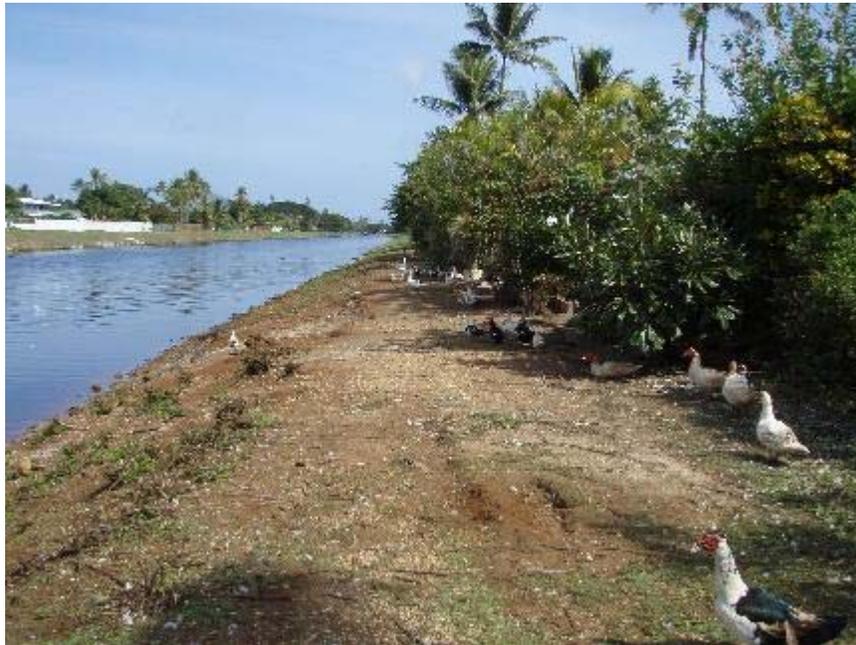
n. Sta. 81+60, RB, restore eroded levee side slope and re-establish ground cover vegetation.

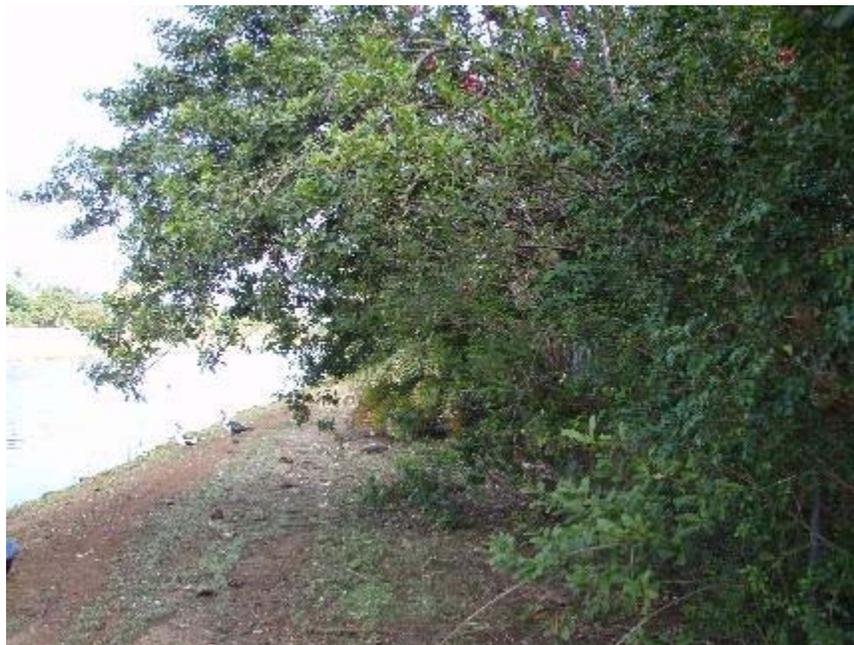
o. Sta. 79+50, remove woody vegetation within maintenance easement and re-establish ground cover vegetation.

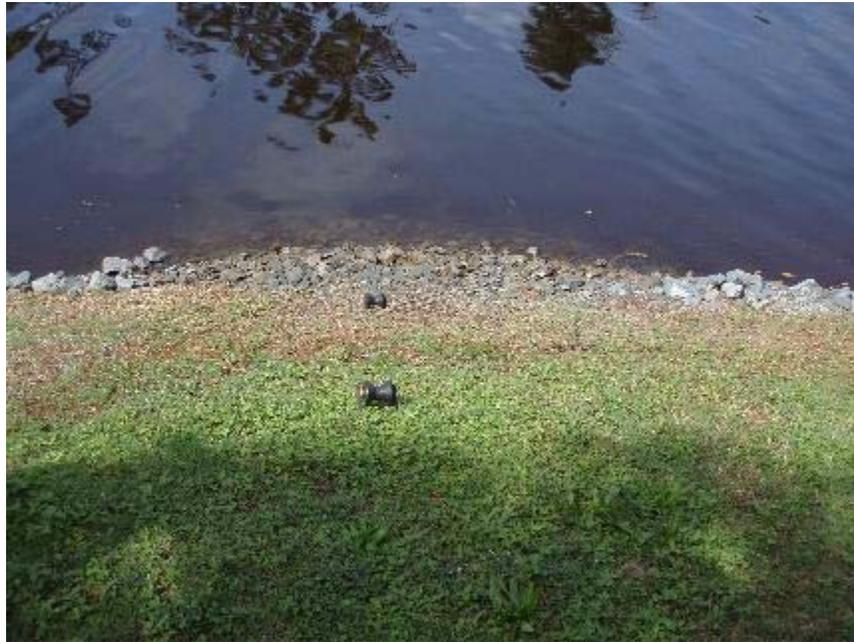
p. Sta. 77+85, RB, remove unauthorized boat rollers from side slope.

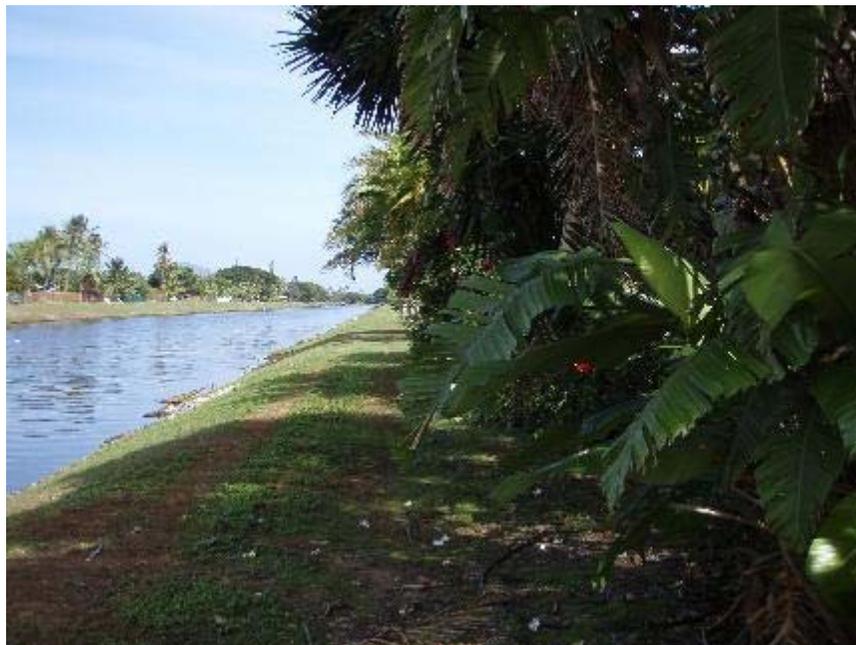
q. Sta. 77+85, RB, remove woody vegetation within maintenance easement.

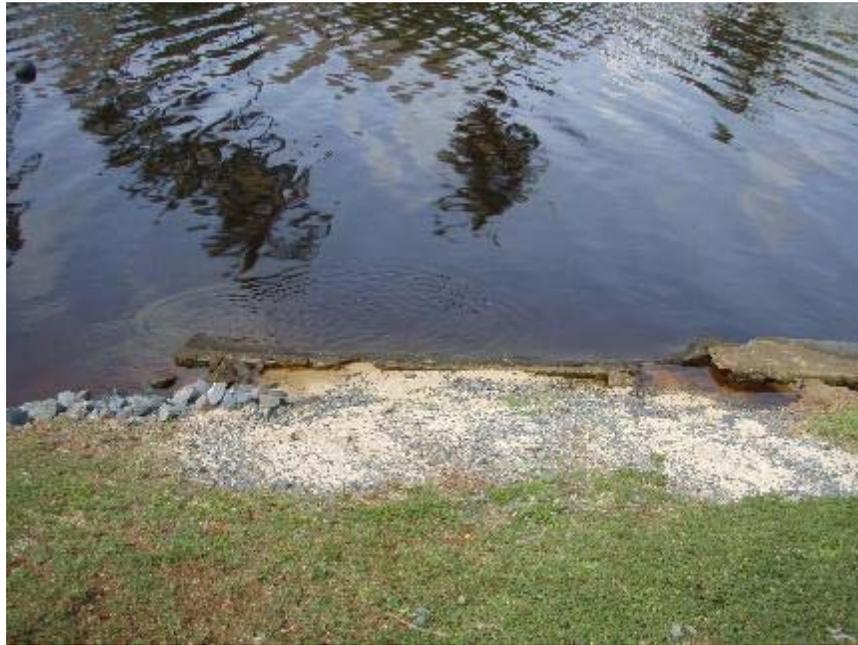
r. Sta. 77+00, RB, unauthorized concrete ramp removed.

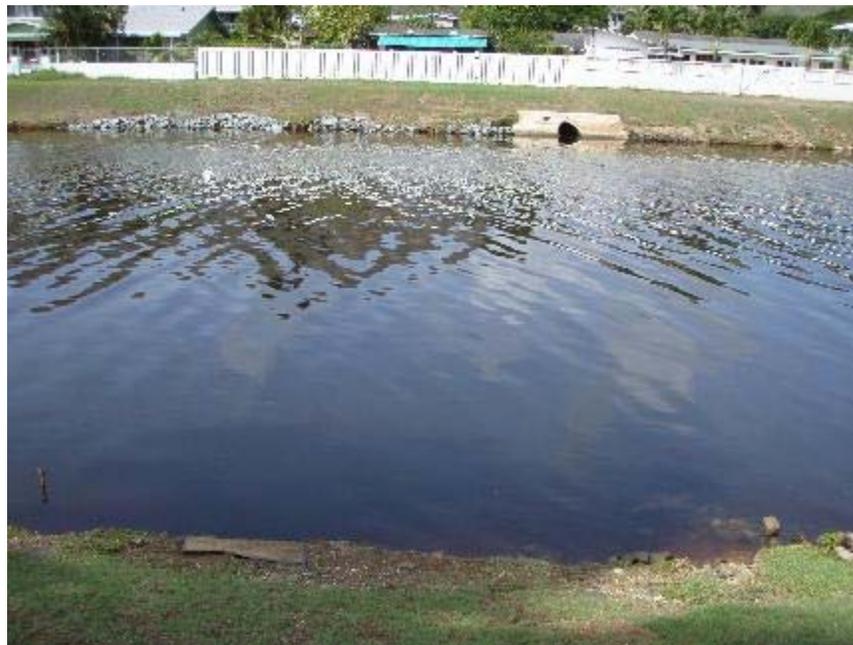
s. Sta. 76+10, RB, unauthorized concrete ramp removed.

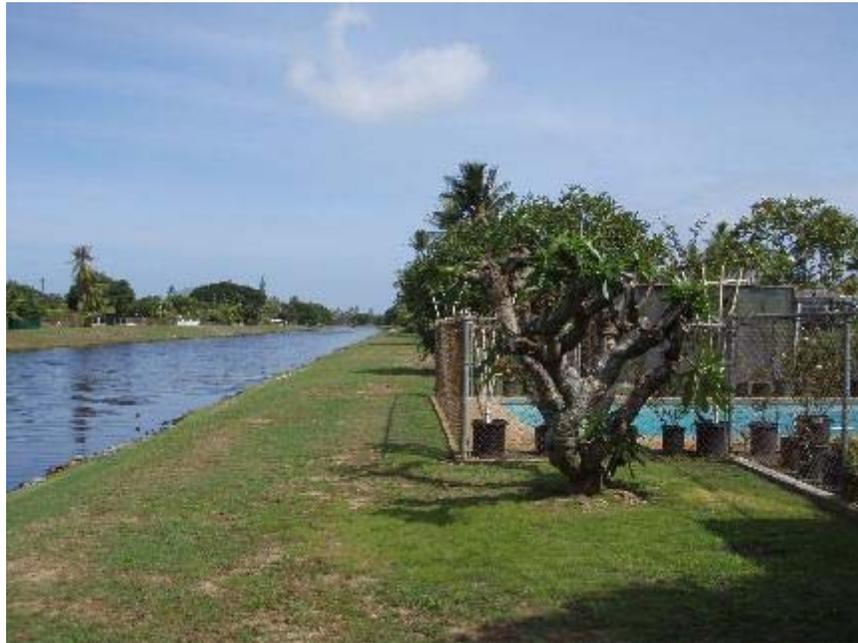
- t. Sta. 75+50, verify maintenance easement and remove unauthorized encroachments within the easement.

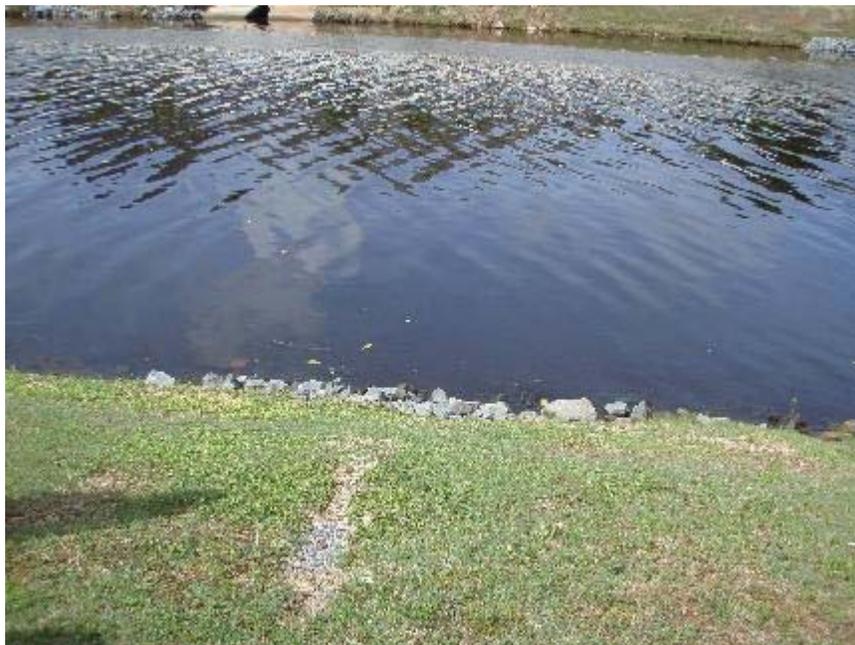
- u. Sta. 75+00, RB, unauthorized PVC drain outlet removed.

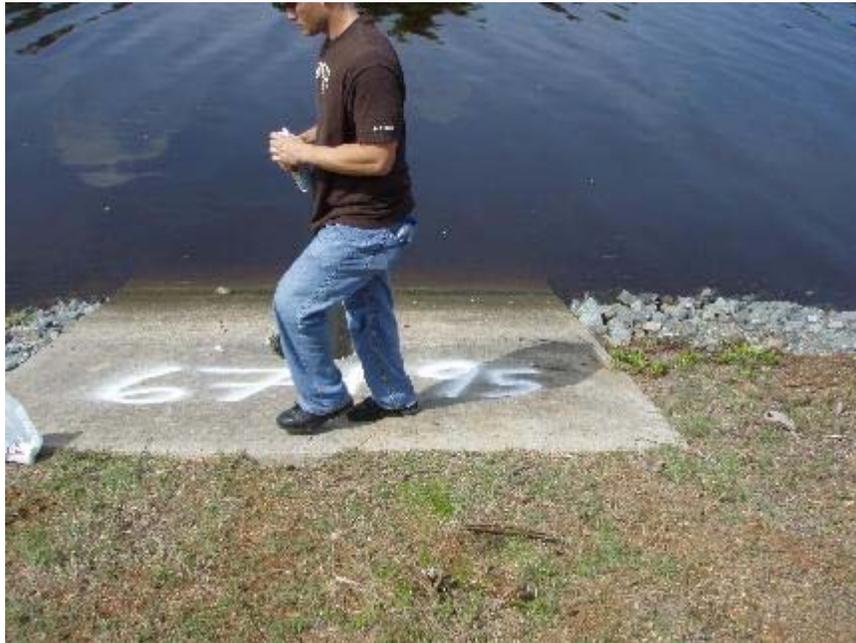
x. Sta. 67+95, RB, vegetation removed at 18" Pipe outlet, remove young koa trees around the outlet.

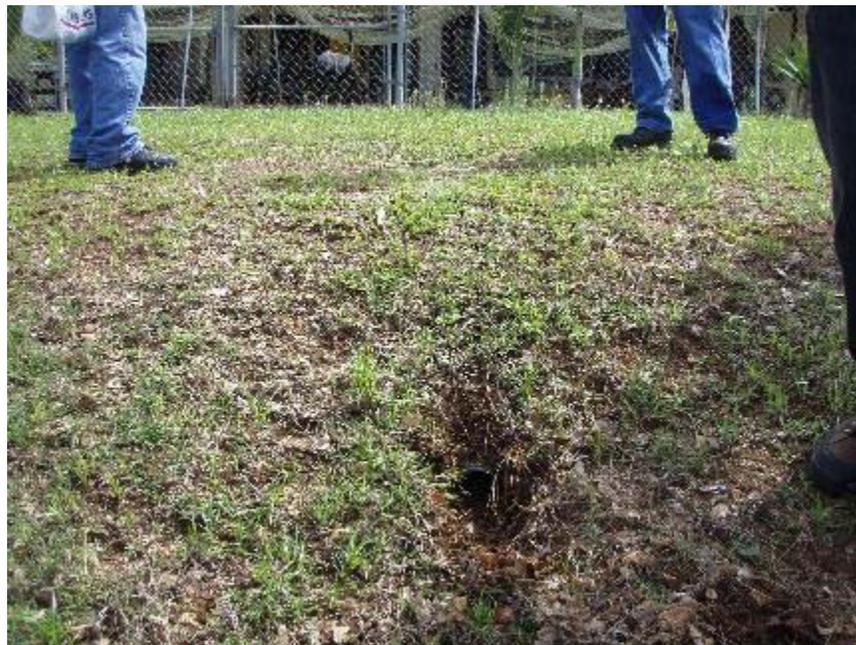
y. Sta. 60+00, RB, remove unauthorized 3" black HDPE pipe and restore side slope.

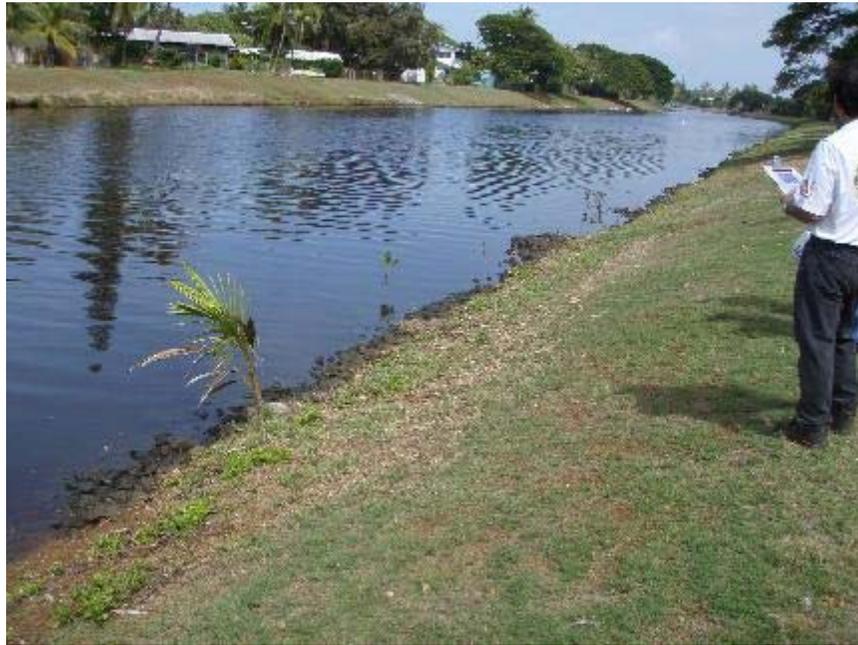
z. Sta. 63+00, RB, remove coconut tree from side slope.

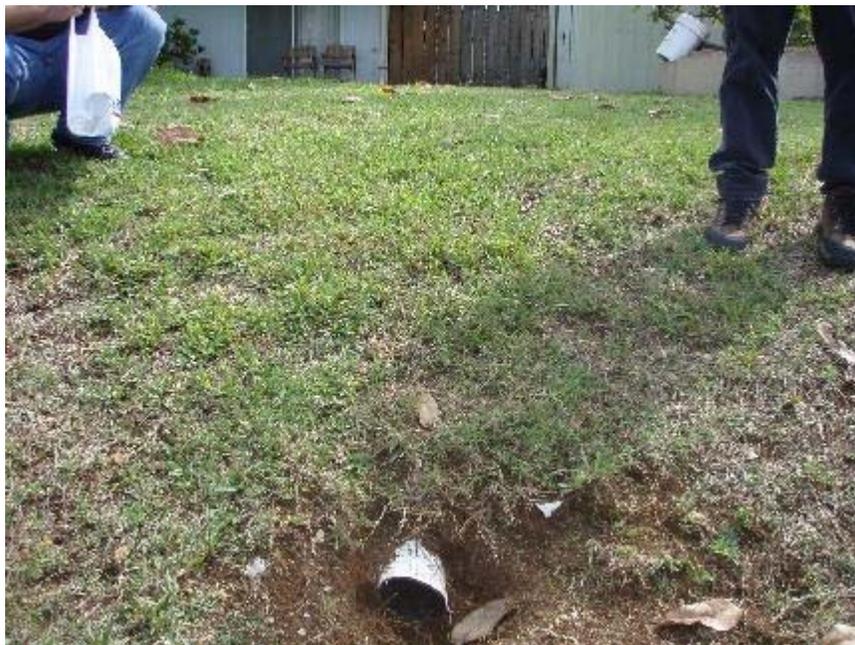
aa. Sta. 63+28, RB, remove unauthorized 4" white PCV pipe and restore side slope.

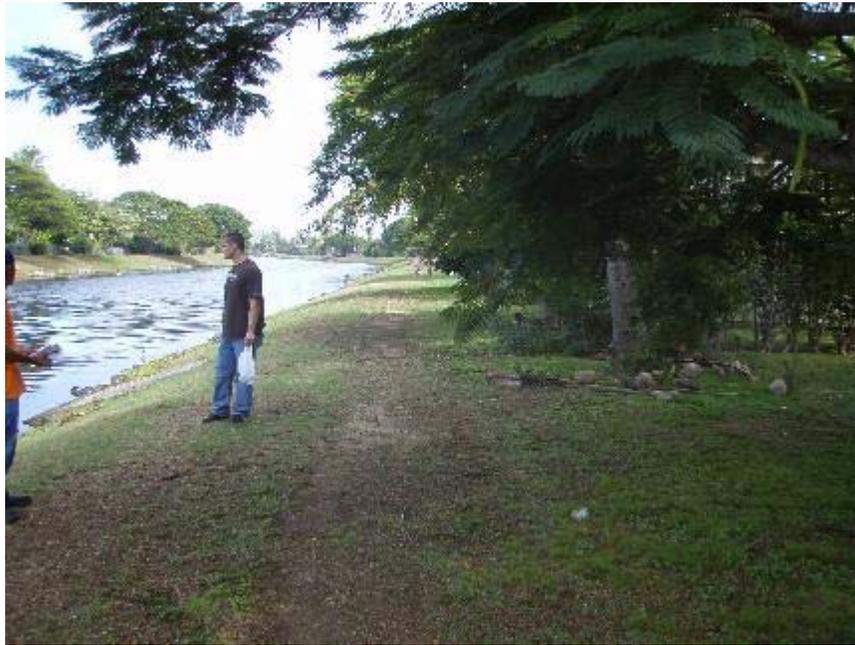
bb. Sta. 62+50, RB, remove woody vegetation within maintenance easement.

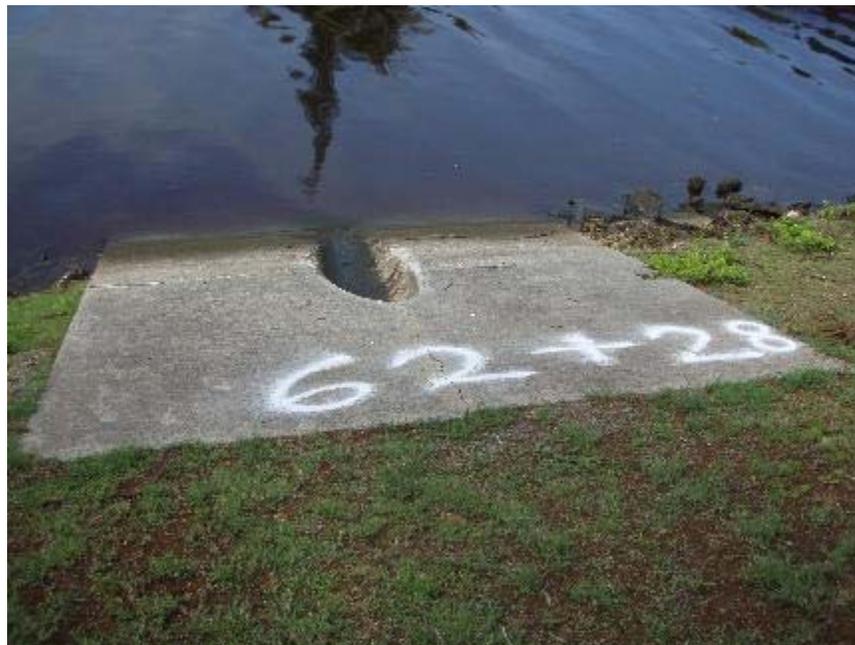
cc. Sta. 62+28, RB, 18" Pipe Outlet, remove woody vegetation.

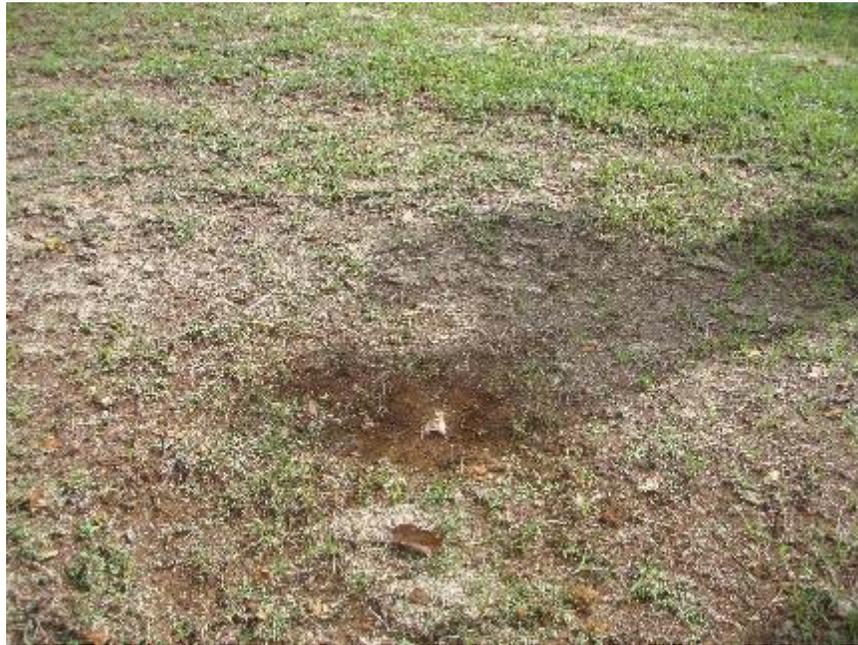
dd. Sta. 60+00, RB, remove unauthorized 1.5" pvc drainline and restore side slope.

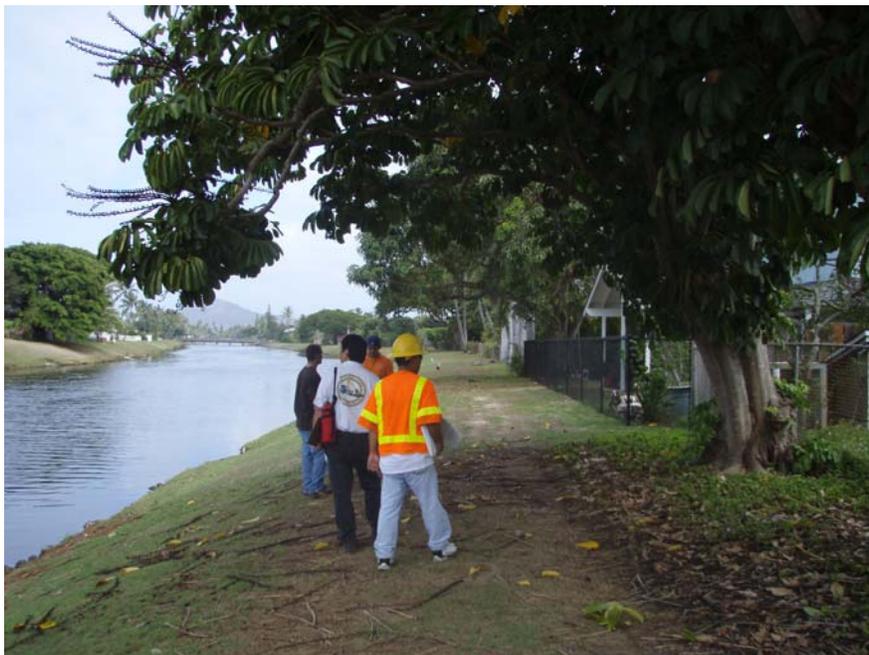
ee. Sta. 58+00, RB, remove woody vegetation within maintenance easement.

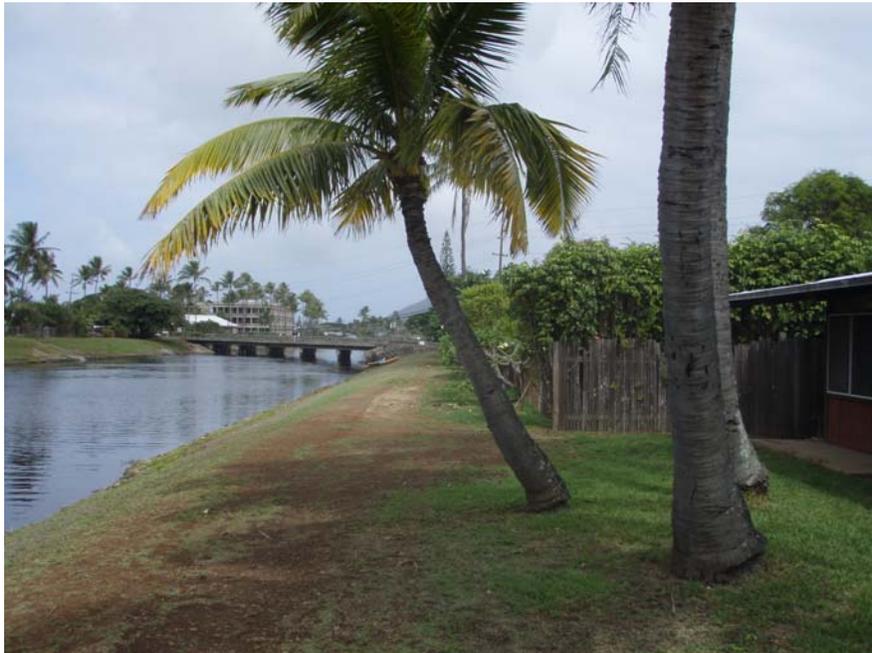
mm. Sta. 43+00, RB, remove coconut and plumeria trees within maintenance easement.

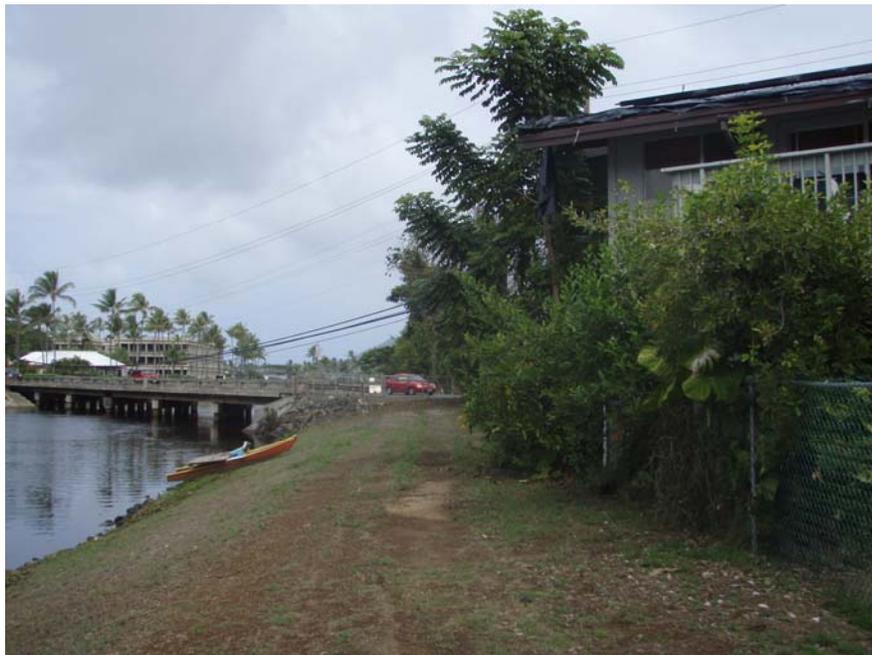
oo. Sta. 41+30, RB, remove woody vegetation within maintenance easement.

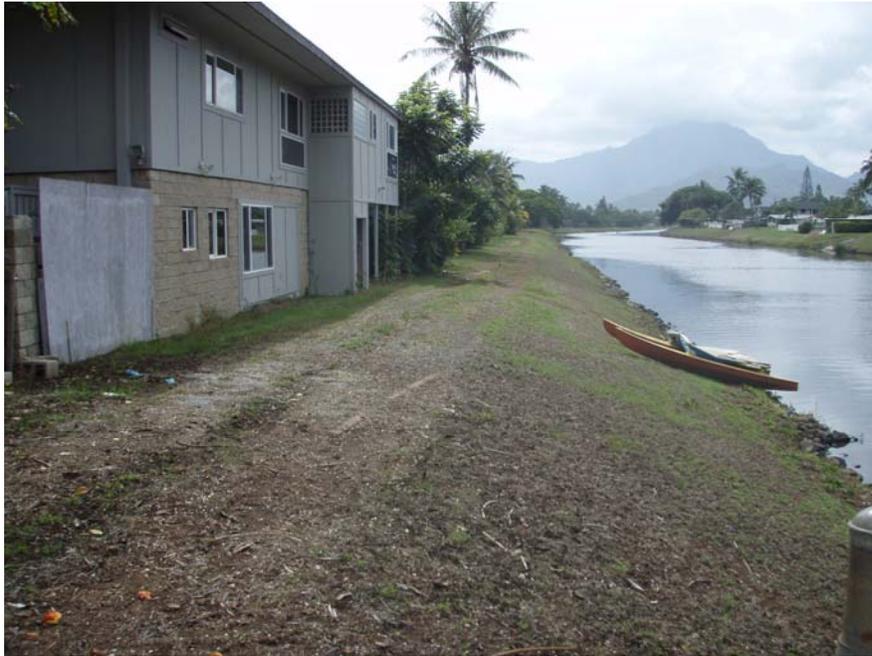
pp. Sta. 40+40, RB, facing marsh, Begin Riprap, woody vegetation removed.

Note: Kalaheo St. Bridge starts at Sta. 40+40.

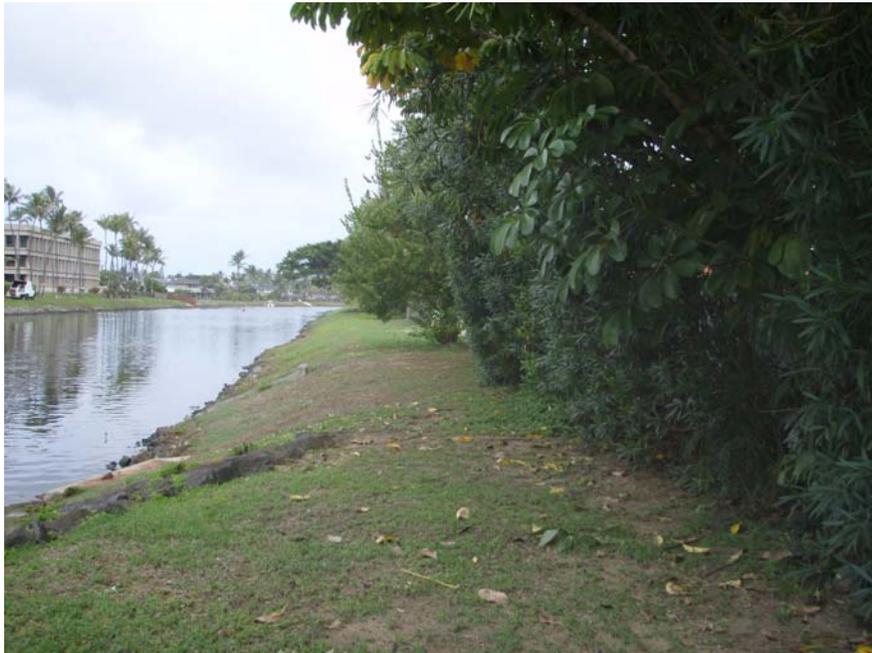
qq. Sta. 38+20, Overview, remove trees within maintenance easement.

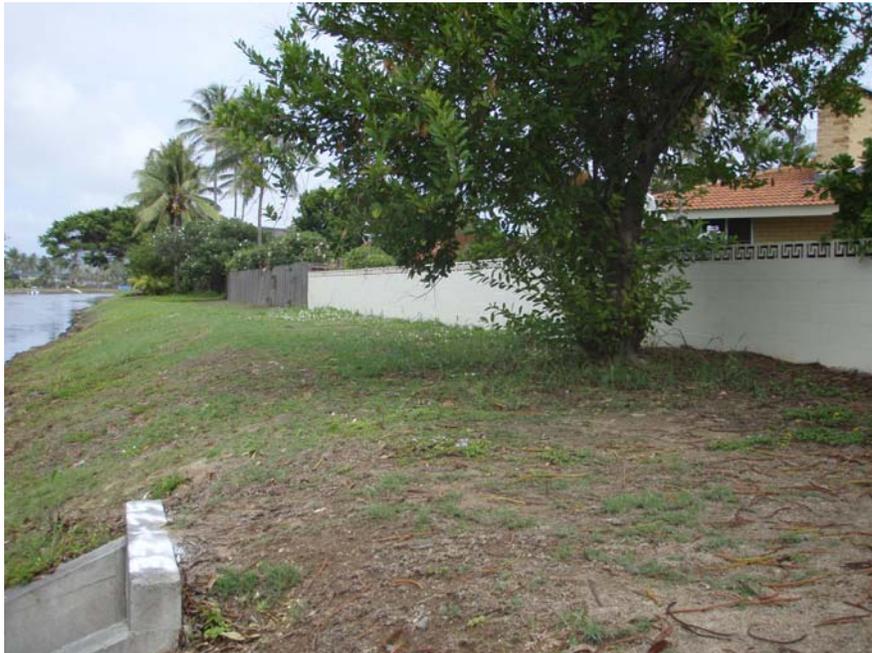
ss. Sta. 37+75, RB, 24" Pipe Outlet, remove tree within maintenance easement.

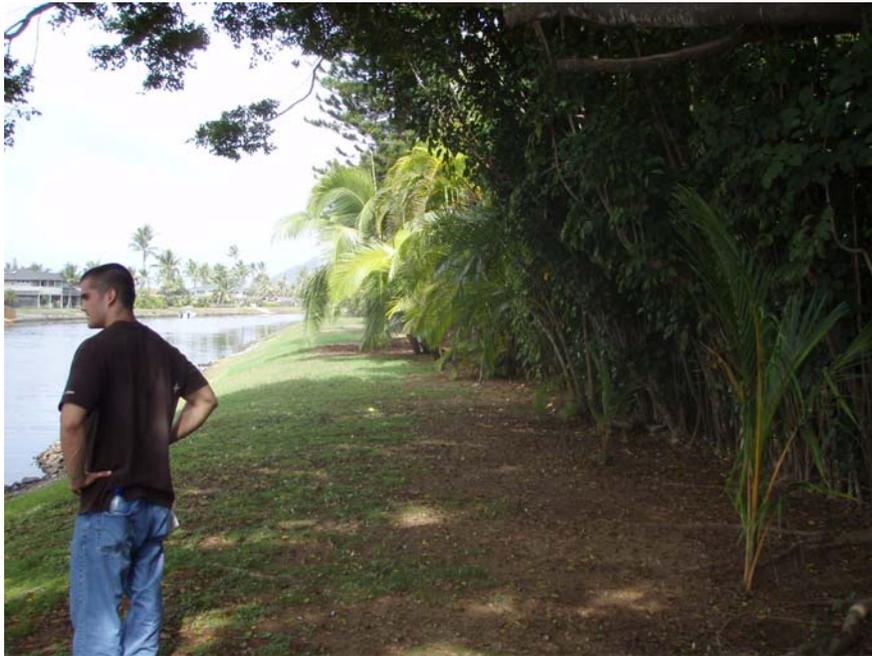
uu. Sta. 33+00 - 32+00, RB, remove trees within maintenance easement.

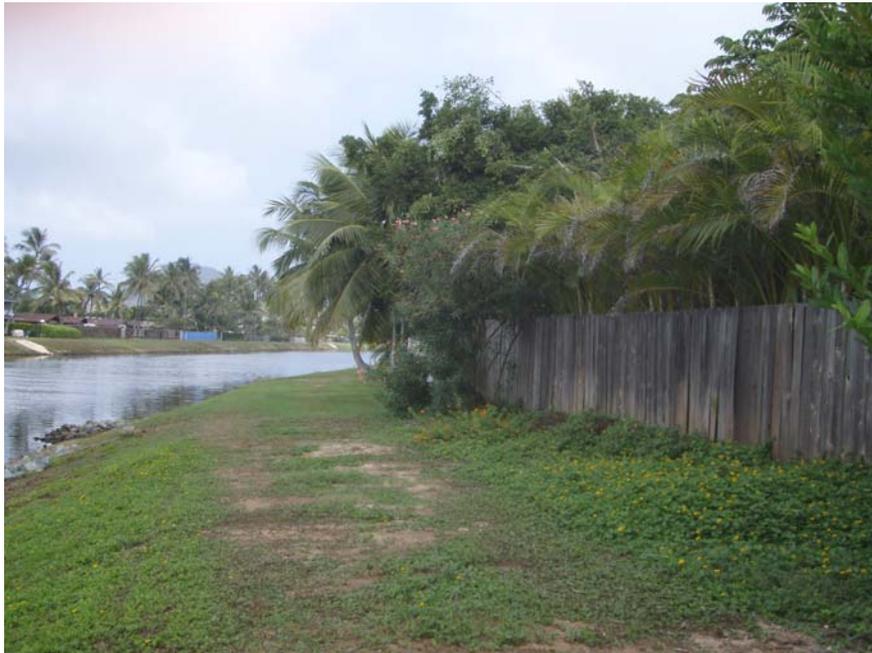
ww. Sta. 29+00 - Sta. 35+00, RB, remove woody vegetation within maintenance easement.

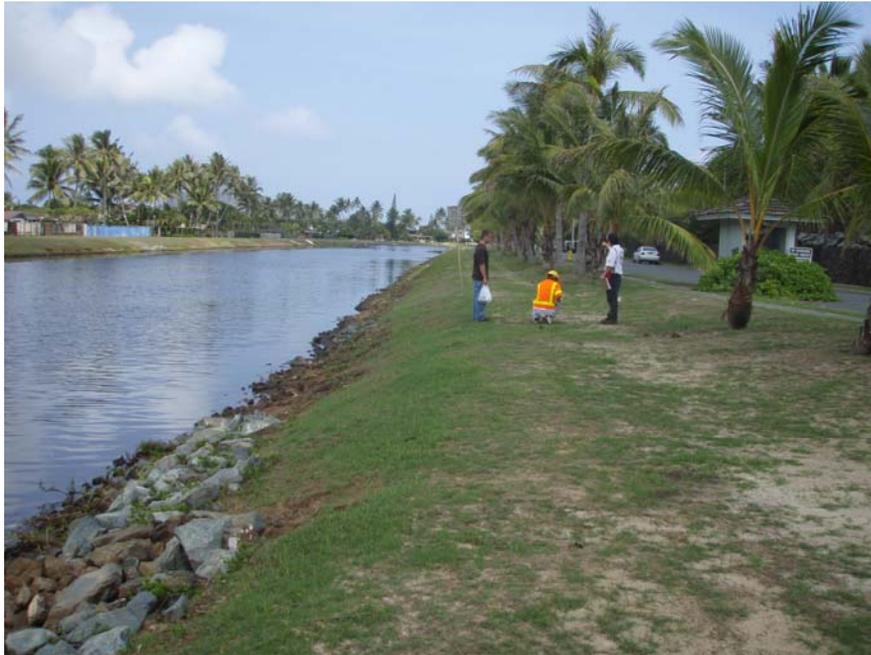
yy. Sta. 28+90, RB, remove unauthorized stone structure and restore toe.

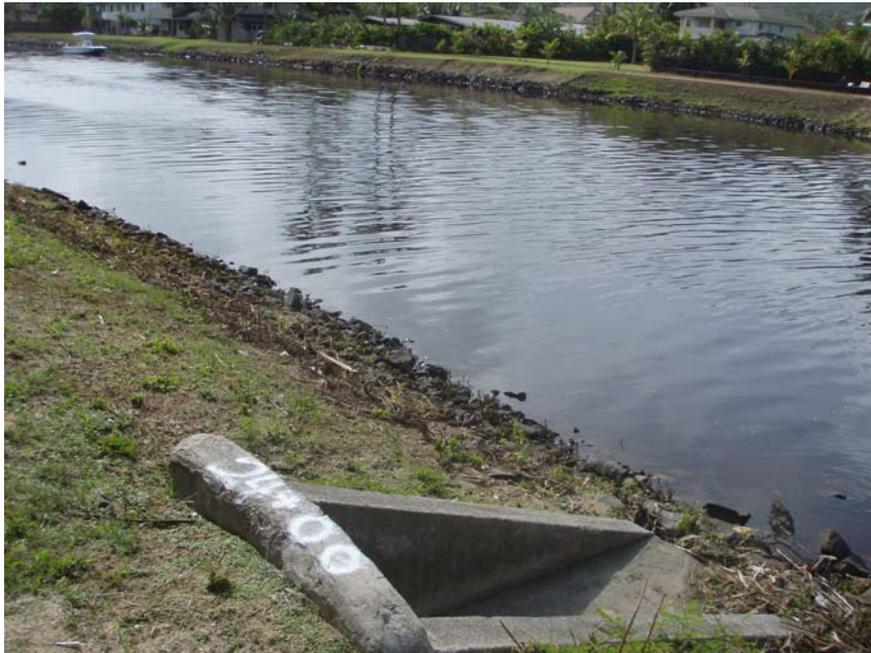
zz. Sta. 25+00, RB, Overview, steps removed and side slope restored. Verify that the coconut trees are outside of the maintenance easement. Remove all trees within the easement
