**CONTINUING ELIGIBILITY INSPECTION (CEI) REPORT
FOR FLOOD CONTROL WORKS
Honolulu Engineer District
CEPOH-EC-T**

1. Project Name: Kawainui Marsh Flood Control Project
2. Date of Inspection: November 7 & 14, 2007
3. Inspection Personnel:

4. Ratings for FY08
Project Rating: **"MS, Marginally Satisfactory"**
Project Condition Code: **"MA, Minimally Acceptable"**
Project Status: **"Active"**
5. Discussion:

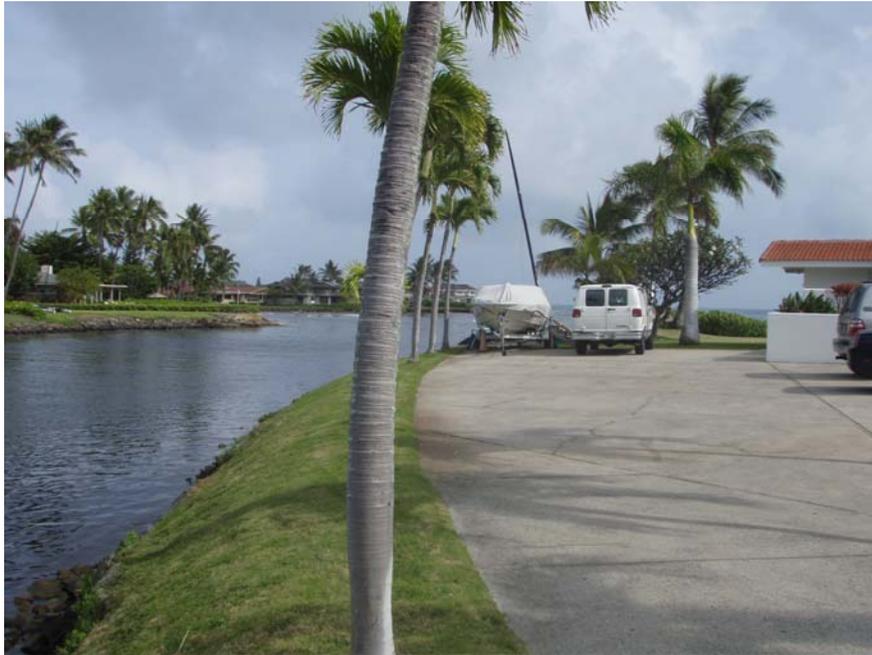
eee. Sta. 12+90, RB, concrete culvert, remove all trees within maintenance right of way and restore maintenance easement.

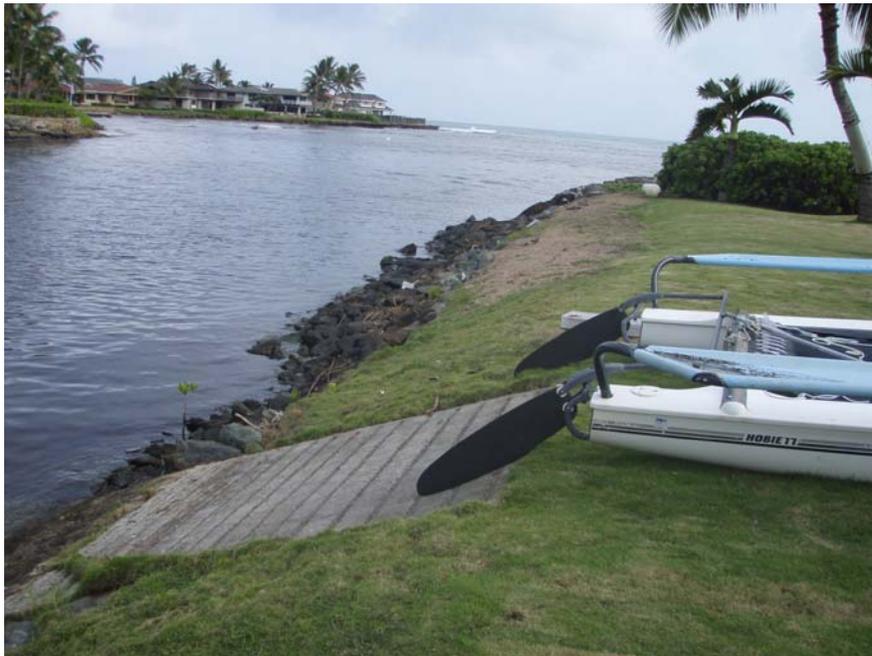
fff. Sta. 7+50, RB, Overview, remove all trees within maintenance easement.

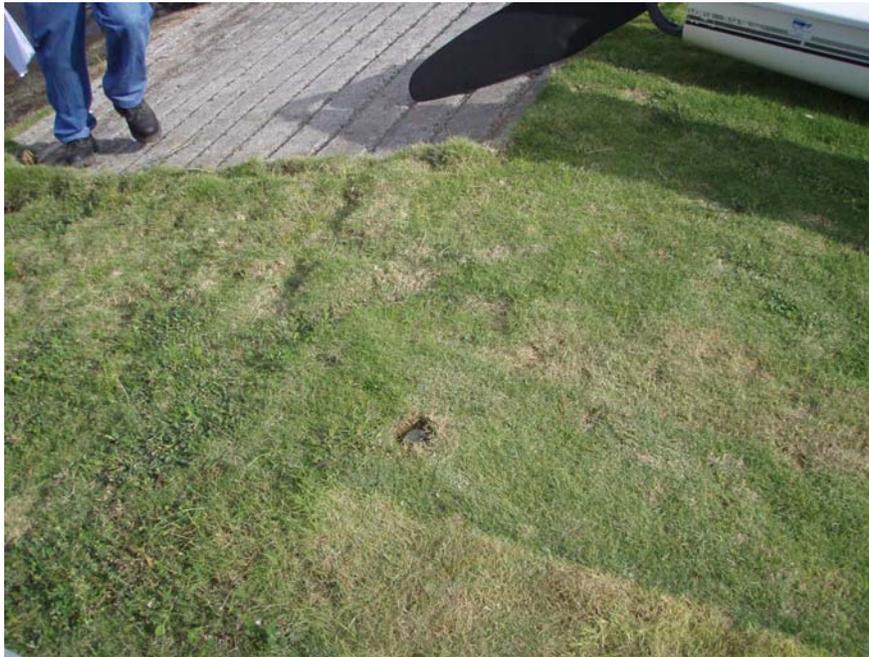
ggg. Sta. 6+40, RB, remove unauthorized encroachment, boat ramp.

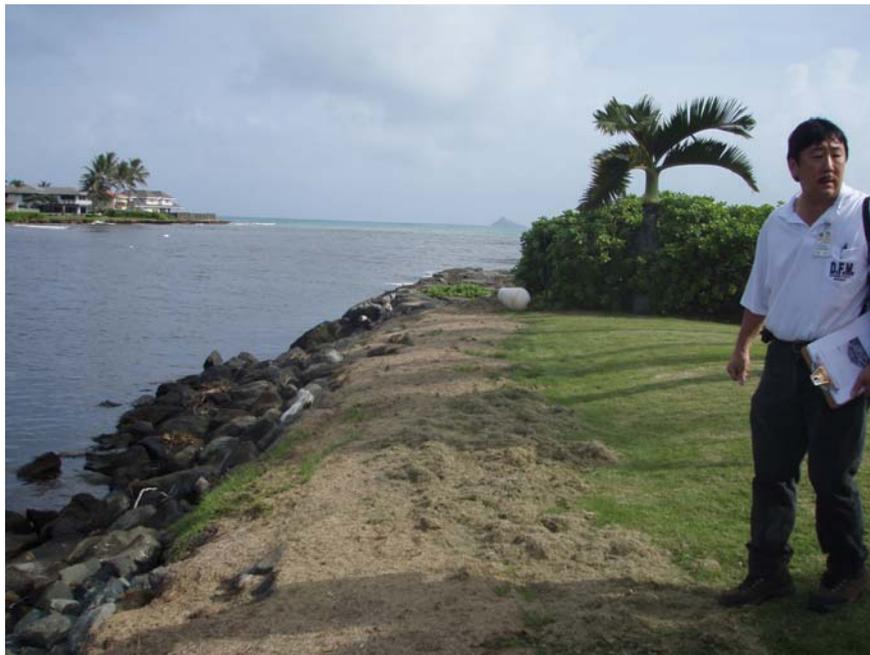
a. Sta. 6+00, RB, Begin Riprap, remove all vegetation from rip rap.

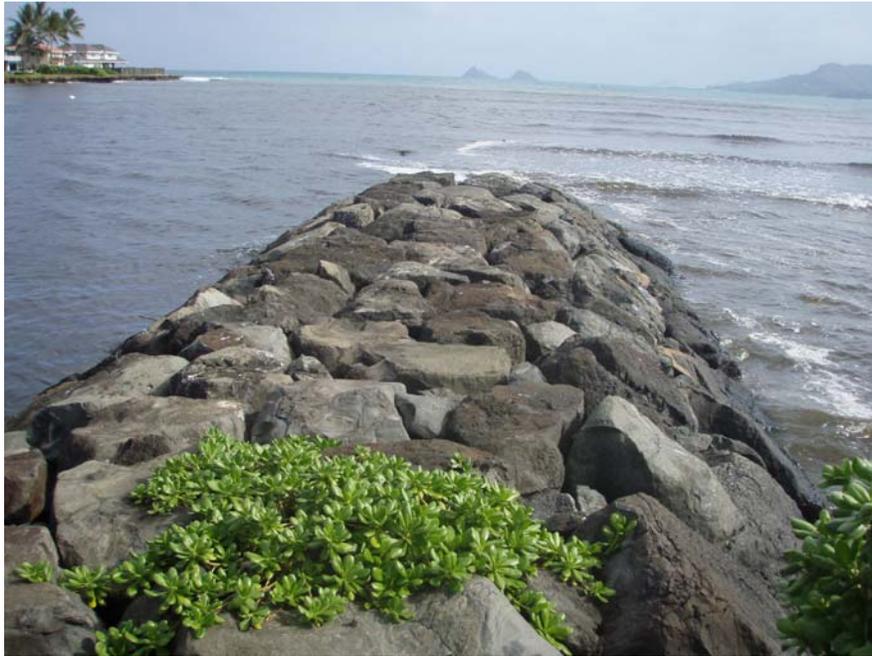
b. 5+24, RB, Begin Revetment / Groin, Overview, remove all vegetation from revetment, naupaka plant.

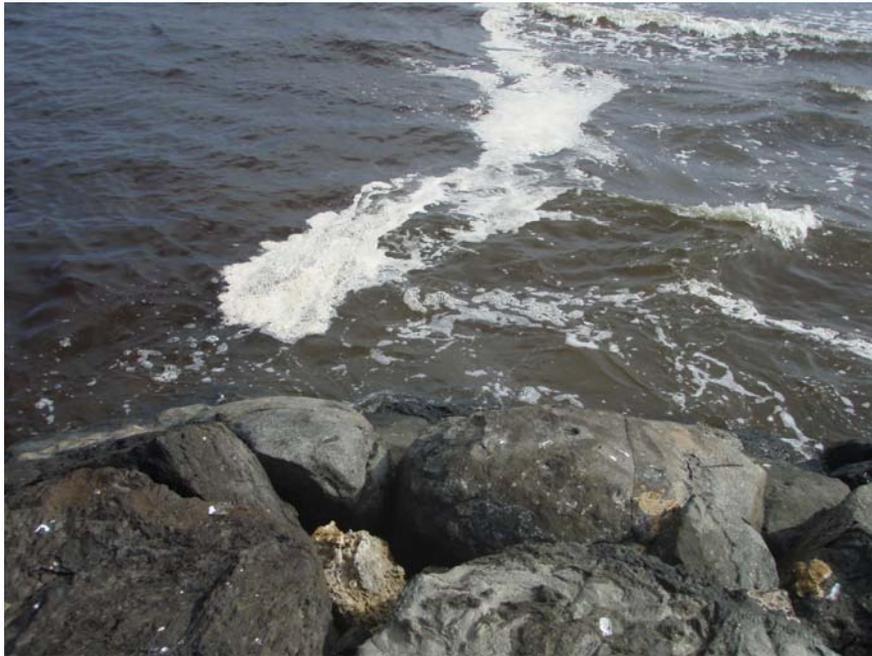
d. Sta. 4+74, RB, End of groin, picture of the head.

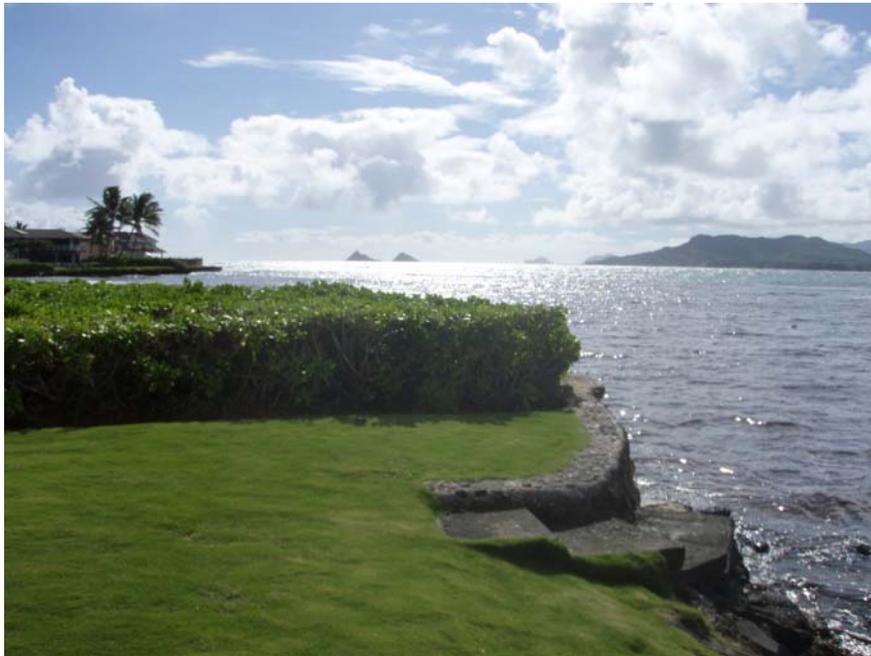
a. Sta. 4+32, LB, beginning of project connected to existing CRM Wall, Overview. Remove unauthorized encroachments, sprinkler system at the hinge.

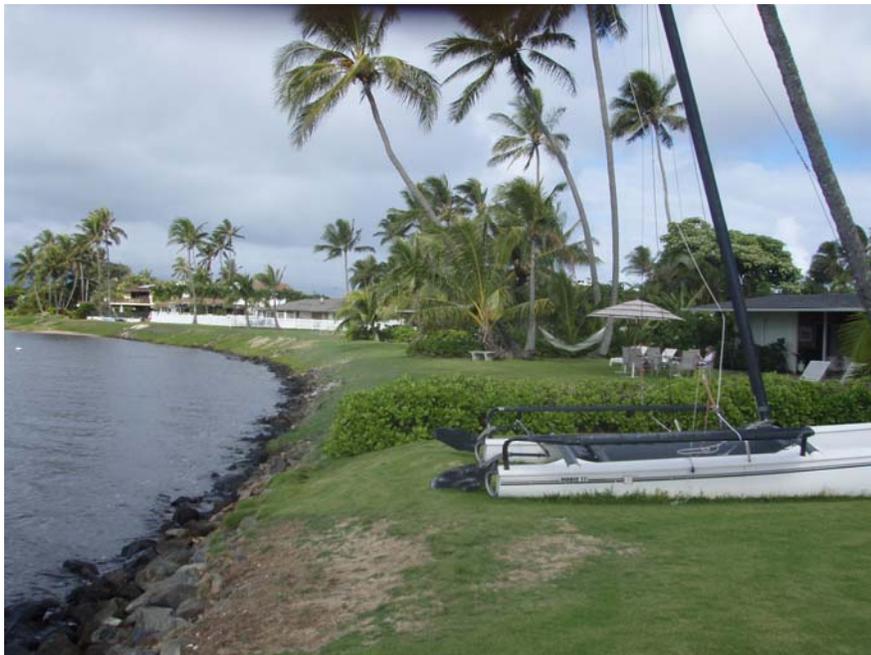
b. approx. Sta. 5+00, LB, remove naupaka plant within maintenance easement.

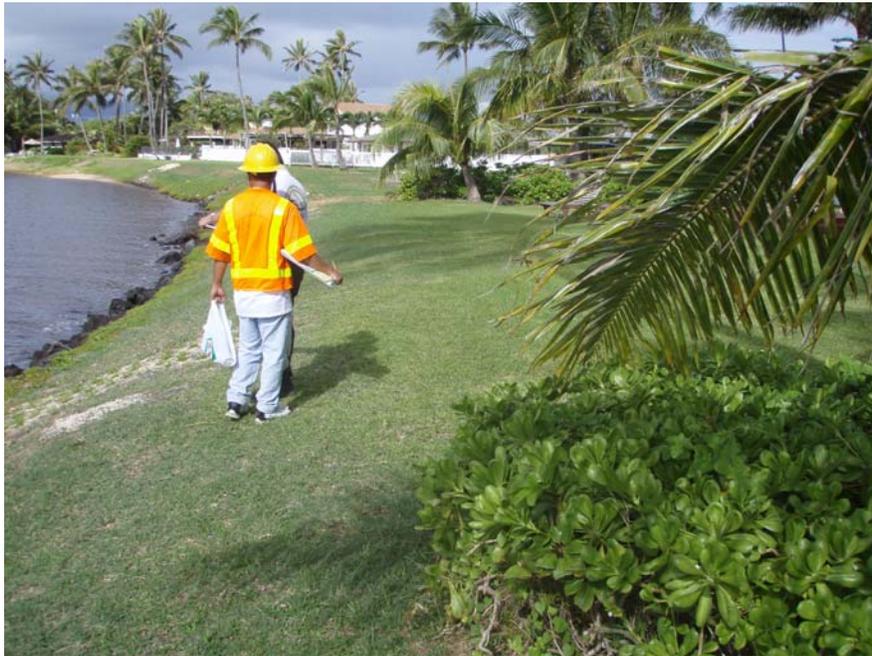
d. Sta. 6+31, LB, remove woody vegetation within maintenance easement.

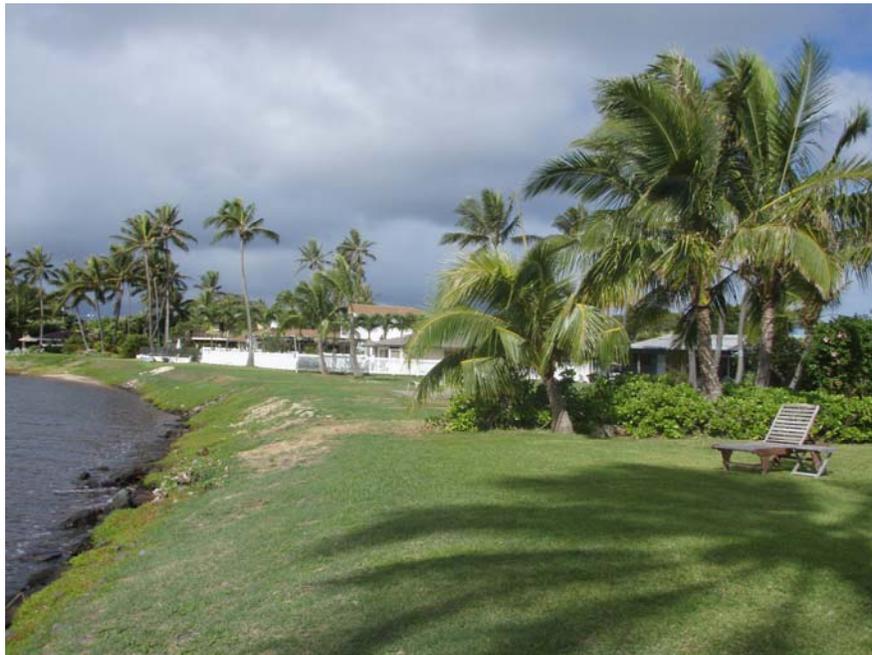
f. Sta. 7+20, LB, remove woody vegetation to within maintenance easement, stairs removed on side slope.

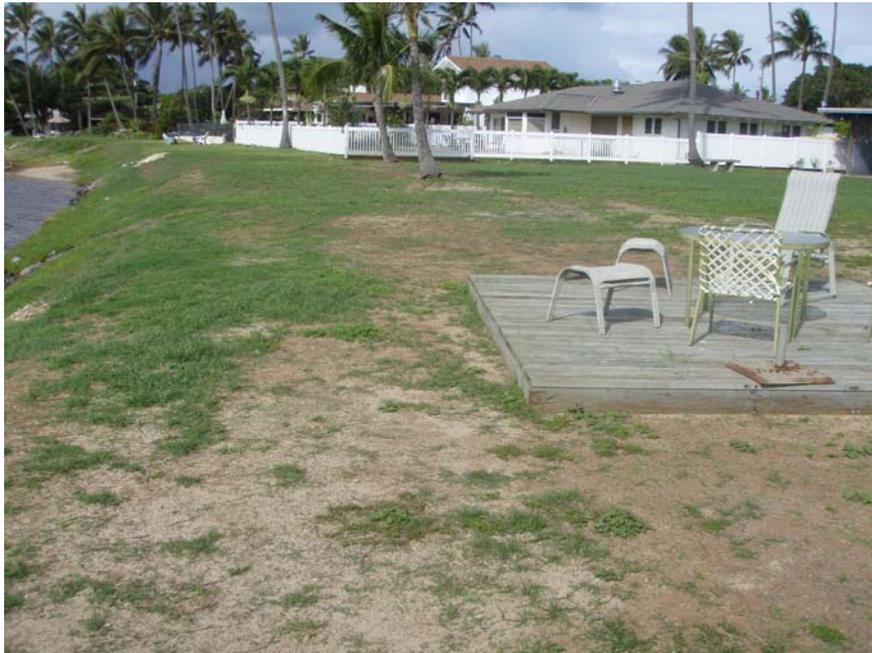
h. Sta. 7+71, LB, remove platform within maintenance easement.

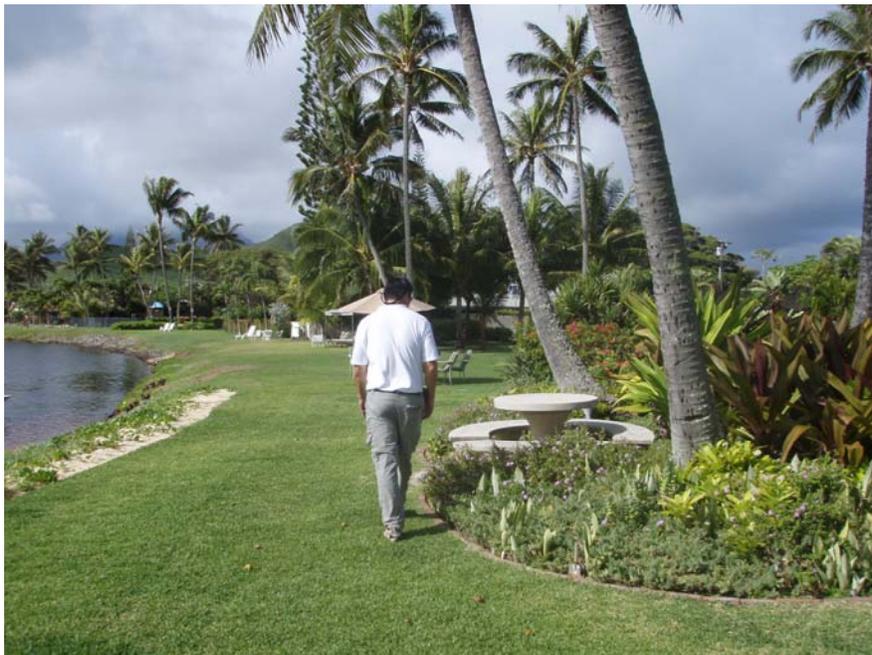
- j. Sta. 10+67, LB, verify easement right of way, remove encroachments within maintenance easement.

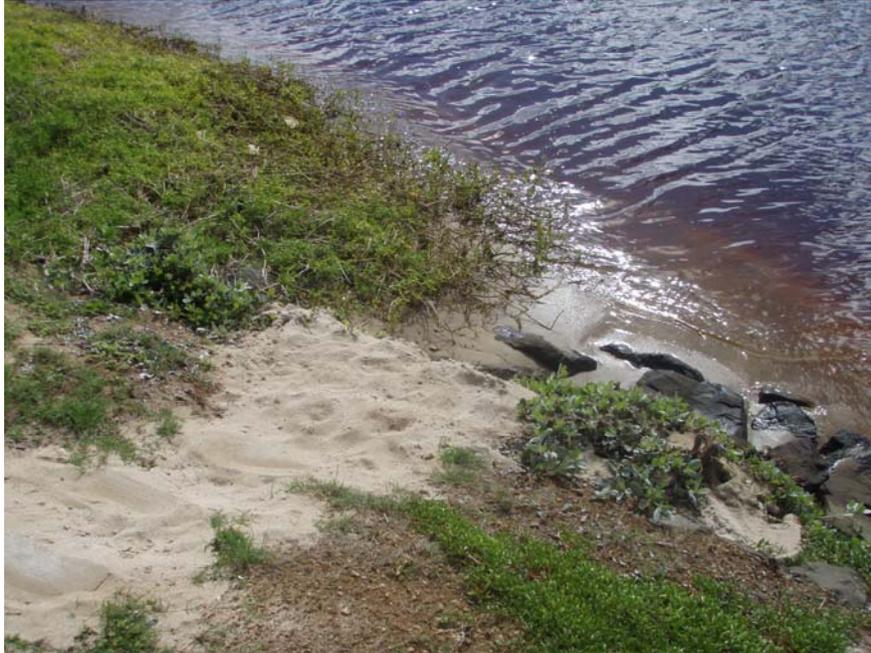
k. Sta. 11+14, LB, remove all unauthorized encroachments: steps, mooring cleat and sprinkler system. Restore side slope.

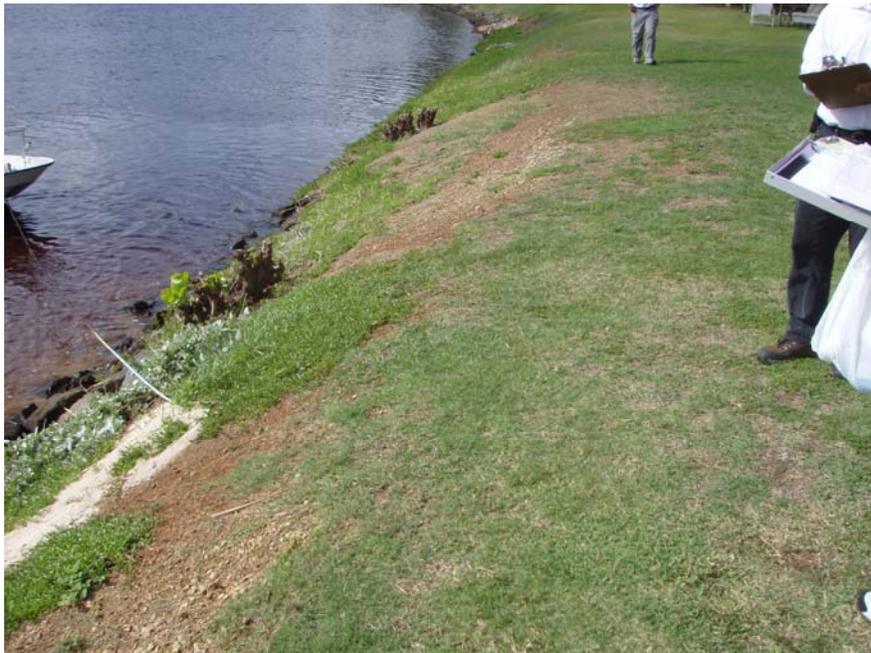
l. Sta. 10+14 - 12+65, LB, remove woody vegetation on side slope. Remove unauthorized encroachments, sprinkler system, within maintenance easement.

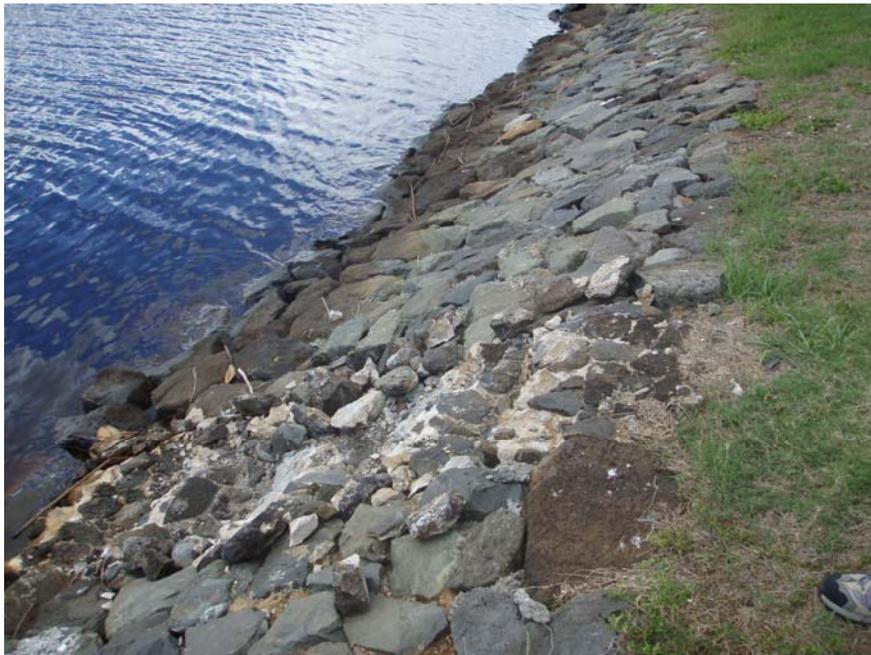
n. Sta. 13+84, LB, remove all unauthorized encroachments, landing and stairs, and re-establish rip rap to match existing grade.

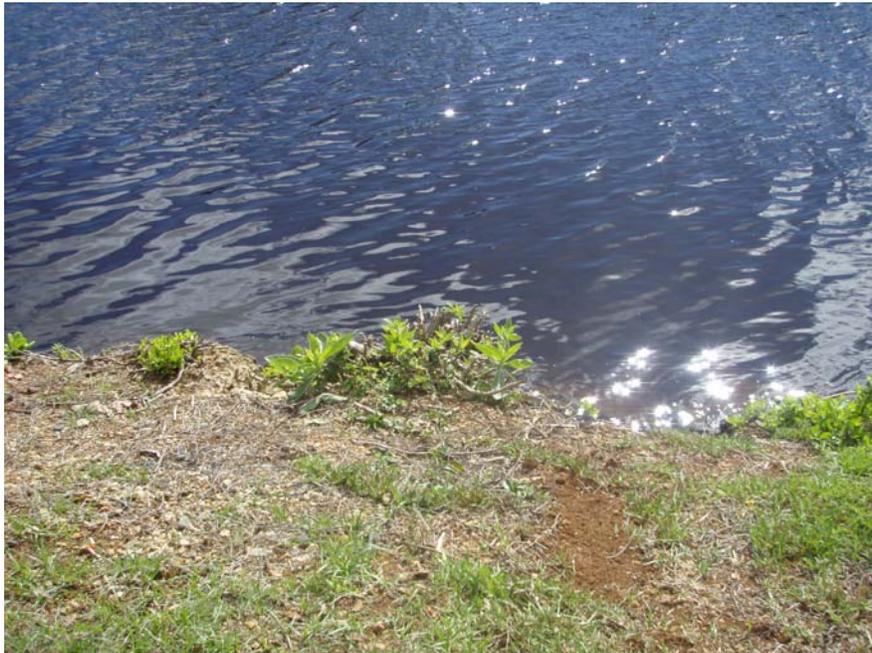
p. Sta. 14+71, LB, remove woody vegetation along side slope.

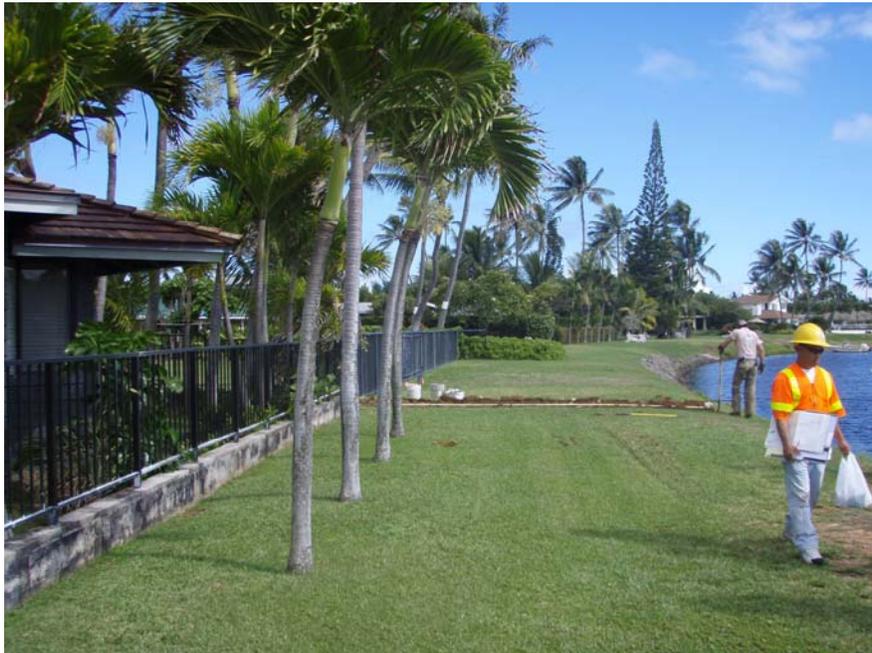
r. Sta. 15+33, LB, remove palm trees within maintenance easement.

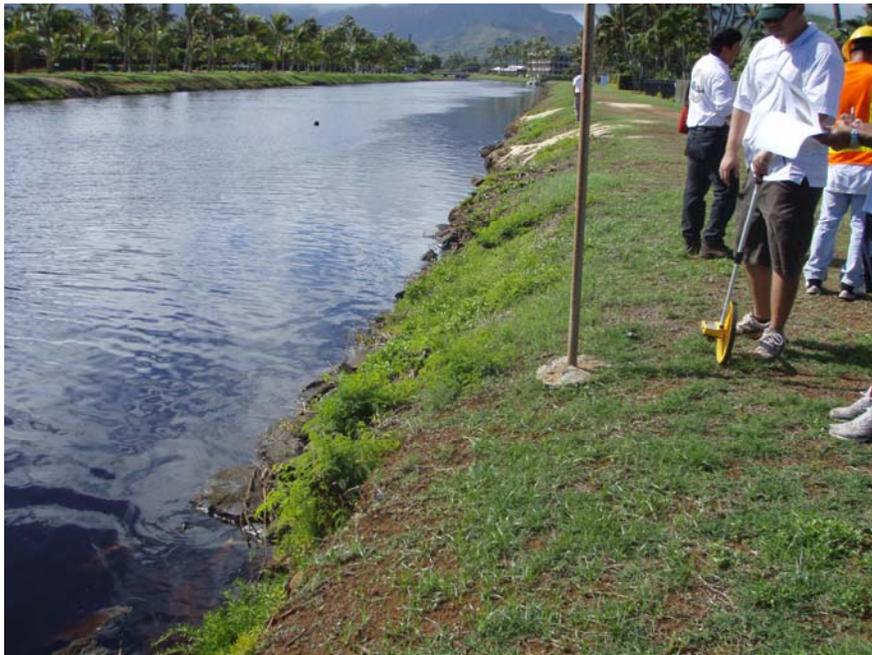
t. Sta. 17+07, LB, remove unauthorized encroachments, sprinkler system, and add 1-man rock to the toe.

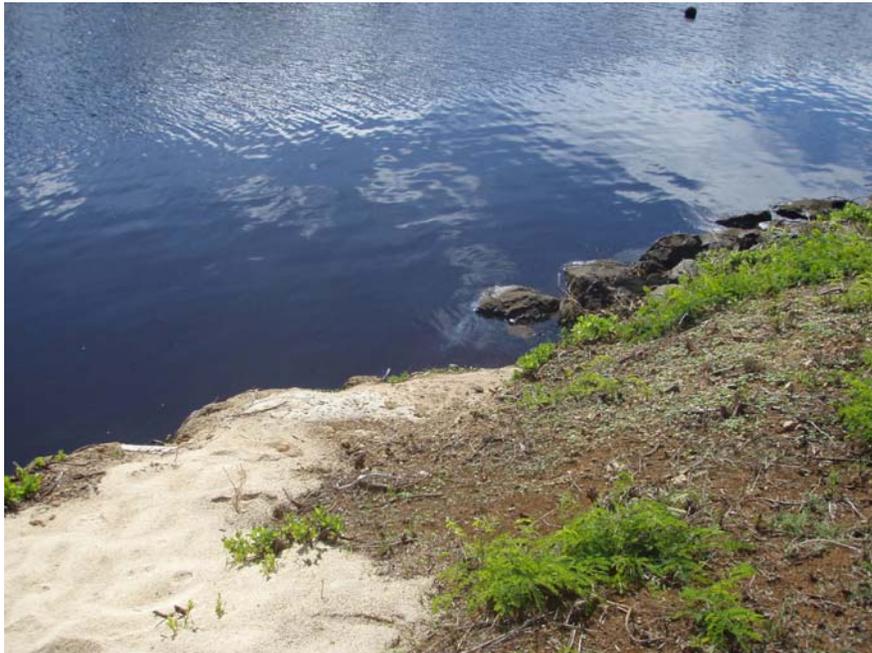
v. Sta. 18+77, LB, restore crest elevation and remove woody vegetation.

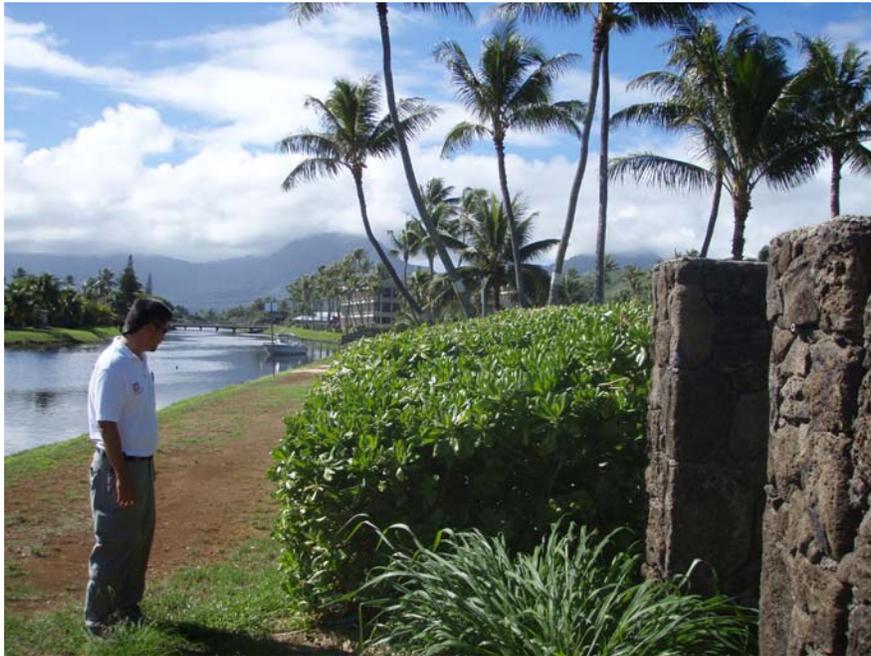
x. Sta. 26+33, LB, remove naupaka plant within maintenance easement.

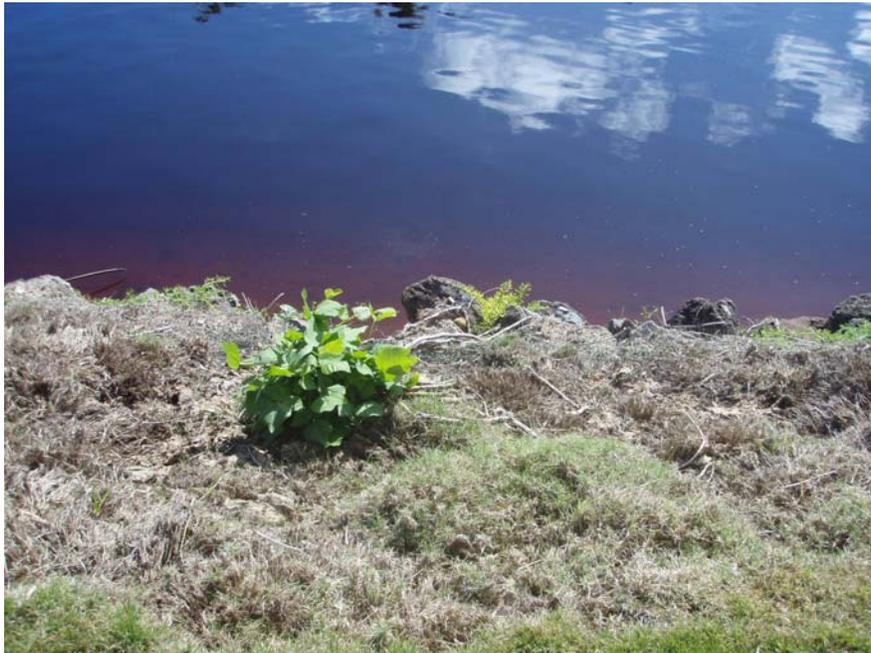
z. Sta. 28+04, LB, remove juvenile tree from side slope.

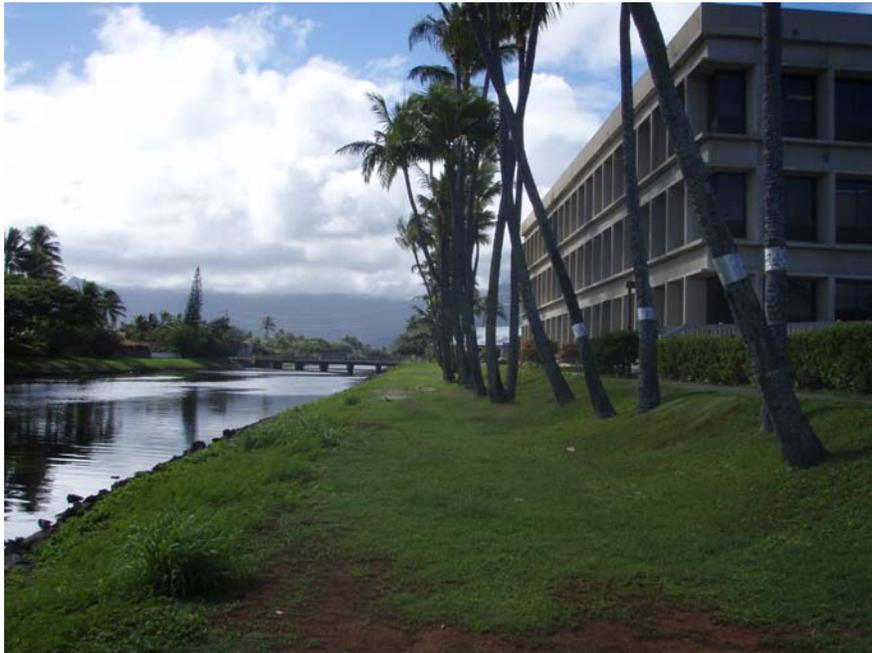
ff. Sta. 33+09, LB, remove palm trees within maintenance easement.

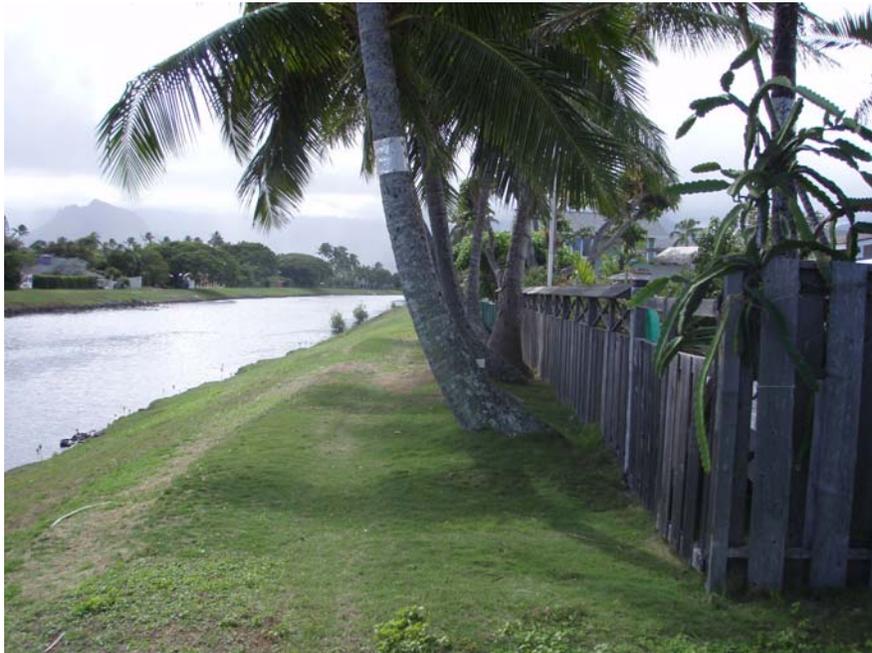
ll. Sta. 41+58, LB, remove coconut trees (8 ea.) within maintenance easement.

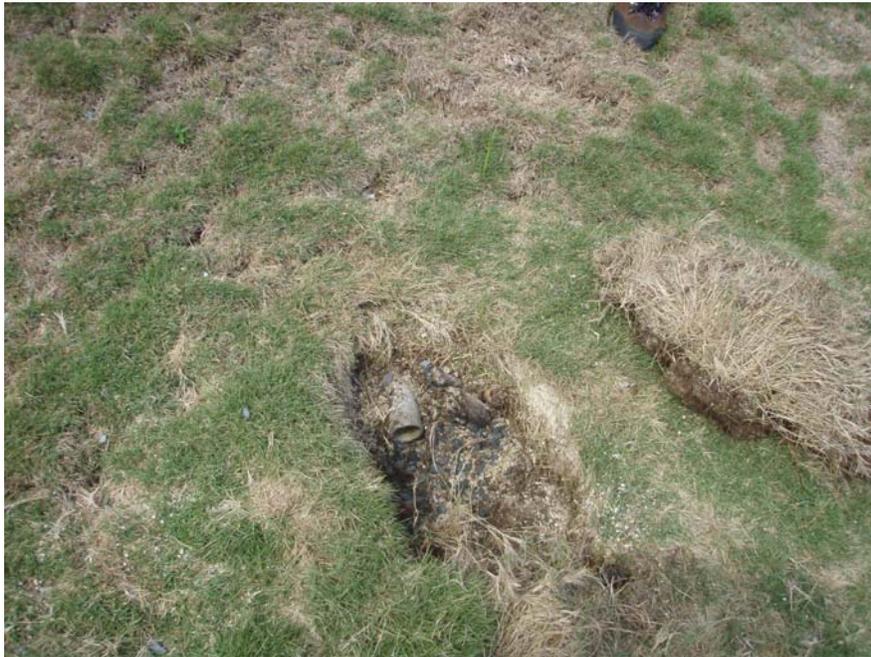
mm. Sta. 41+58, LB, remove unauthorized encroachment, drain pipe, hidden under grass.

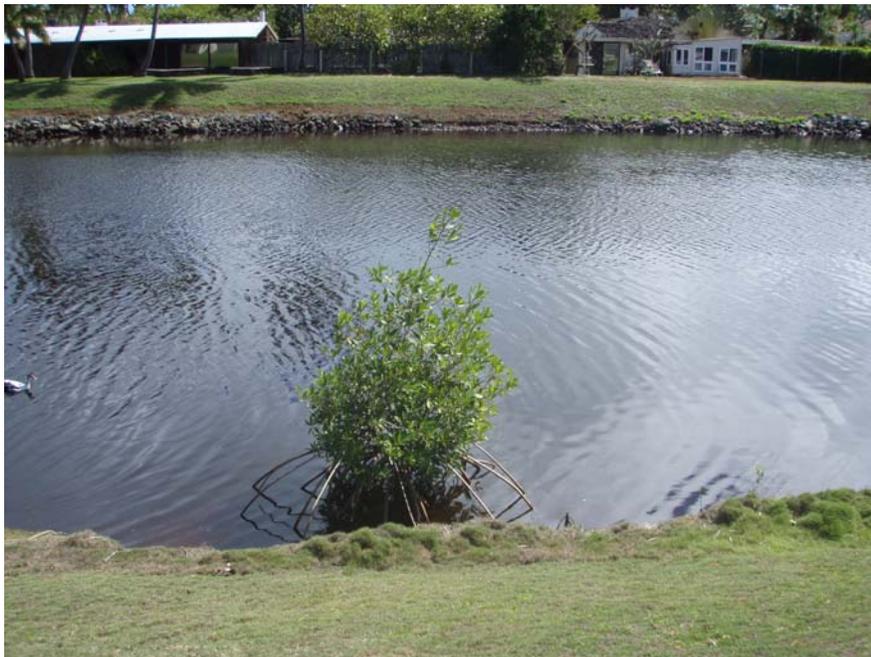
nn. Sta. 45+17, LB, remove 3 mangrove plants.

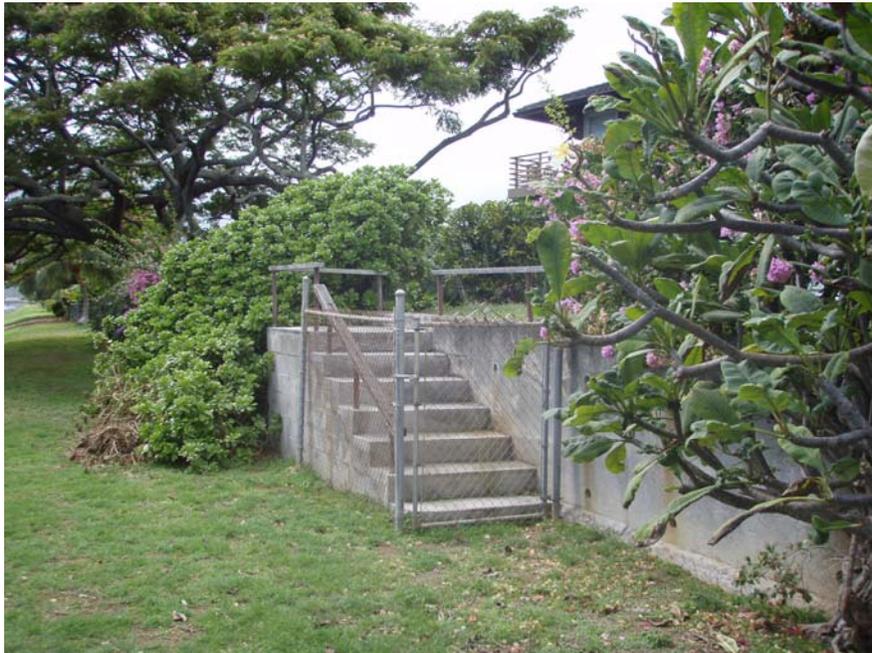
tt. Sta. 55+25, LB, remove unauthorized encroachments, steps and woody vegetation, within maintenance easement.

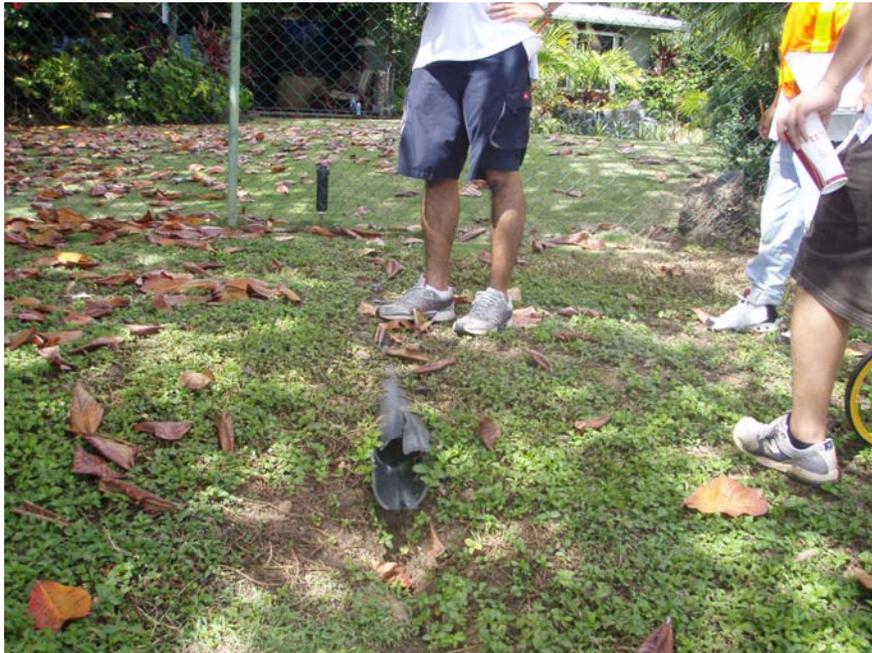
vv. Sta. 57+55, LB, remove unauthorized encroachment, 4" PVC pipe.

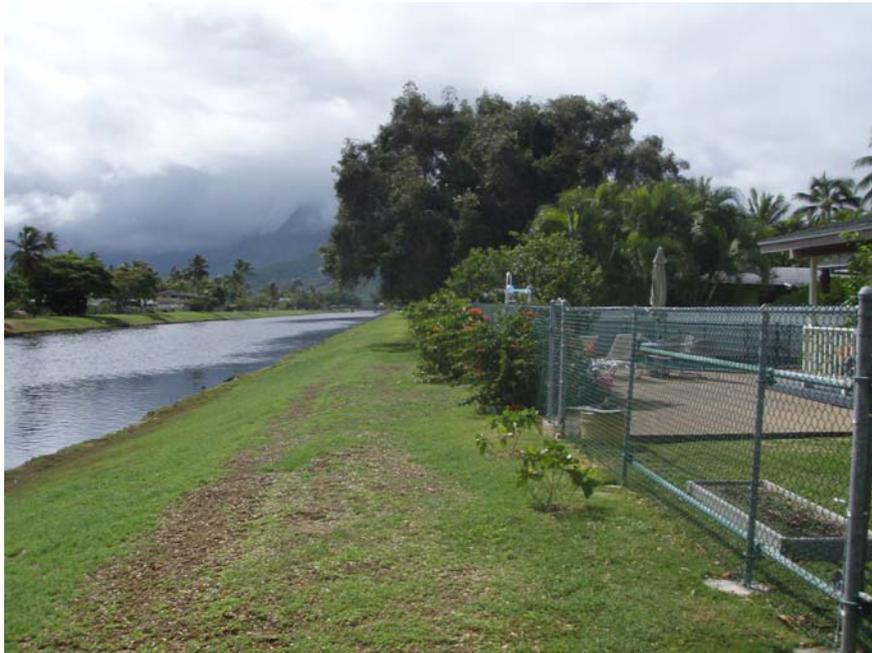
xx. Sta. 59+10 - 61+00, remove woody vegetation within maintenance easement.

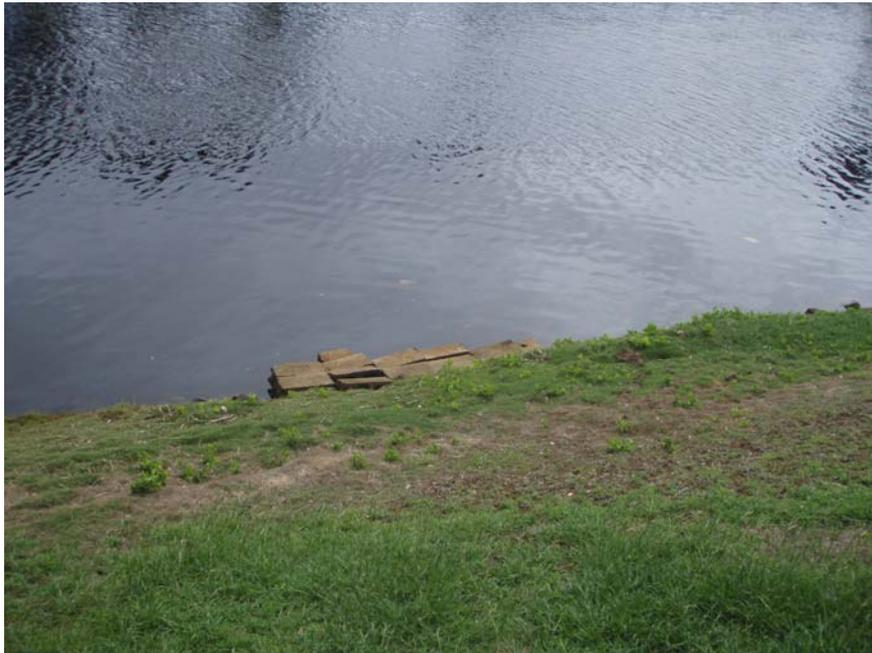
bbb. Sta. 65+87, LB, remove unauthorized structure, CMU landing, and restore toe.

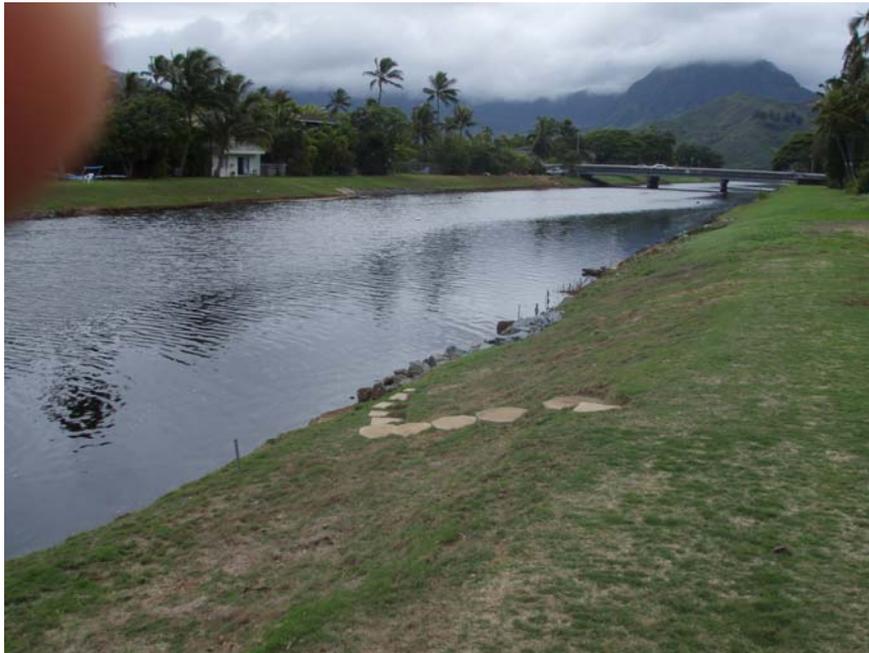
fff. Sta. 74+38 - 74+75, LB, remove unauthorized encroachments, pins and steps. Restore side slope and toe.

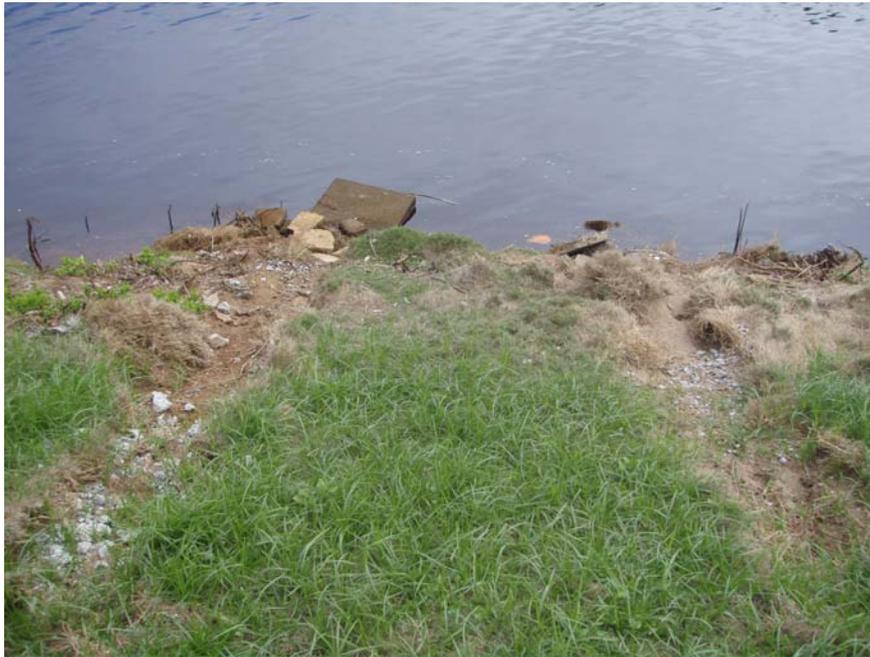
ggg. Sta. 75+63, LB, re-establish side slope and remove debris.

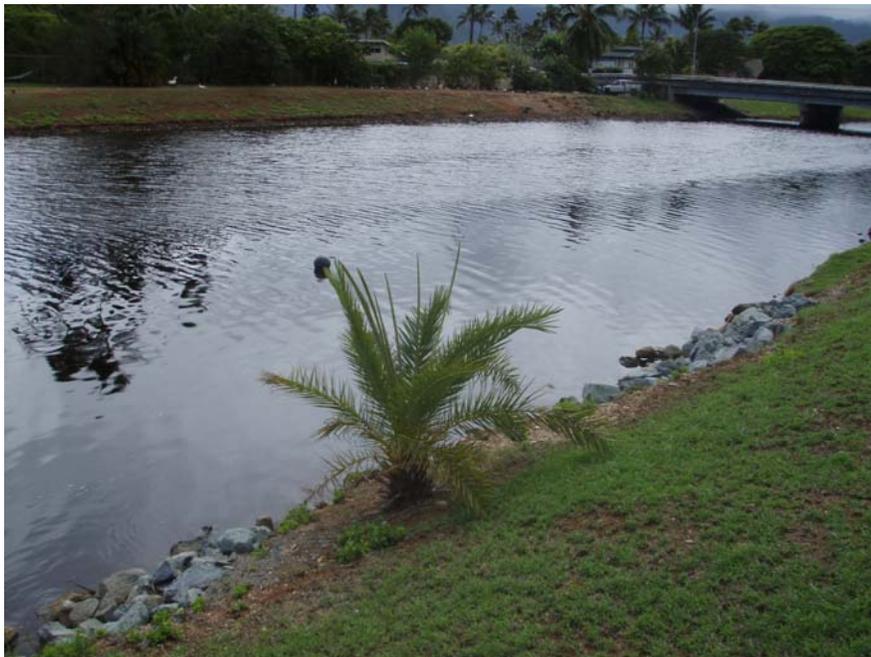
jjj. Sta. 78+32, LB, remove palm tree from side slope.

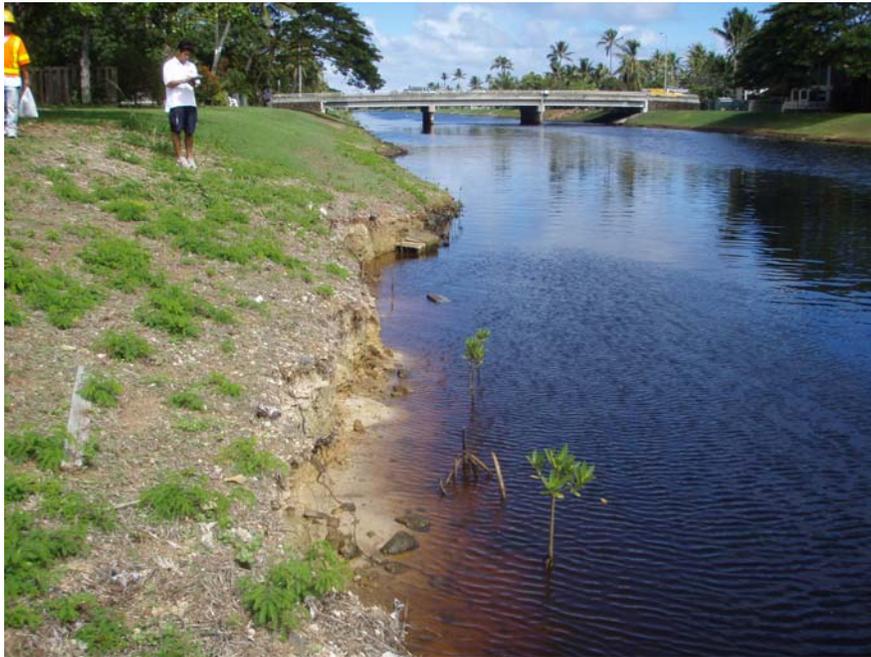
ooo. Sta. 86+40 - 87+40, LB, looking Makai, remove unauthorized steps and re-establish toe.

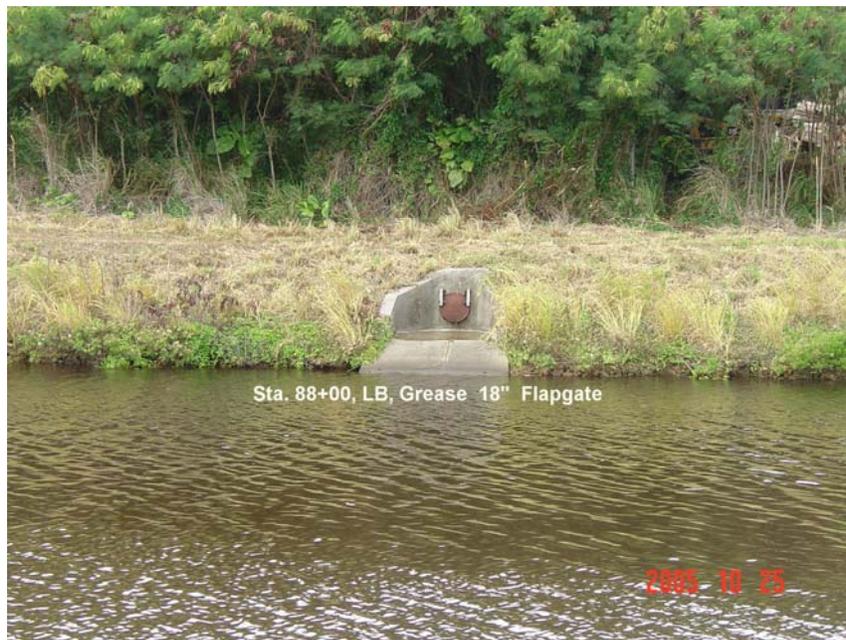
ppp. Sta. 88+00, LB, grease 18" flapgate. (picture taken in 2005)

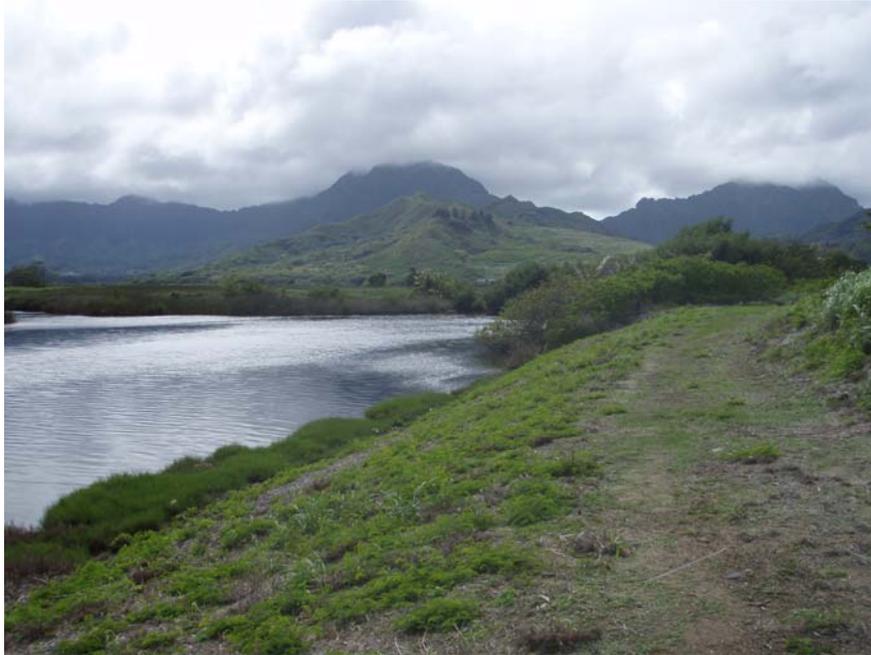
qqq. Sta. 93+00, Overview.
