O & M INSPECTION REPORT  
FOR NAVIGATION AND SHORE PROTECTION PROJECTS

1. PROJECT NAME: WAIANAE SMALL BOAT HARBOR

2. DATE OF INSPECTION: 29 AUGUST 2002

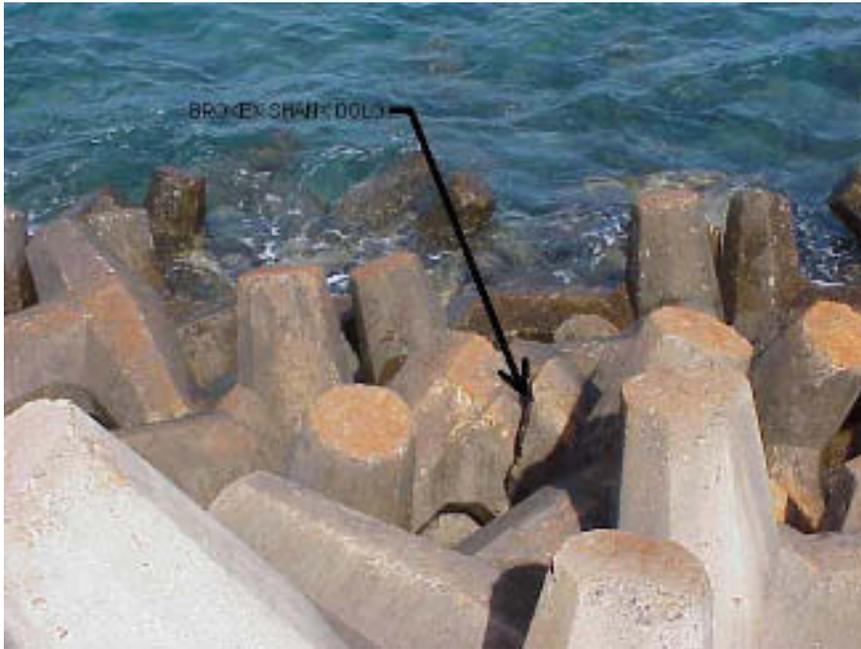
Sta. 4+55, OS: 1 - Dolosse, 8-14-78, on sideslope with broken shank.

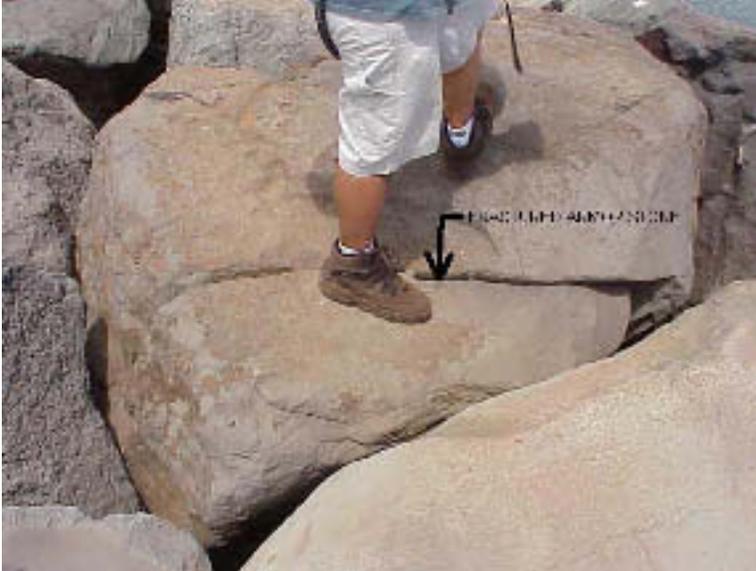
Sta. 5+15, Crest: Fractured armor stone.

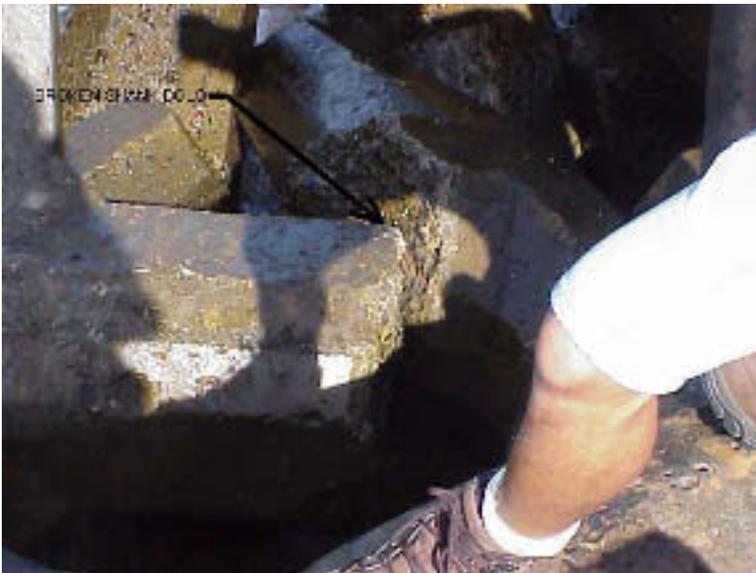
Sta. 5+25, OS: 2 - Dolosse on sidelsope with broken shank.

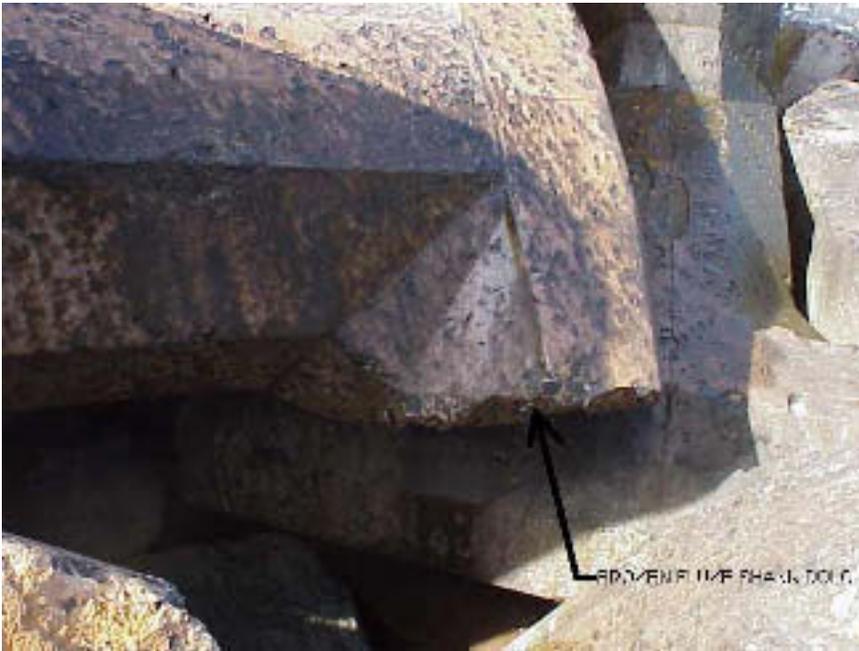
Sta. 5+48, OS: 1 - Dolosse on sideslope with broken fluke shank.

MAIN BREAKWATER: FROM THE GIS ARCVIEW MAP, AREAS OF MAIN CONCERN ARE AT THE TRANSITION ZONE (STATION 3+90 TO 8+90), AND HEAD AND OFF SHORE TRUNK SECTIONS ADJACENT HEAD (STATION 13+50 TO HEAD) ON OCEANSIDE. THESE AREAS FORM CLUSTERS OF DEFECTS IN PROXIMITY TO EACH OTHER.

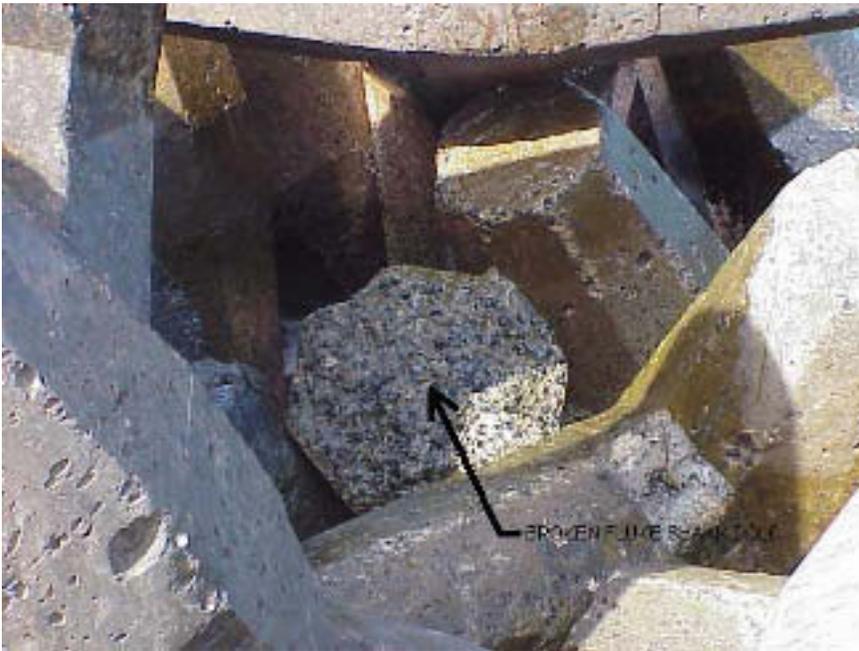
Sta. 5+58, OS: 1 - Dolosse on sideslope with broken fluke shank..

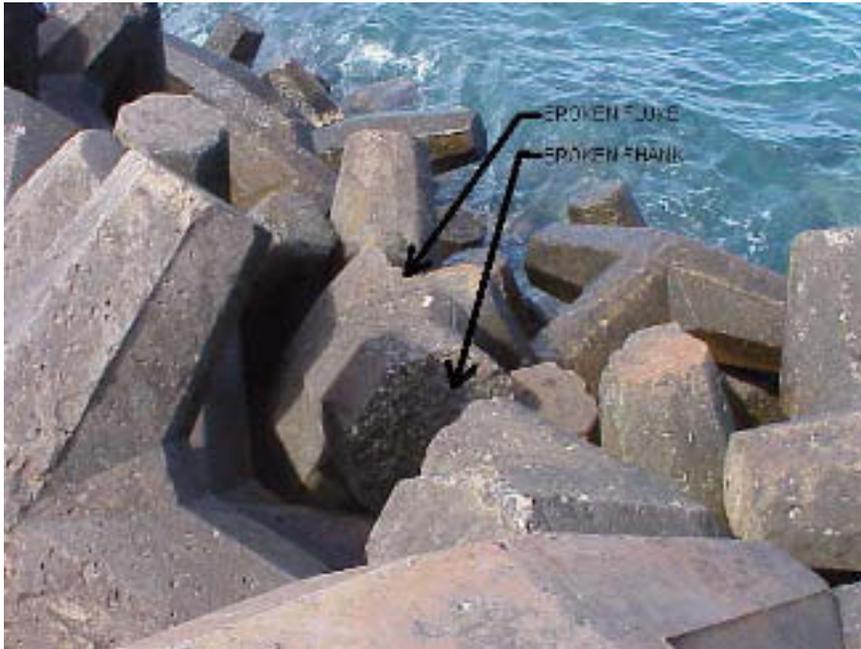
Sta. 5+70, OS: 1 - Dolosse on sideslope with broken fluke and shank. There is also a 1 foot separation between the crest hinge and start of the dolosse sideslope - possibly sliding of slope.

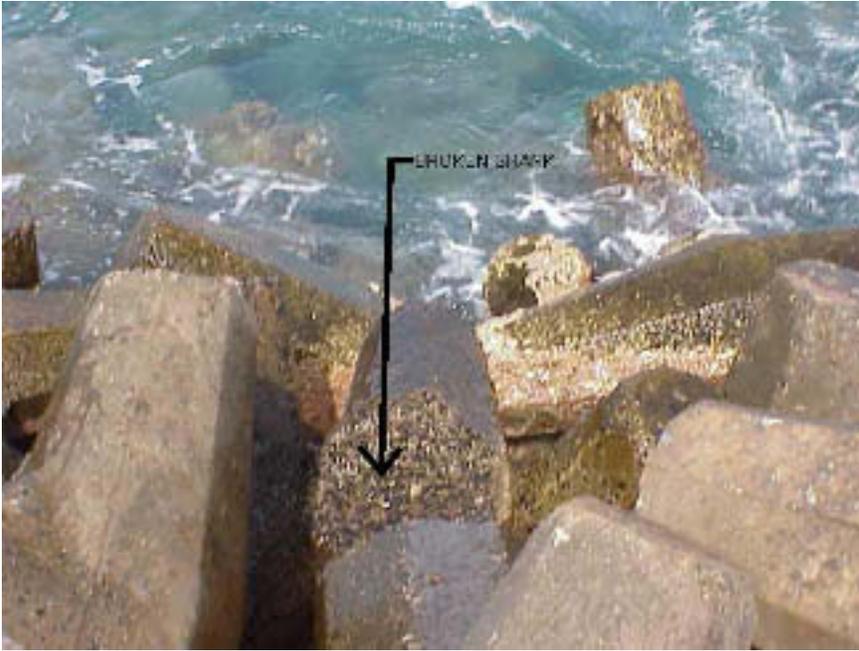
Sta. 6+10, OS: 1 - Dolosse at water line with broken shank below #31, 7-18-78.

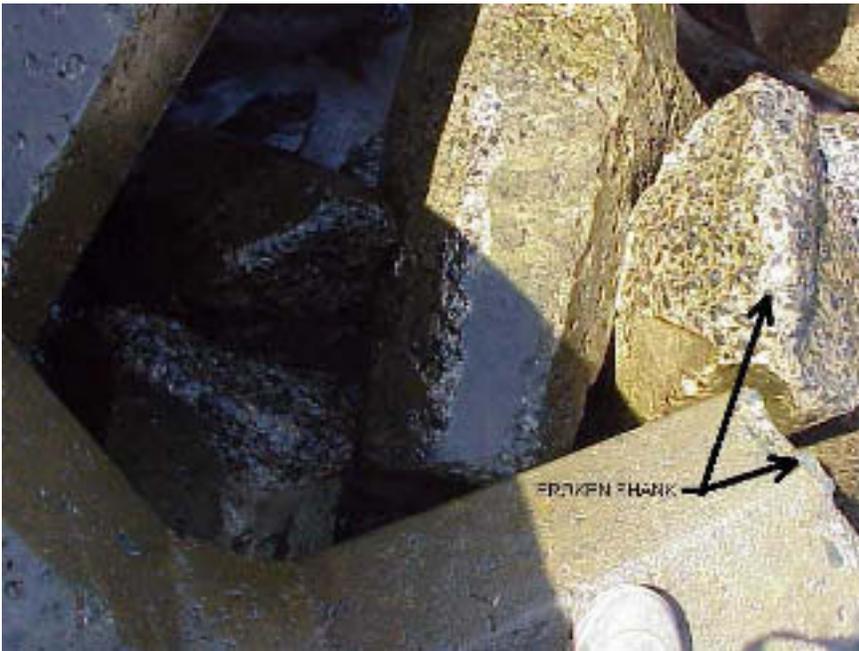
Sta. 6+50, OS: 1 - Dolosse near water line with broken shank.

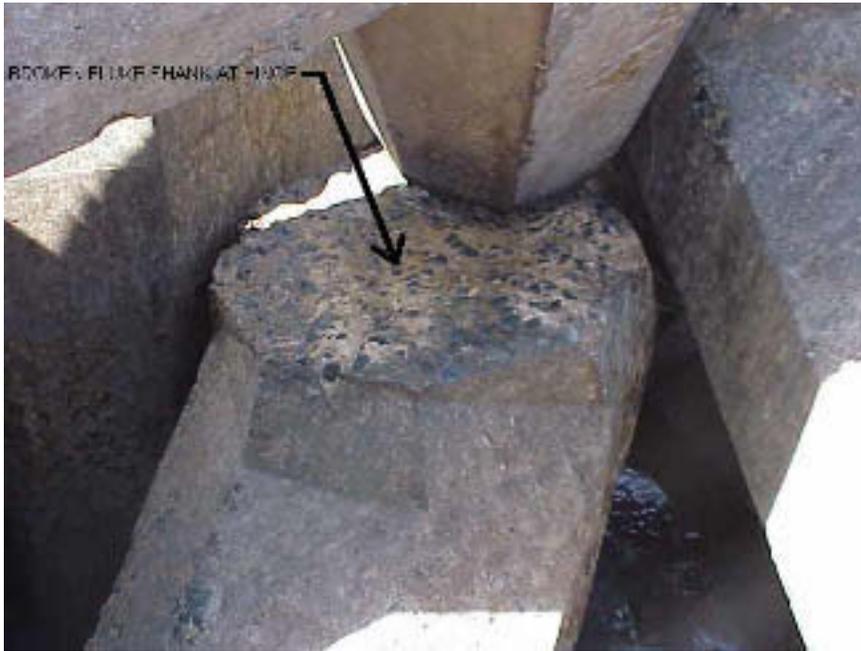
Sta. 6+65, OS: 1 - Dolosse at hinge with broken fluke shank below #38, 6-5-78.

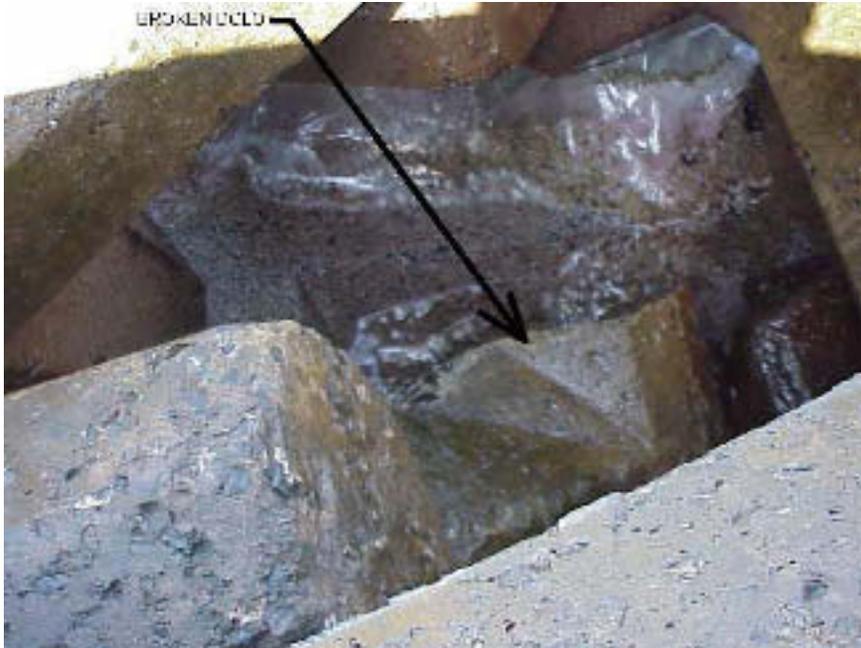
Sta. 6+70, OS: 1 - Broken dolosse used as under layer to other dolosse structures above it.

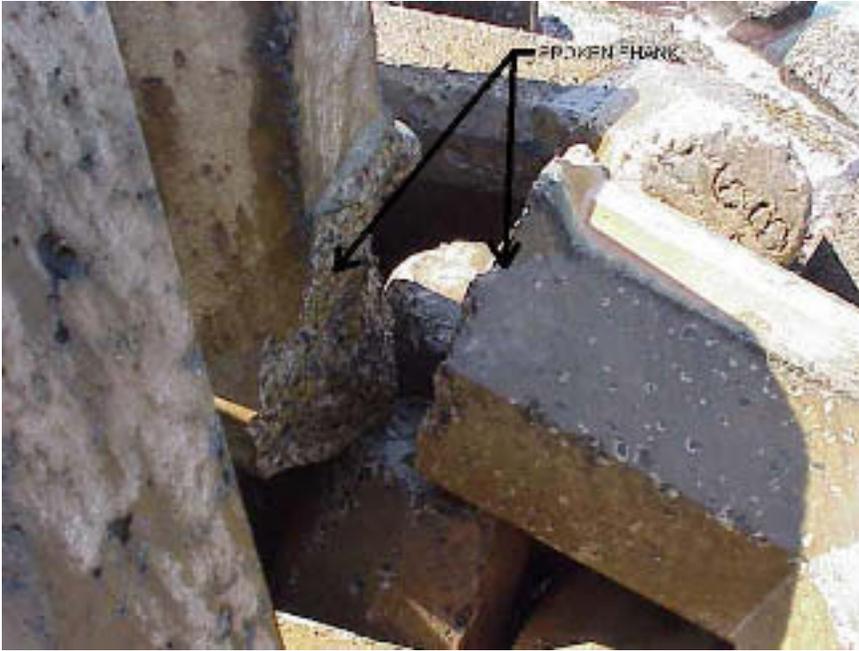
Sta. 7+10, OS: 1 - Dolosse on sideslope with broken shank below #30, 6-2-78.

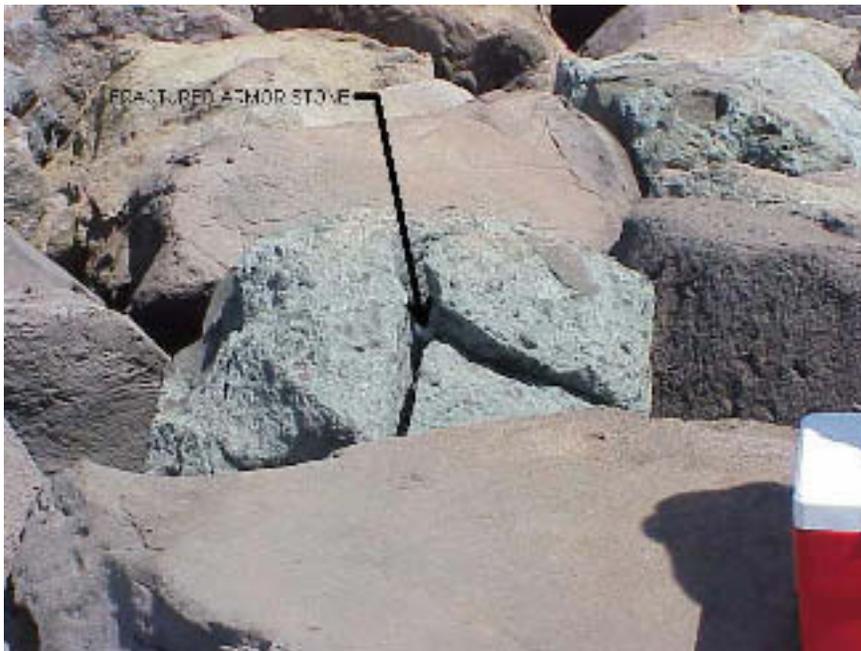
Sta. 7+50, Crest: 1 - Fractured green armor stone.

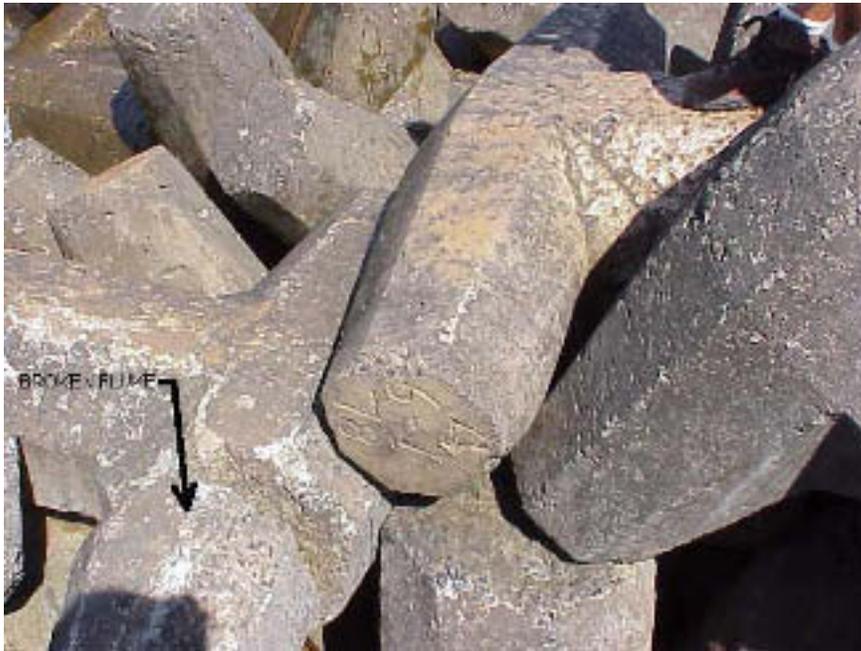
Sta. 7+65, OS: 1 - Dolosse on sideslope with broken fluke.  
 1 - Dolosse on sideslope with cracked shank identified as #11, 6-8-78.

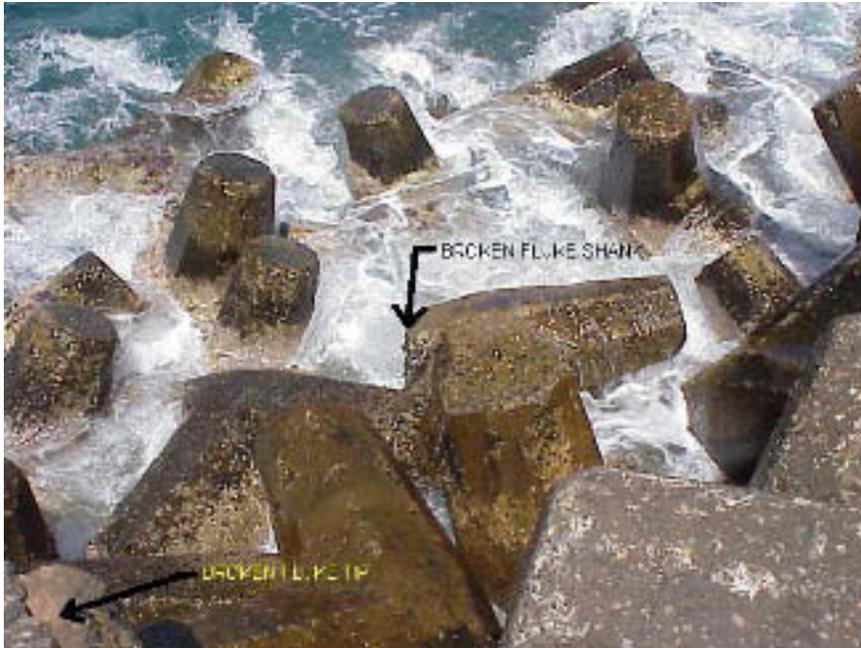
Sta. 7+67, OS: 1 - Dolosse at water line with broken fluke shank.  
 1 - Dolosse at water line with broken fluke tip.

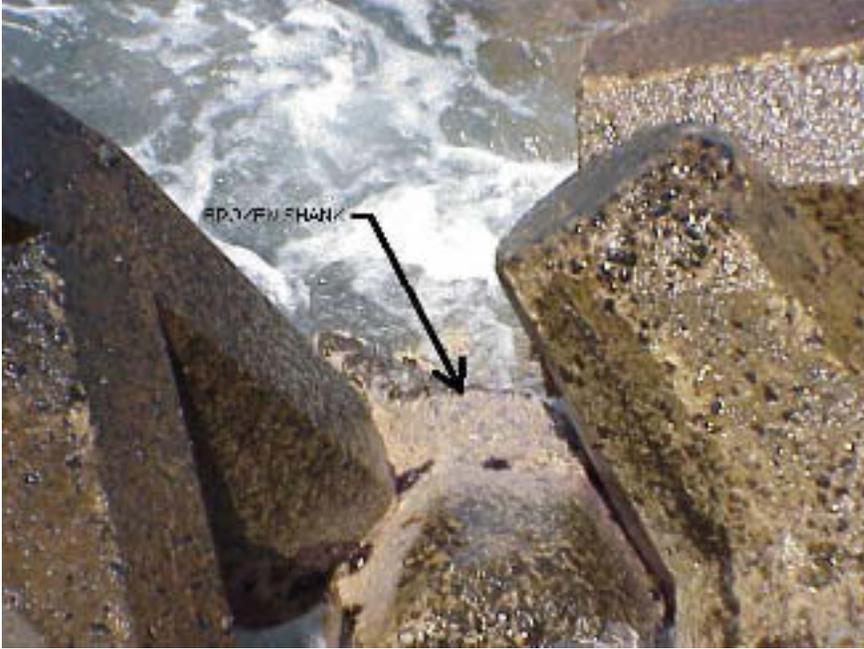
Sta. 7+95, OS: 1 - Dolosse at water line with broken shank.  
White marker target located on crest (no picture of marker).

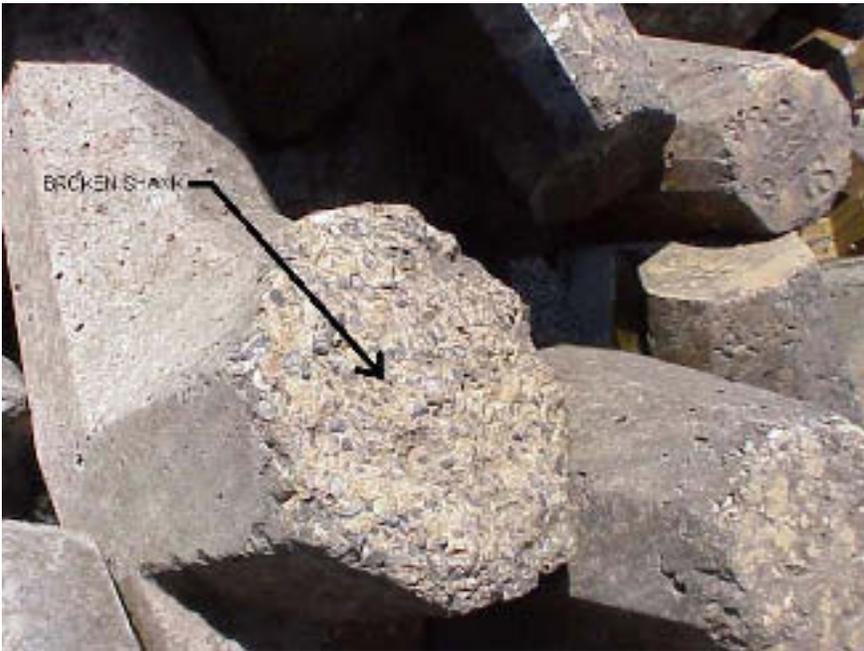
Sta. 8+15, Crest: 1 - Dolosse on sideslope with broken shank next to #6, 6-7-78.

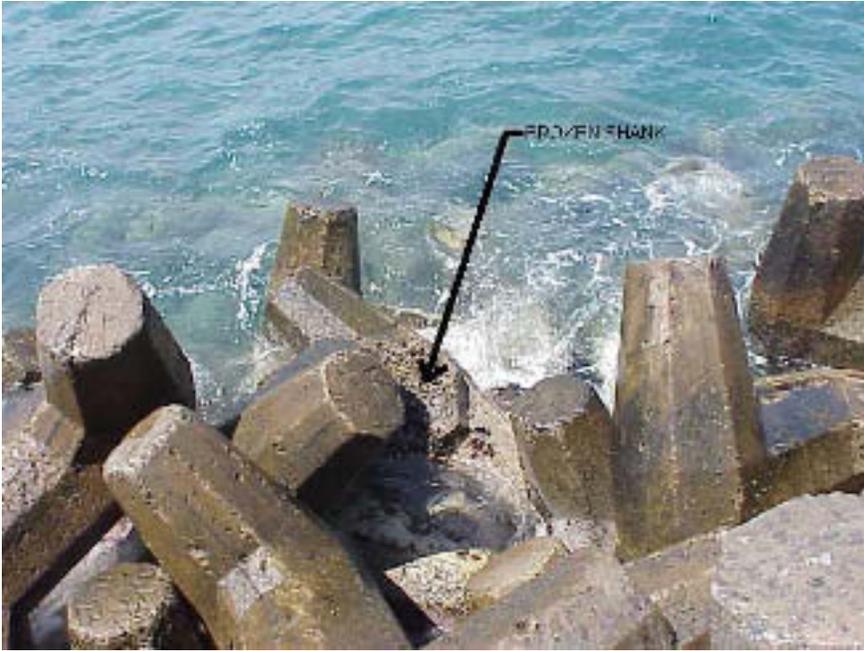
Sta. 8+25, OS: 1 - Dolosse at water line with broken shank below #12, 4-27-78.

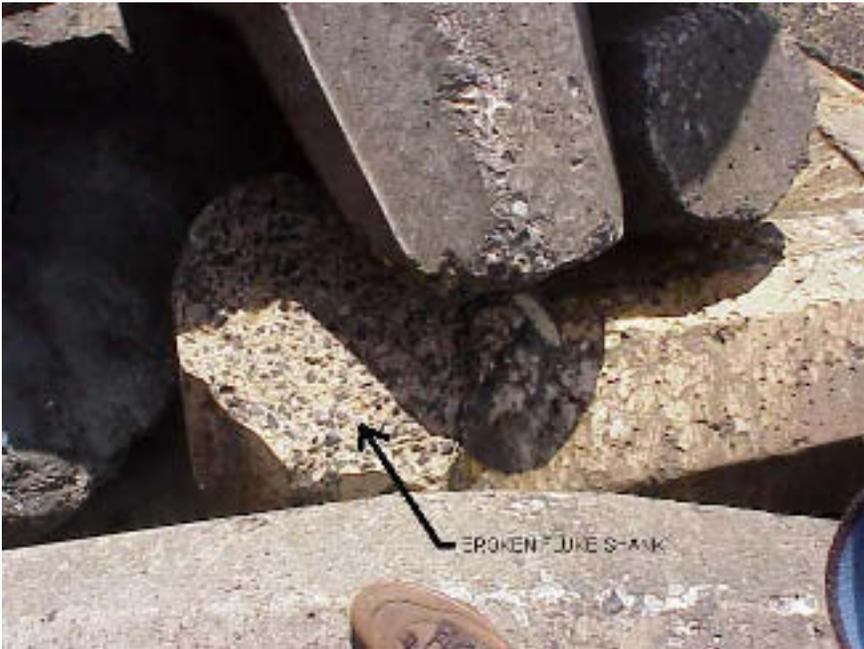
Sta. 8+30, OS: 1 - Dolosse on sideslope with broken fluke shank.

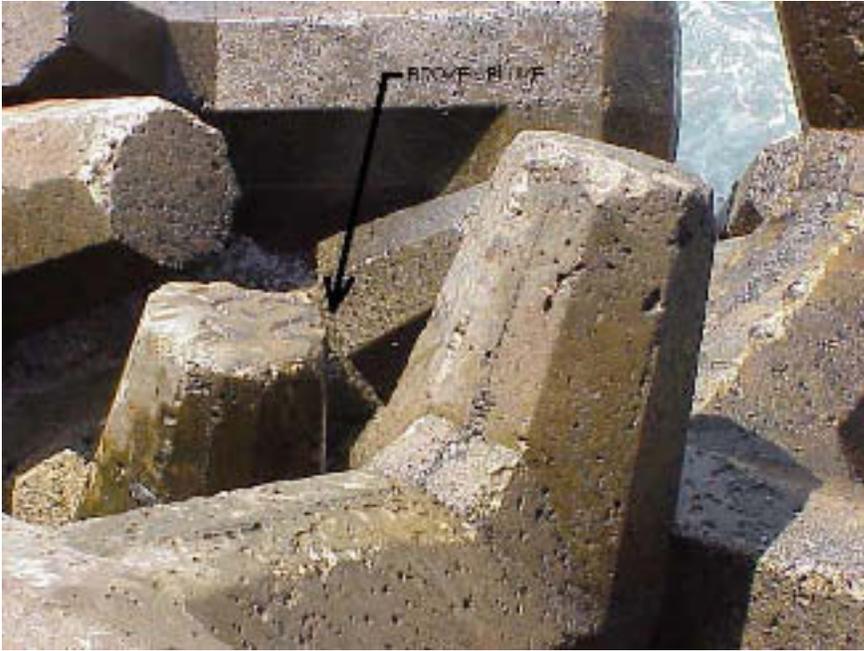
Sta. 8+35, OS: 1 - Dolosse at water line with broken fluke.

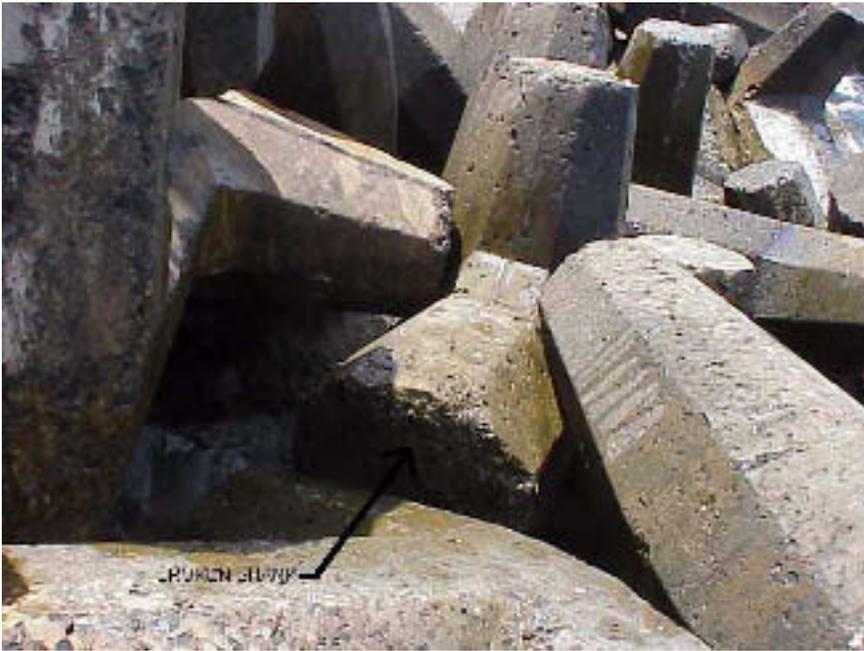
Sta. 8+35, OS: 1 - Dolosse on sideslope with shank break.

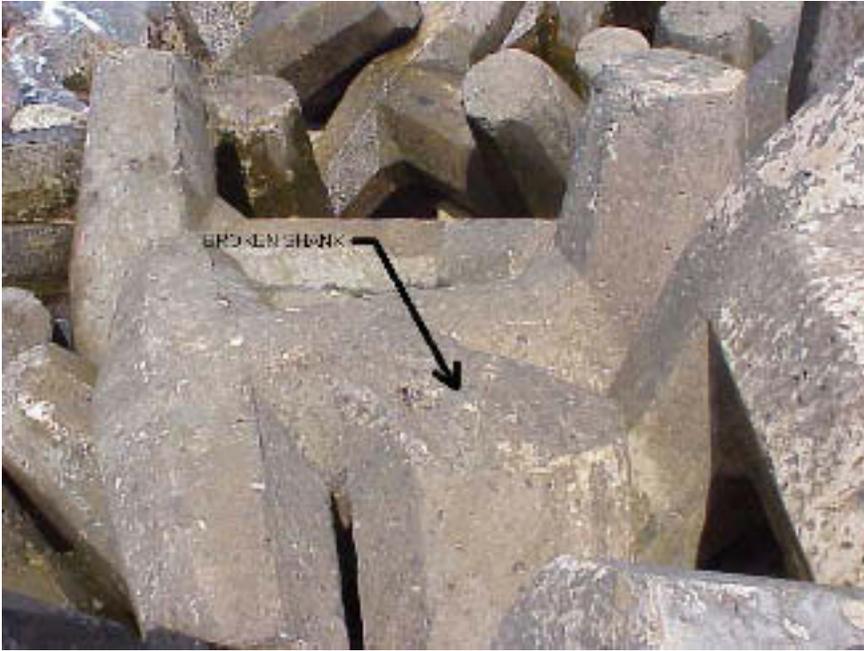
Sta. 8+48, OS: 2 - Dolosse on sideslope with broken shank.

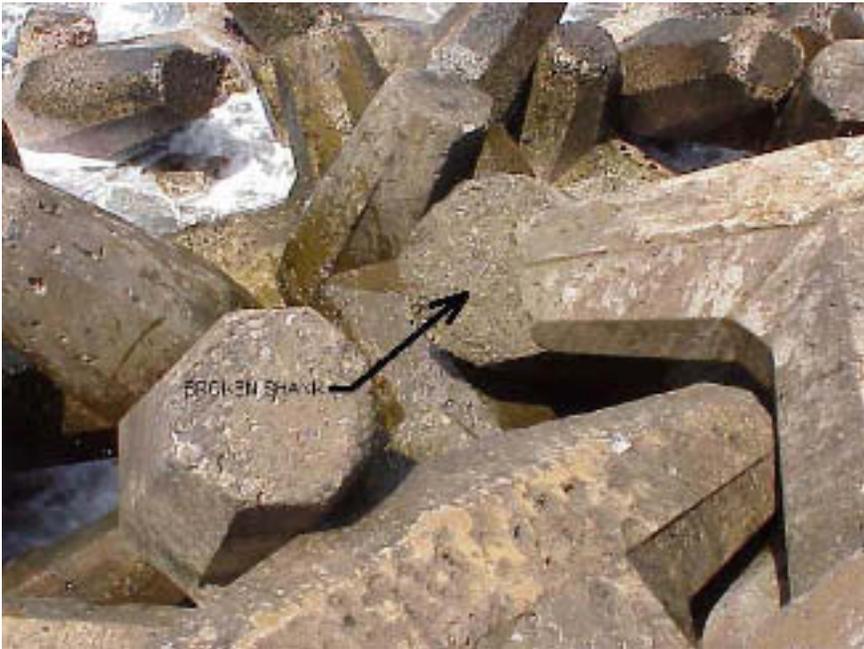
Sta. 8+70, OS: 2 - Dolosse on sideslope with broken shank.

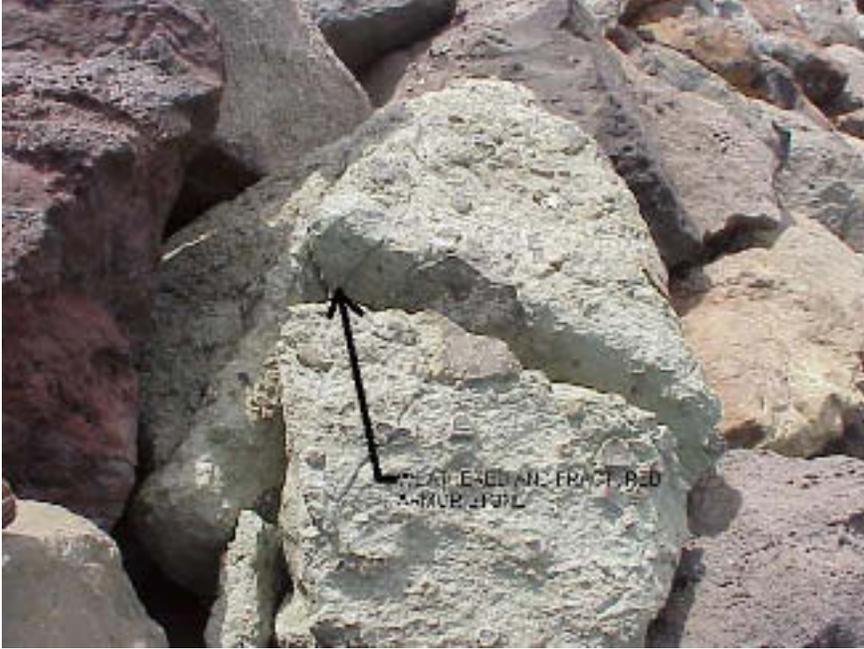
Sta. 8+85, Crest: Weathered and fractured armor stone.

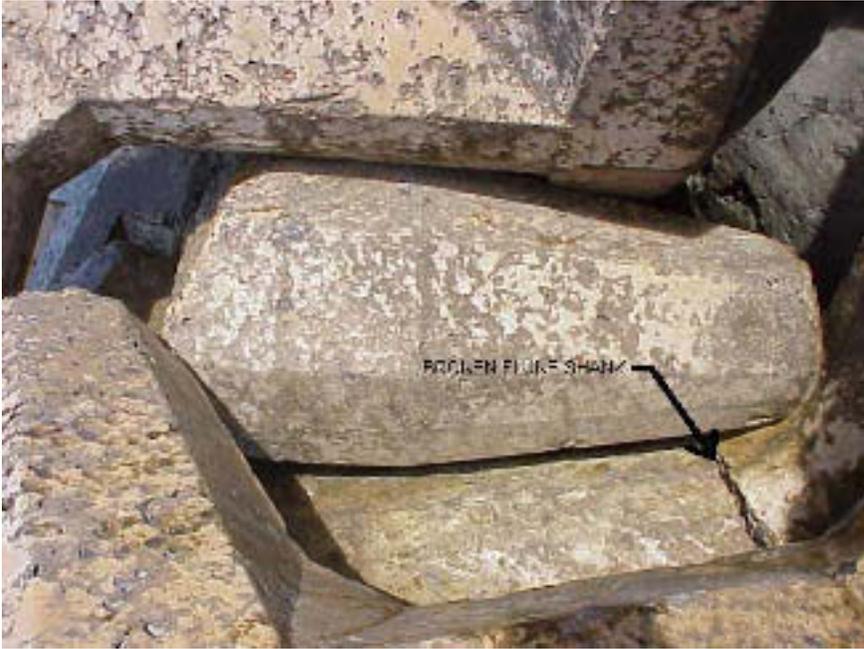
Sta. 8+90, OS: 1 - Dolosse at crest with broken shank (no picture).  
1 - Dolosse on sideslope with broken fluke shank.

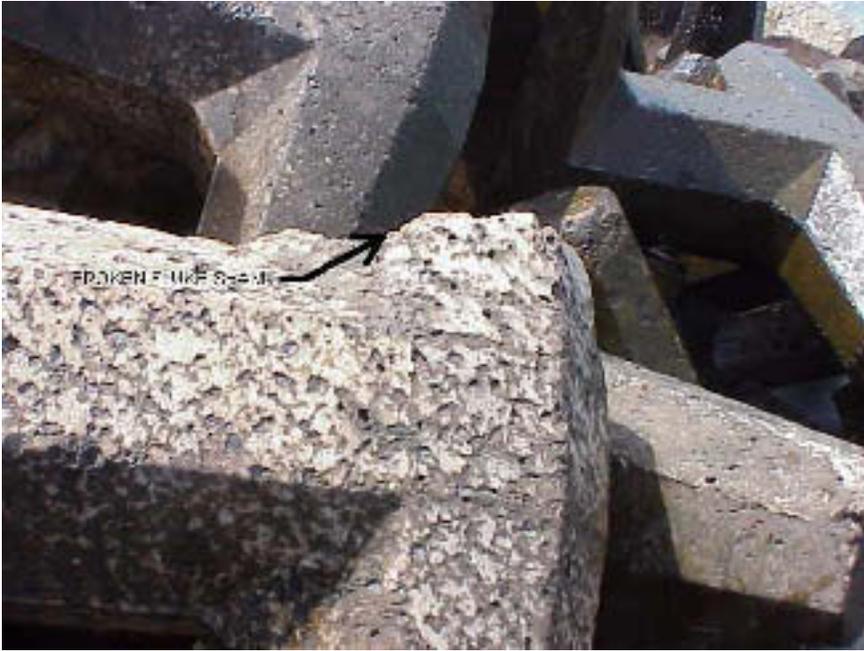
Sta. 9+00, Crest: 2 - Dolosse with broken fluke shanks.

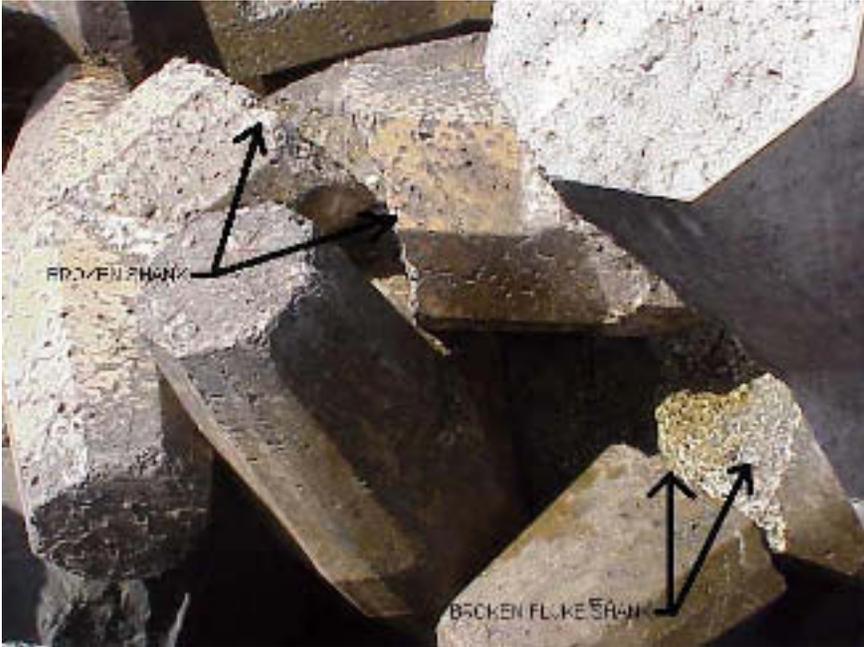
Sta. 9+30, OS: 1 - Dolosse at hinge with broken shank.  
2 - Dolosse at hinge with broken fluke shank.

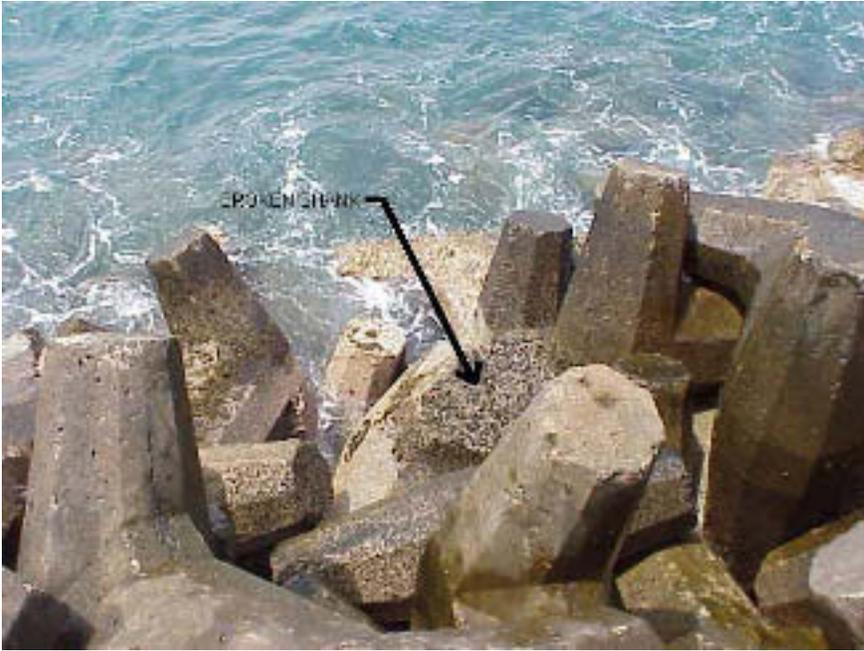
Sta. 9+35, OS: 1 - Dolosse, #25, 10-7-77, near water line with broken shank.

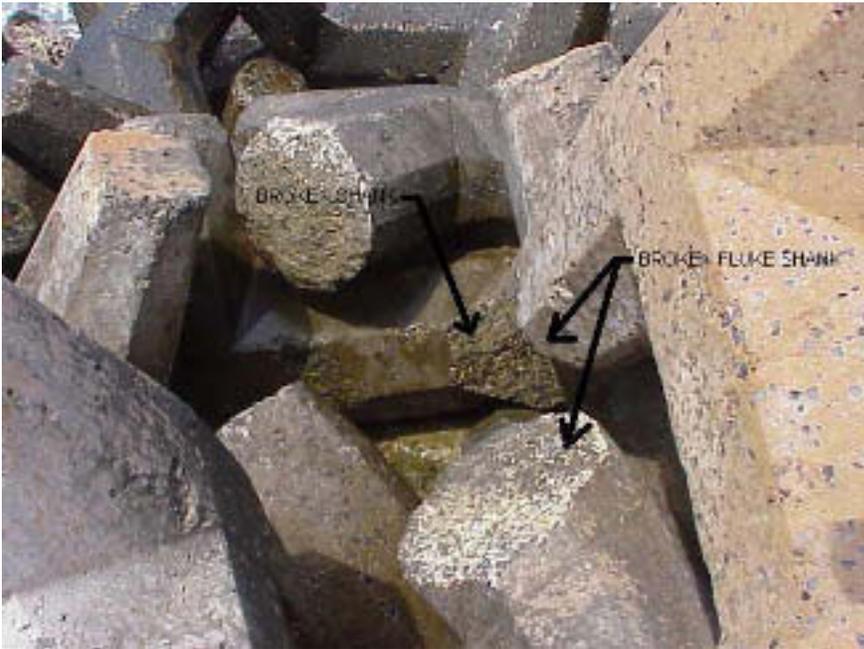
Sta. 9+62, OS: 1 - Dolosse on sideslope with broken shank.  
2 - Dolosse on sideslope with broken fluke shank.

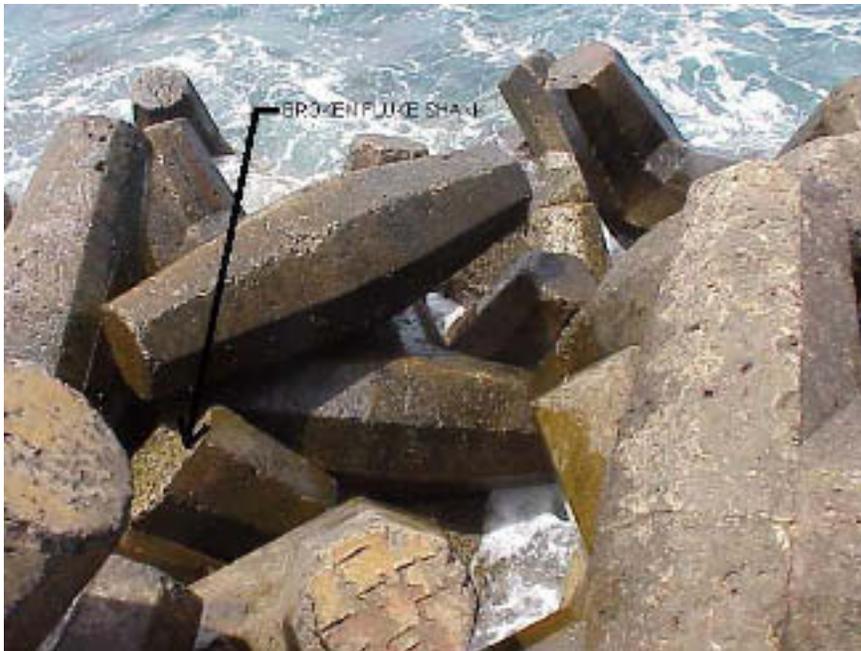
Sta. 9+82, OS: 3 to 5 - Dolosse with fluke shank breaks spread over this area.

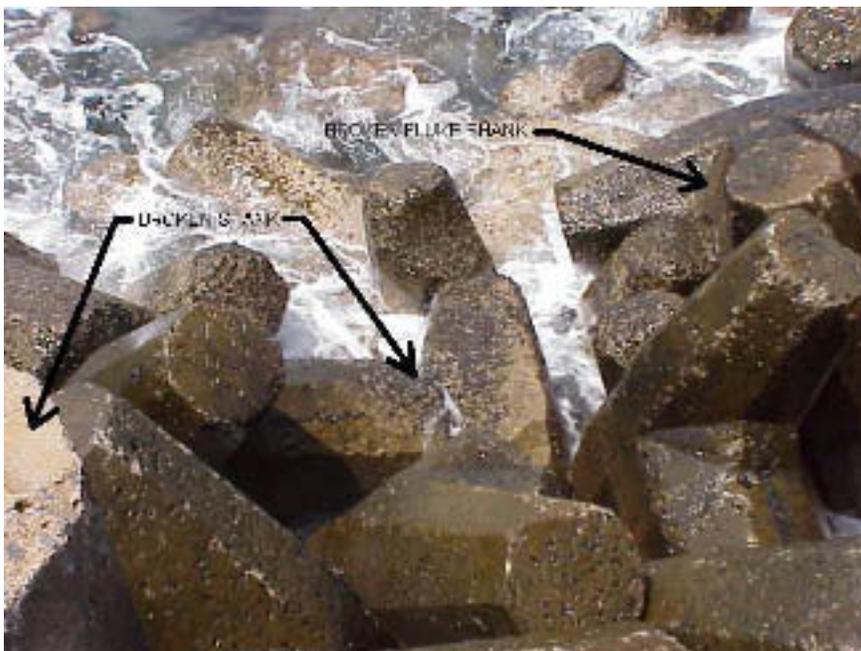
Sta. 10+40, OS: 2 - Dolosse at water line with broken shank.  
1 - Dolosse at water line with broken shank and fluke shank.

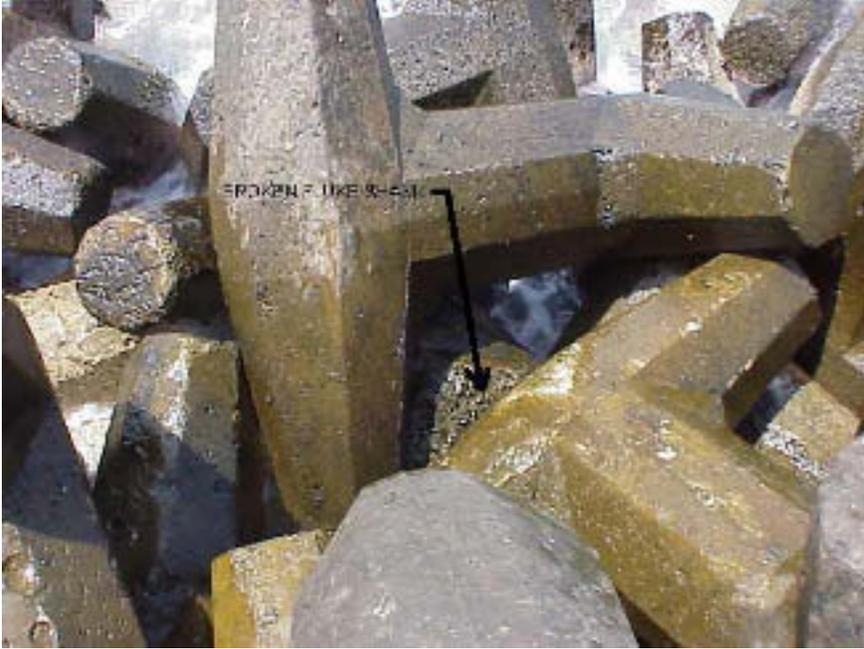
Sta. 10+75, OS: 1 - Dolosse at water line with broken fluke shank below #41, 5-30-78.

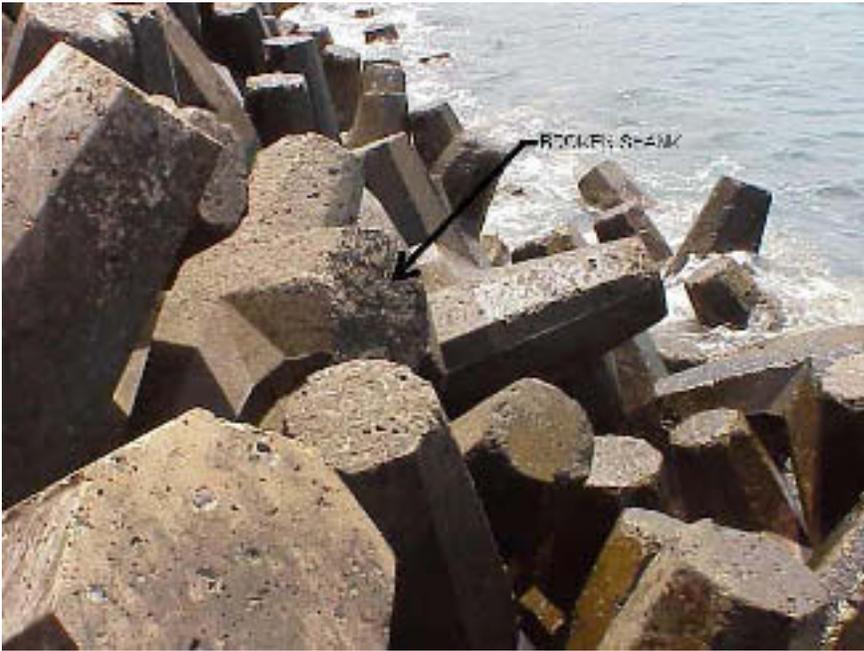
Sta. 11+10, OS: 1 - Dolosse on sideslope with broken shank.

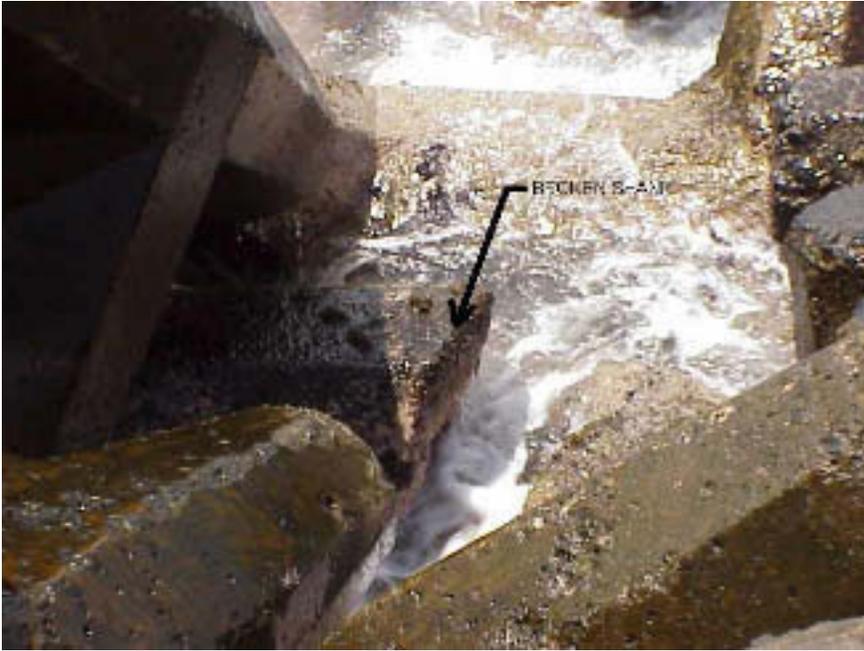
Sta. 11+10, OS: 1 - Dolosse at water line with broken shank.

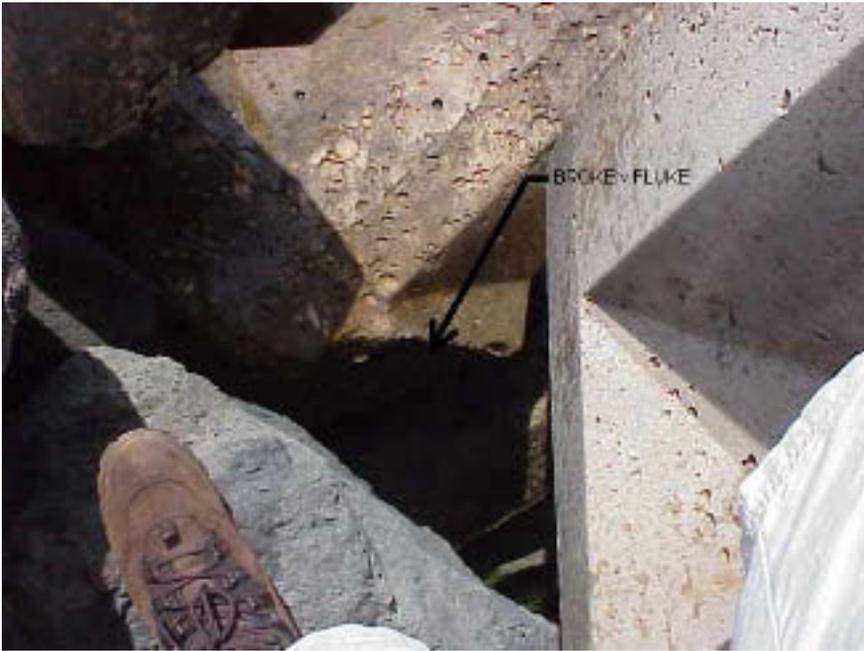
Sta. 11+15, OS: 1 - Dolosse, #42, 5-26-78, at hinge with broken fluke.

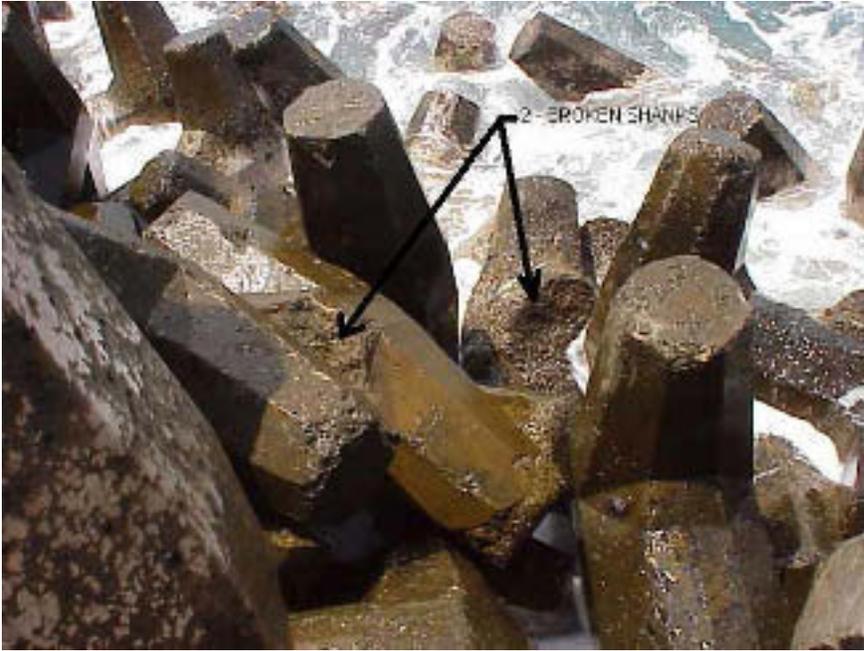
Sta. 11+28, OS: 2 - Dolosse at water line with broken shank.

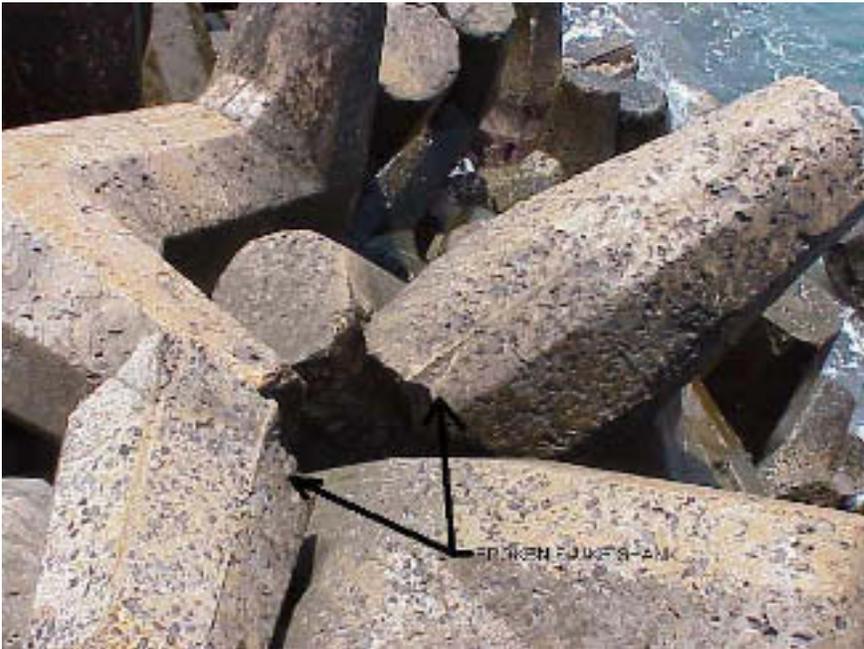
Sta. 11+28, OS: 1 - Dolosse at hinge with broken fluke shank.

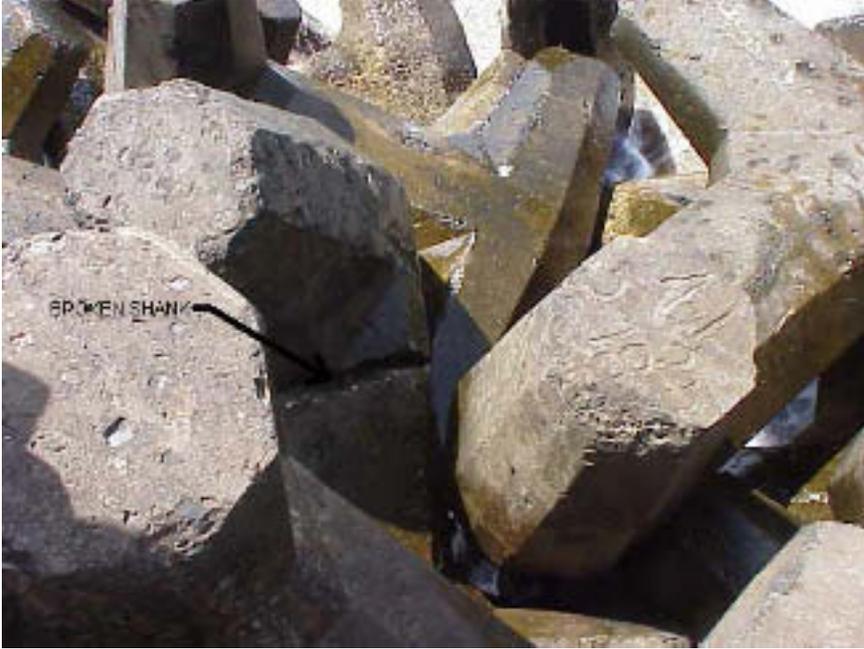
Sta. 11+50, OS: 2 - Dolosse on sideslope with broken shank next to #41, 5-25-78. Marker with 9 dots (no Picture).

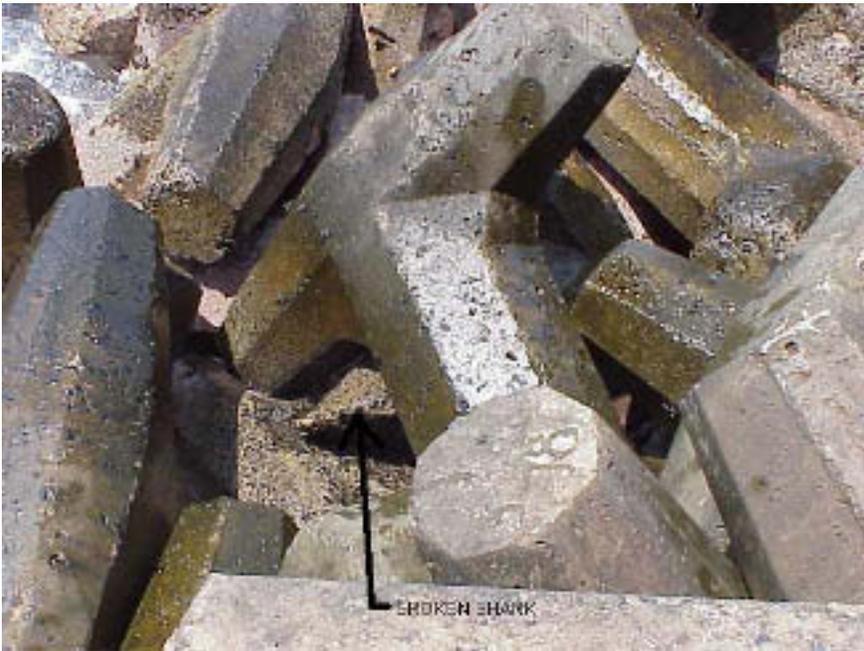
Sta, 11+75, OS: 1 - Dolosse at water line with broken shank.

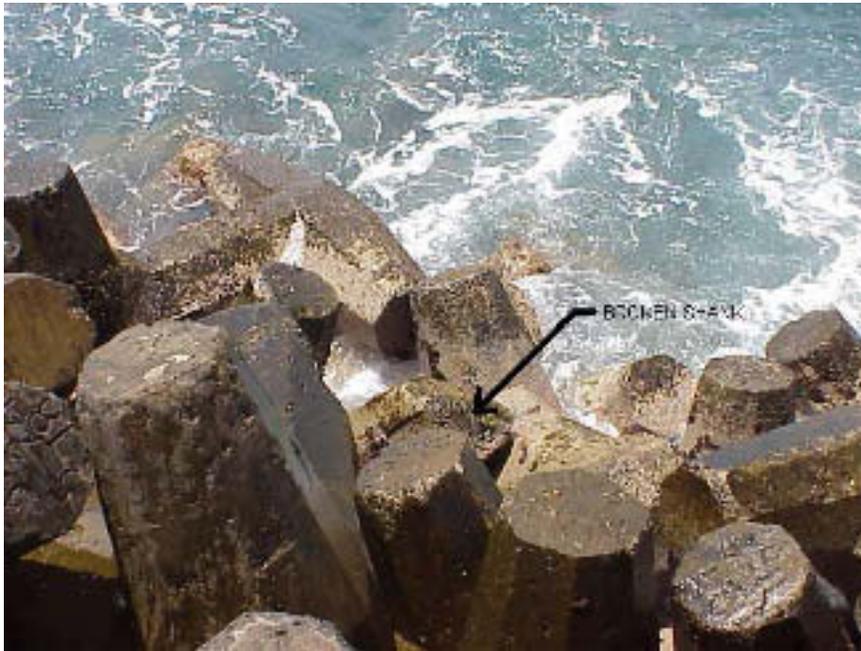
Sta. 12+10, OS: 1 - Dolosse at water line with broken shank.

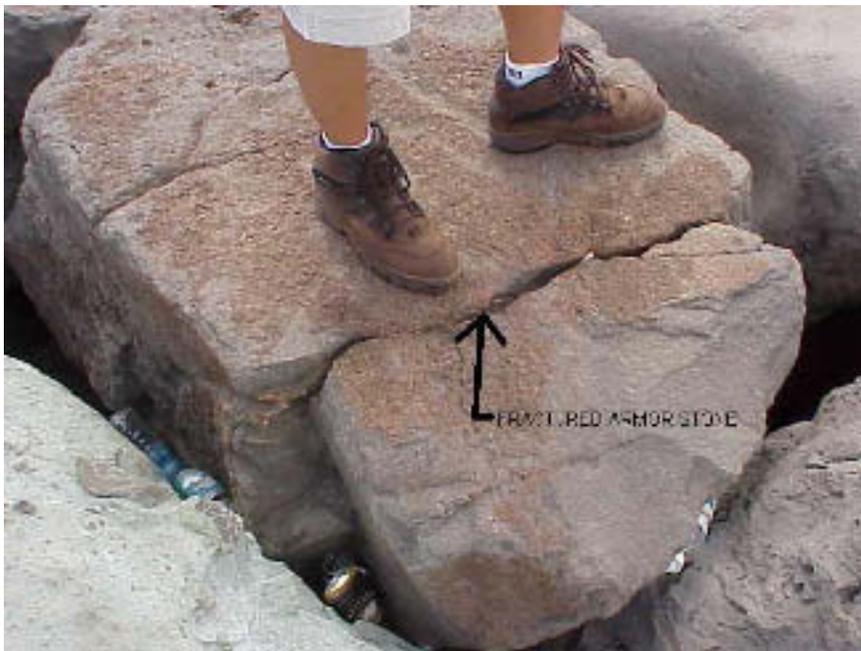
Sta. 12+22, Crest: Fractured armor stone.
