O & M INSPECTION REPORT  
FOR NAVIGATION AND SHORE PROTECTION PROJECTS

1. PROJECT NAME: WAIANAE SMALL BOAT HARBOR

2. DATE OF INSPECTION: 29 AUGUST 2002

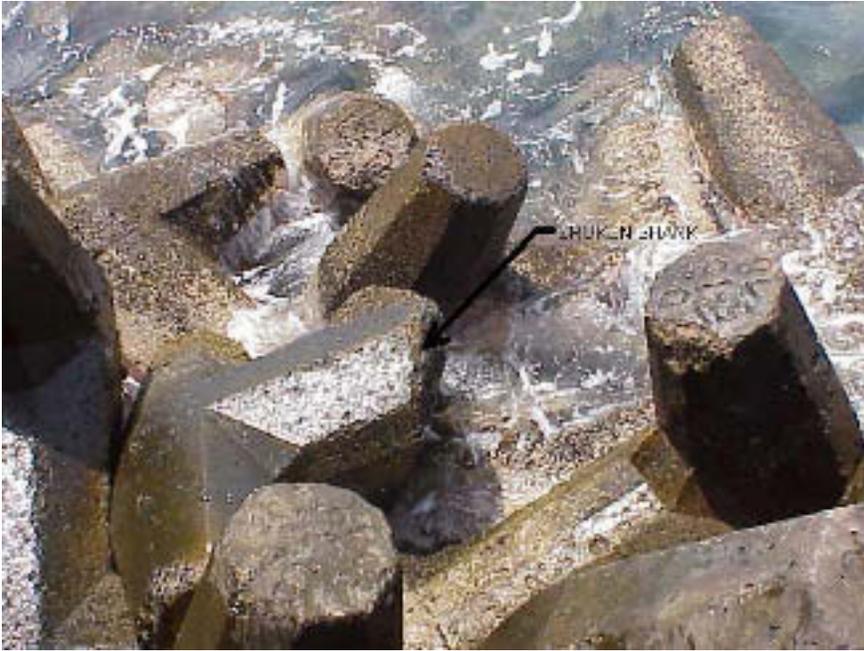
Sta. 12+42, OS: 1 - Dolosse at water line with broken shank.

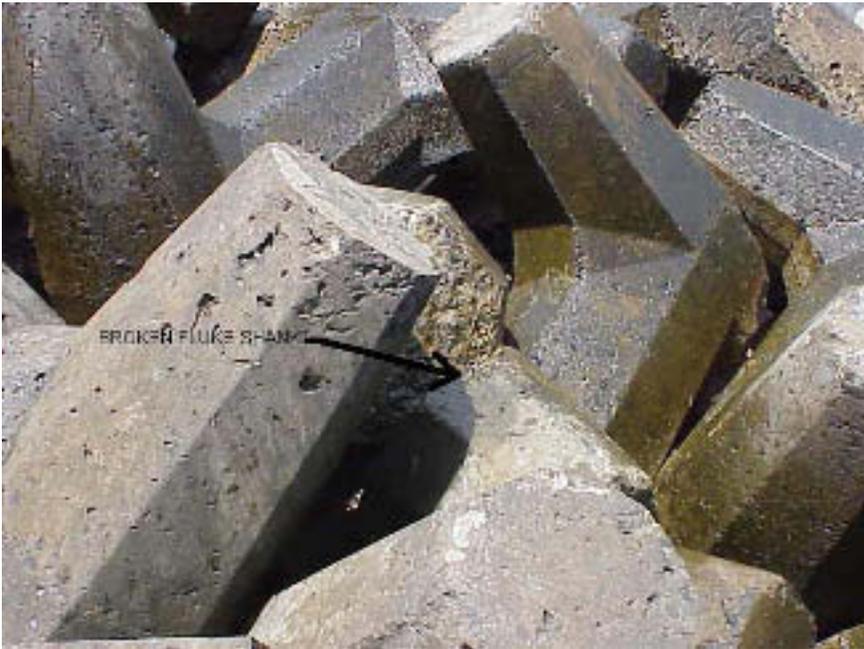
Sta. 12+55, OS: 1 - Dolosse on sideslope with broken fluke shank.

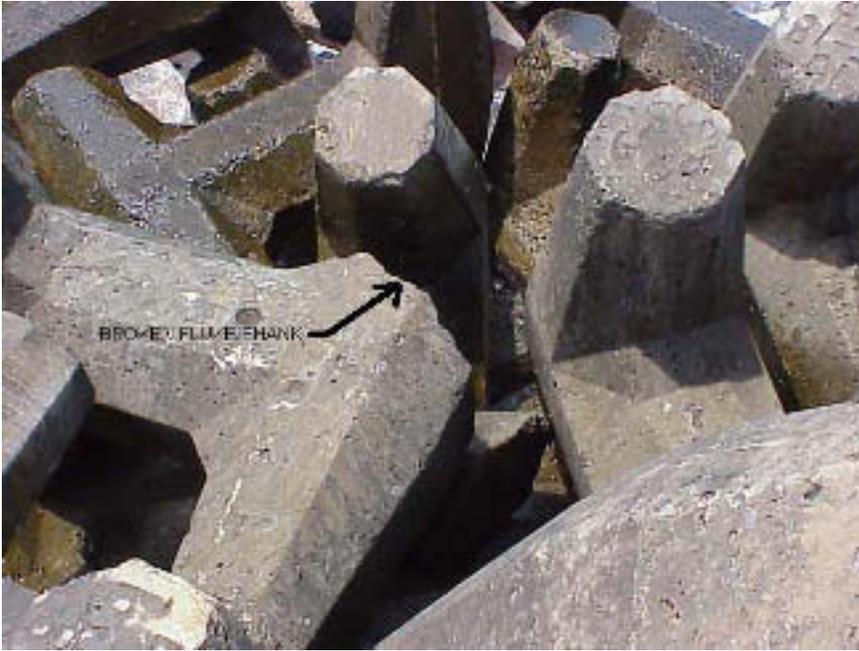
Sta. 12+95, OS: 1 - Dolosse on sideslope with broken fluke shank.

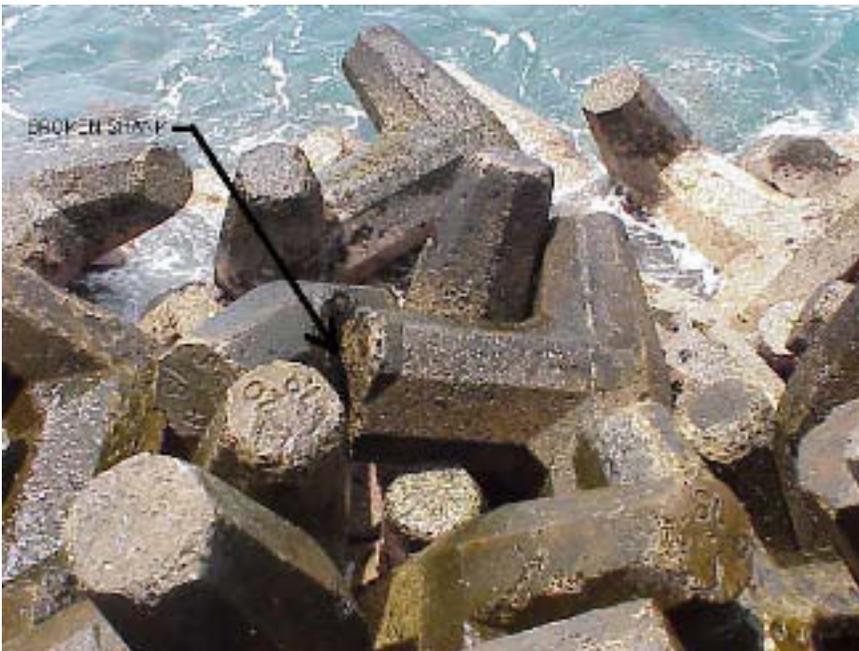
Sta. 13+25, OS: 1 - Dolosse on sideslope with broken shank.  
1 - Dolosse at hinge with broken fluke shank (not pictured)

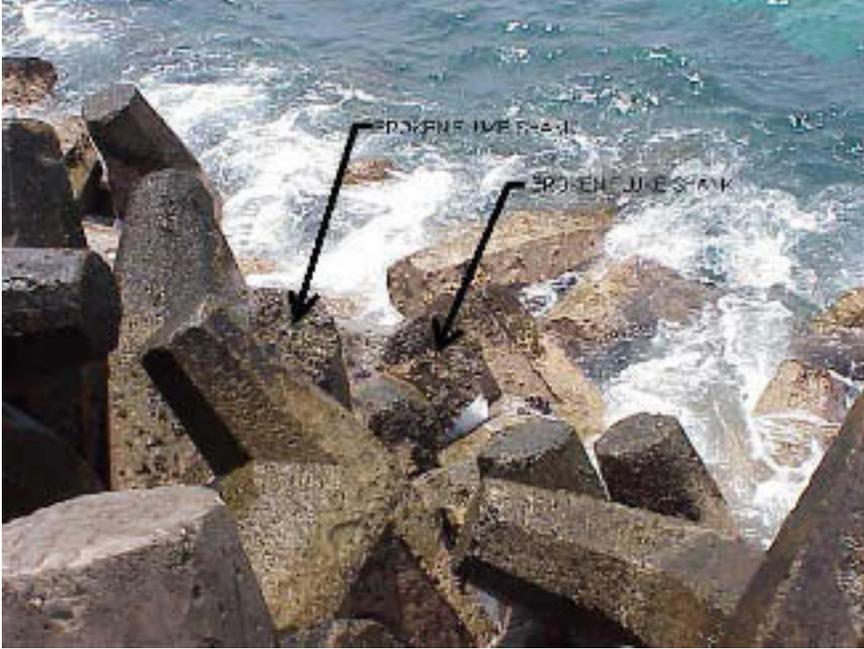
Sta. 13+50, OS: 2 - Dolosse at water line with broken fluke shank.

MAIN BREAKWATER: FROM THE GIS ARCVIEW MAP, AREAS OF MAIN CONCERN ARE AT THE TRANSITION ZONE (STATION 3+90 TO 8+90), AND HEAD AND OFF SHORE TRUNK SECTIONS ADJACENT HEAD (STATION 13+50 TO HEAD) ON OCEANSIDE. THESE AREAS FORM CLUSTERS OF DEFECTS IN PROXIMITY TO EACH OTHER.

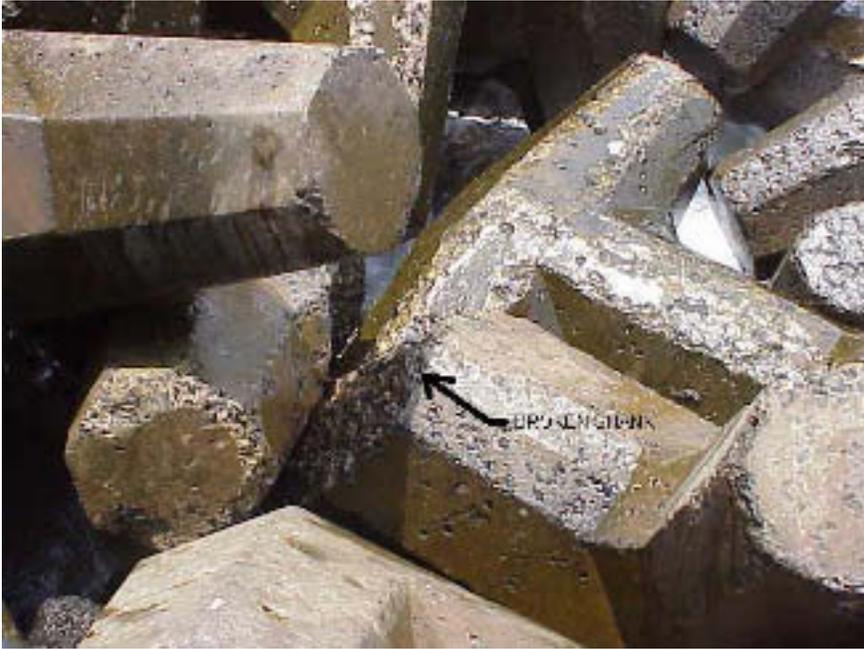
Sta. 13+60, OS: 1 - Dolosse on sideslope with broken shank.

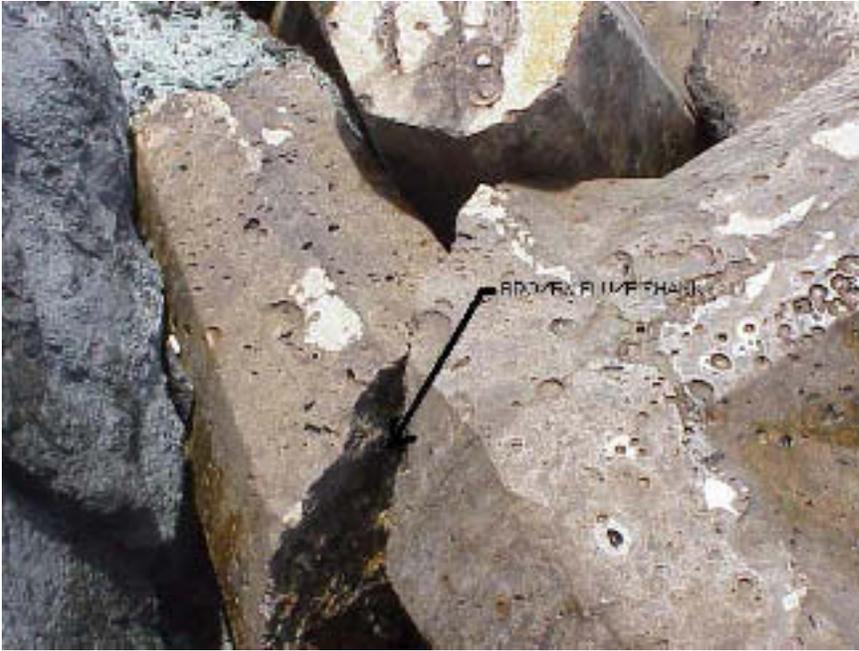
Sta. 13+65, OS: 1 - Dolosse, #11, 1-19-78, at hinge with broken fluke shank.

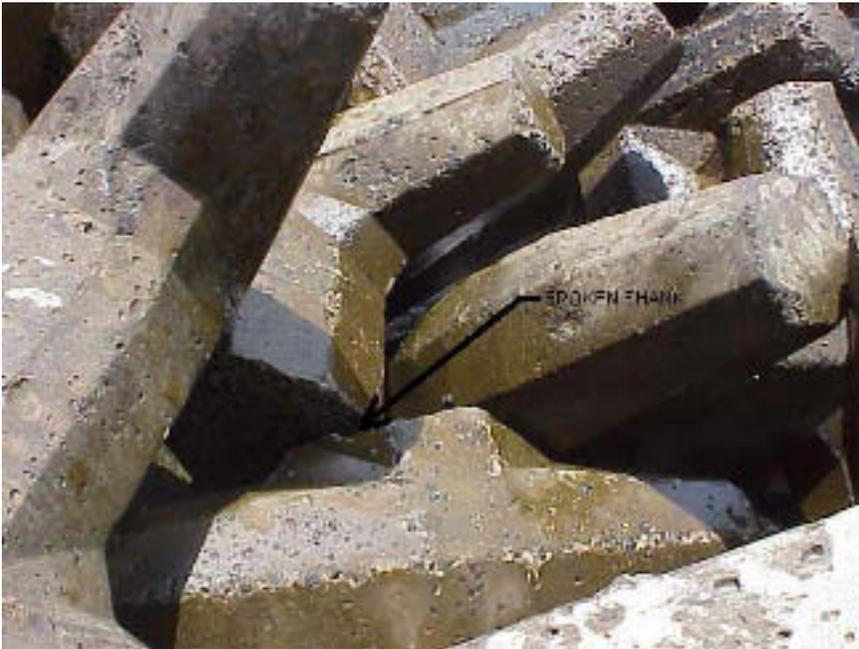
Sta. 13+75, OS: 1 - Dolosse on sideslope with broken shank below #28, 1-19-78.  
1 - Dolosse on sideslope with broken fluke shank (not pictured).

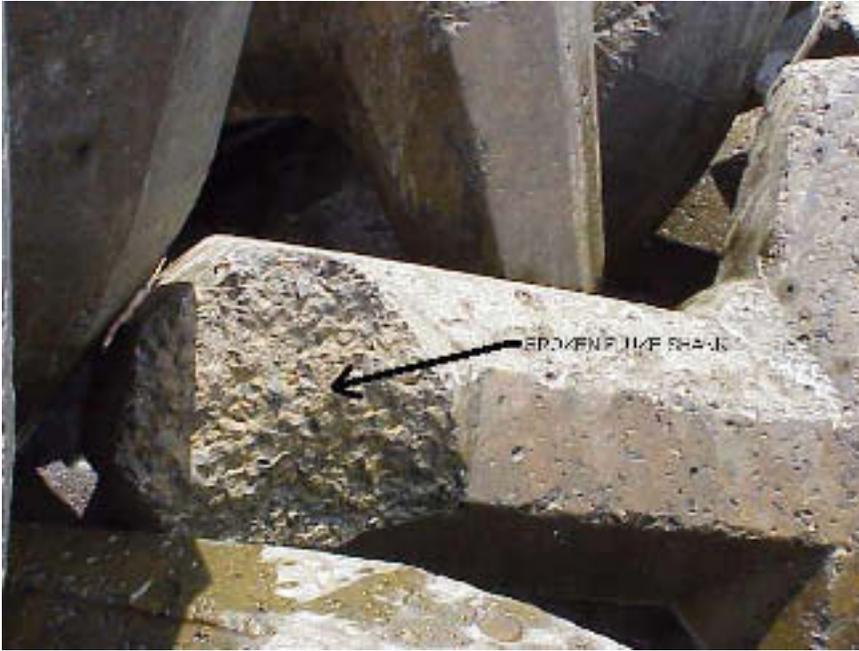
Sta. 13+85, OS: 1 - Dolosse, #41, 6-12-78, on sideslope with broken shank (not pictured).  
1 - Dolosse on sideslope with broken fluke shank.

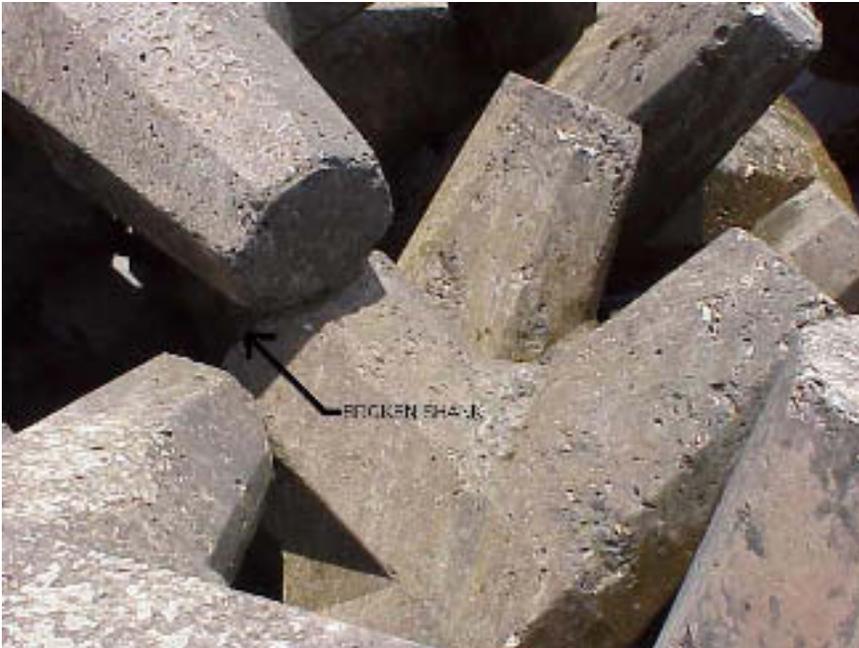
Sta. 14+05, OS: 1 - Dolosse at hinge with broken shank.

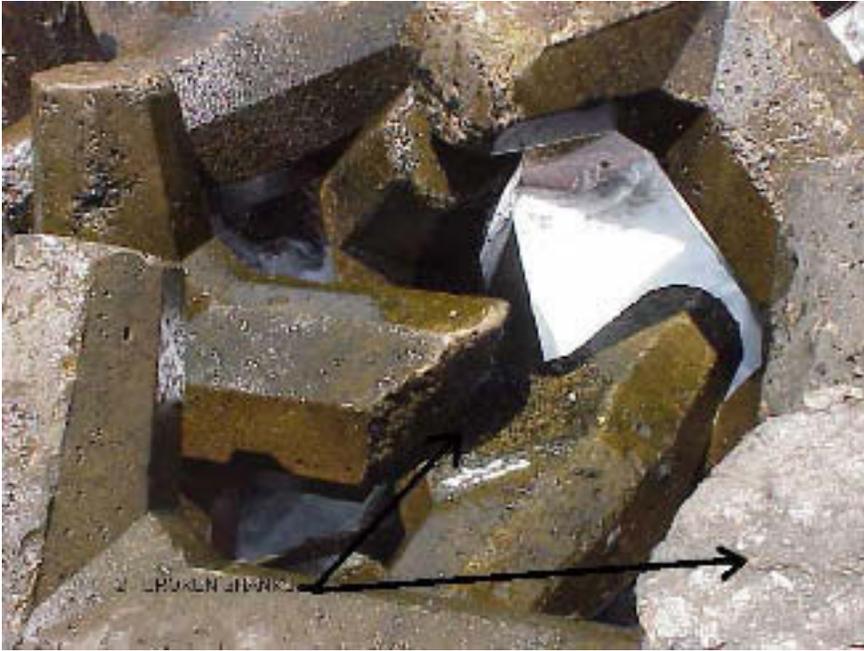
Sta. 14+20, OS: 2 - Dolosse on sideslope with broken shank.

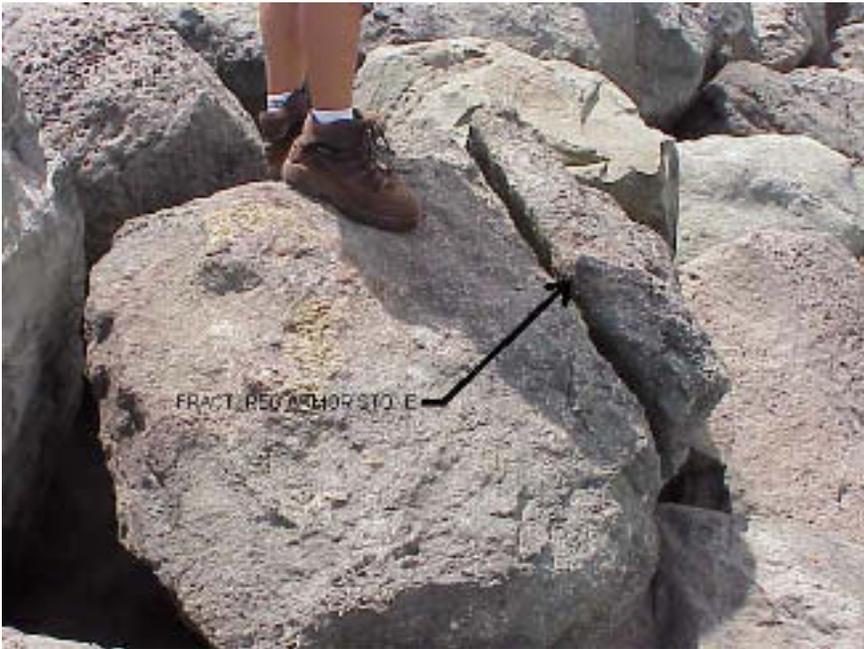
Sta. 14+30, Crest: Fractured armor stone.

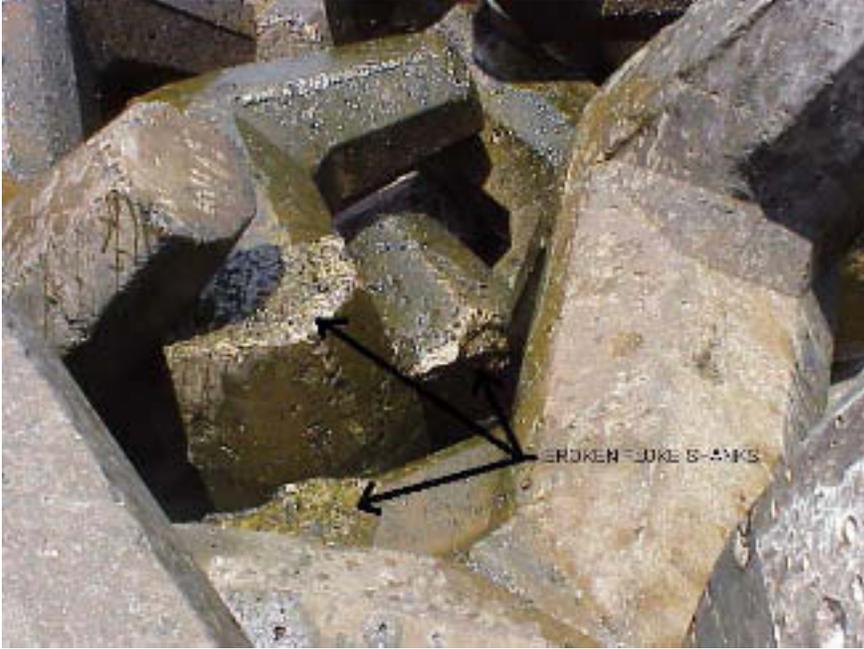
Sta. 14+35, OS: 2 - Dolosse on sideslope with broken fluke shank.

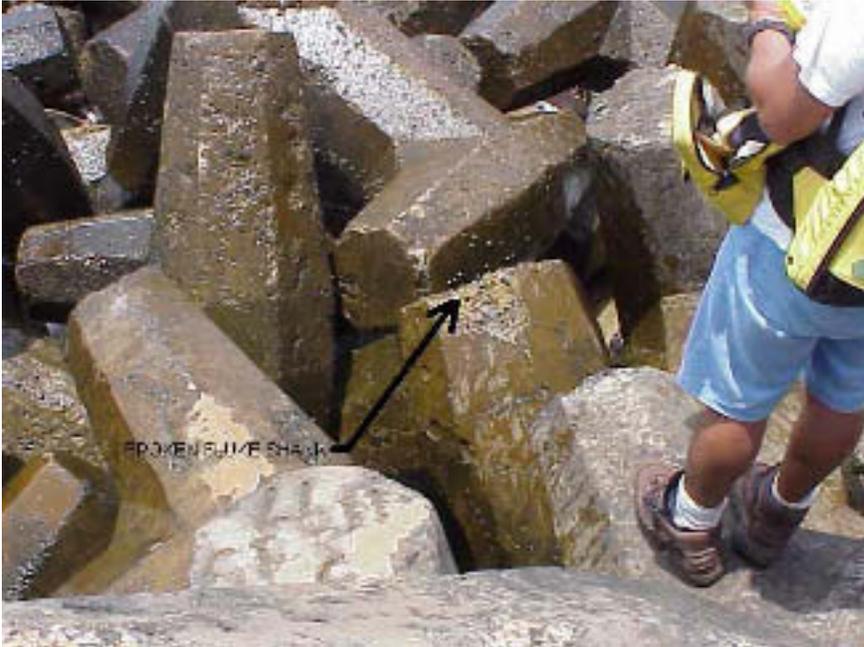
Sta. 14+55, OS: 1 - Dolosse on sideslope with broken fluke shank.

THE MAIN BREAKWATER IS BEGINNING TO SHOW SIGNS OF DOLO MOVEMENT AND SIDESLOPE SETTLING, PARTICULARLY BETWEEN STA. 14+50 AND 16+00, OCEANSIDE. THIS AREA NEEDS TO BE MONITORED AND COMPARED TO PREVIOUS PHOTOGRAPHS ANNUALLY. THE STRUCTURE REMAINS SERVICEABLE AND NO FAILURE IS ANTICIPATED IN THE NEXT YEAR.

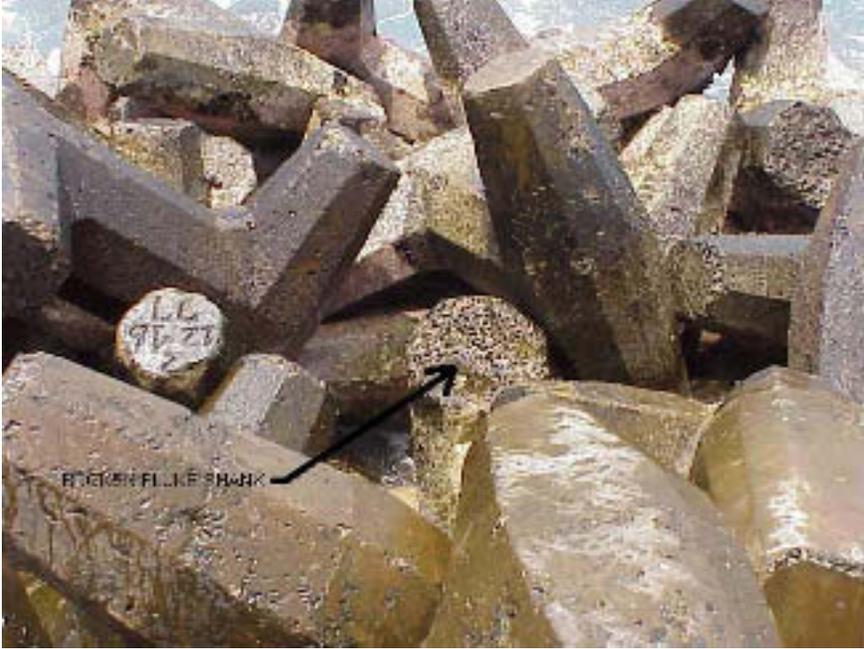
Sta. 14+65, OS: 1 - Dolosse at water line with broken fluke shank.

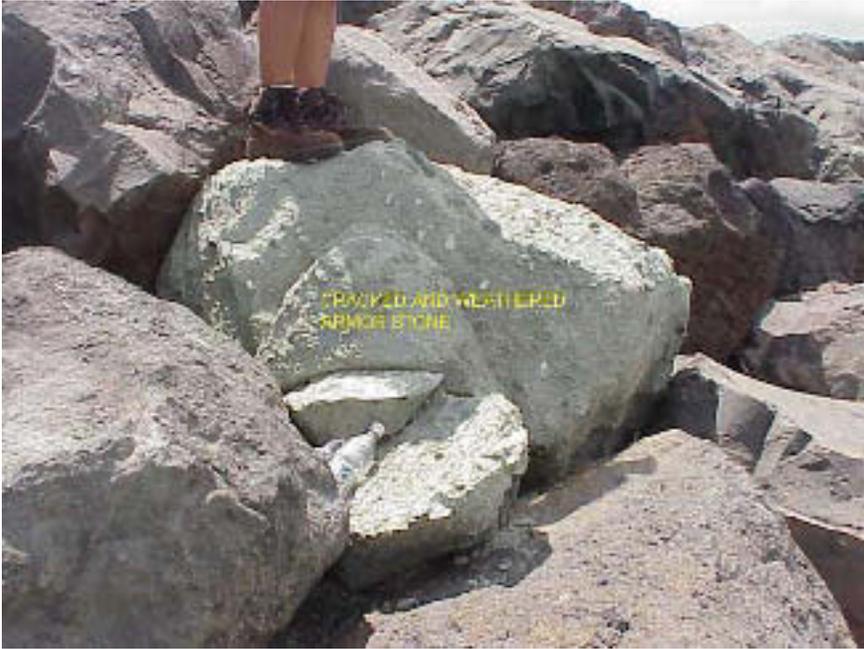
Sta. 14+75, Crest: Cracked and weathered armor stone.

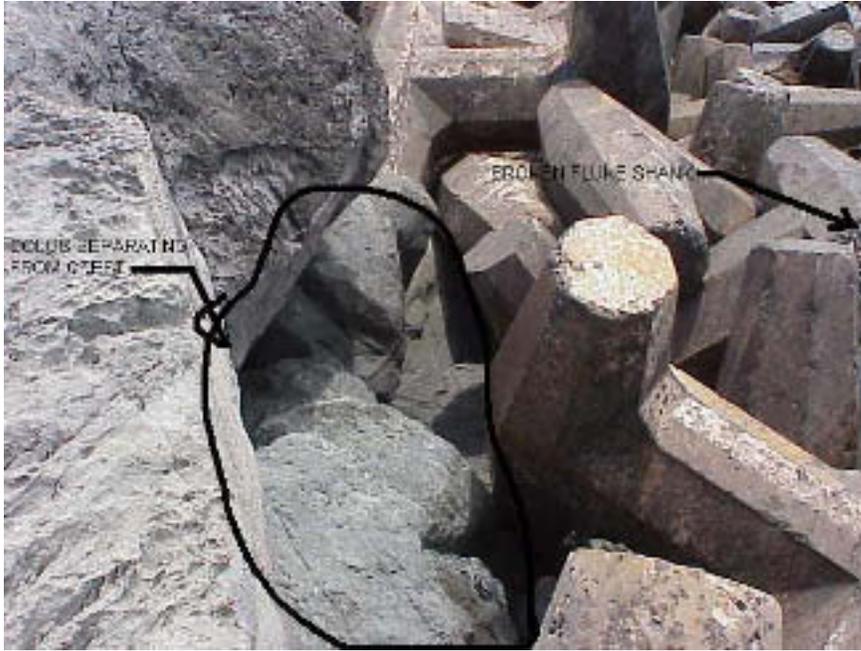
Sta. 14+75, OS: 1 - Dolosse on sideslope with broken fluke shank.  
Separation of dolosse from crest at hinge between sta. 14+55 and sta. 14+90.

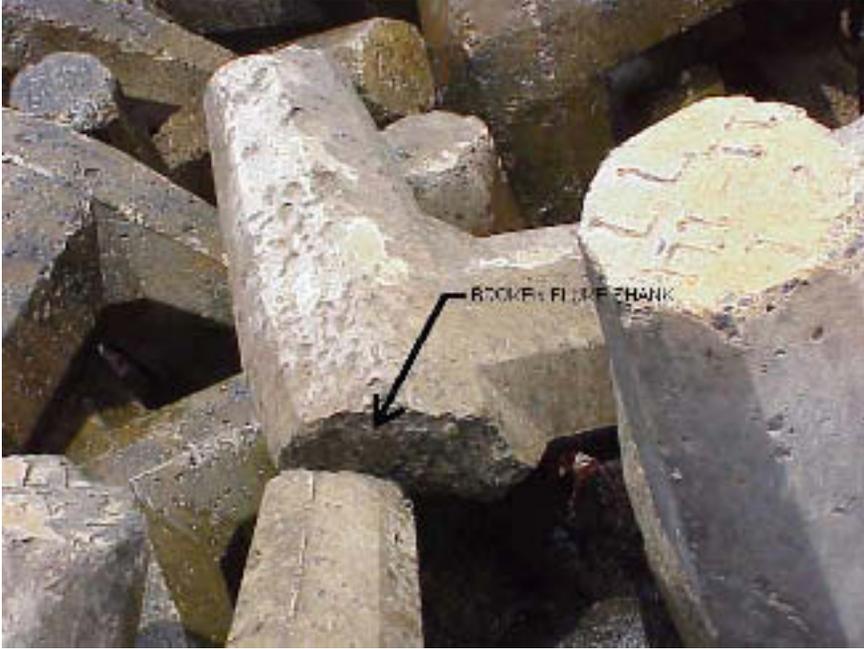
Sta. 15+30, OS: 1 - Dolosse on sideslope with broken fluke shank below #21, 11-14-77.

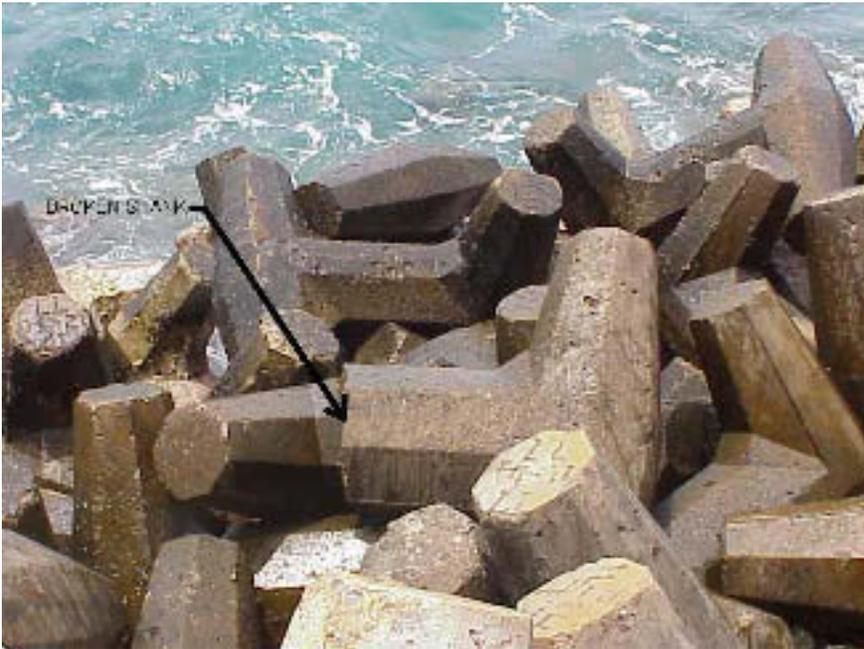
Sta. 15+50, OS: 1 - Dolosse on sideslope with broken shank below #17, 11-14-77.

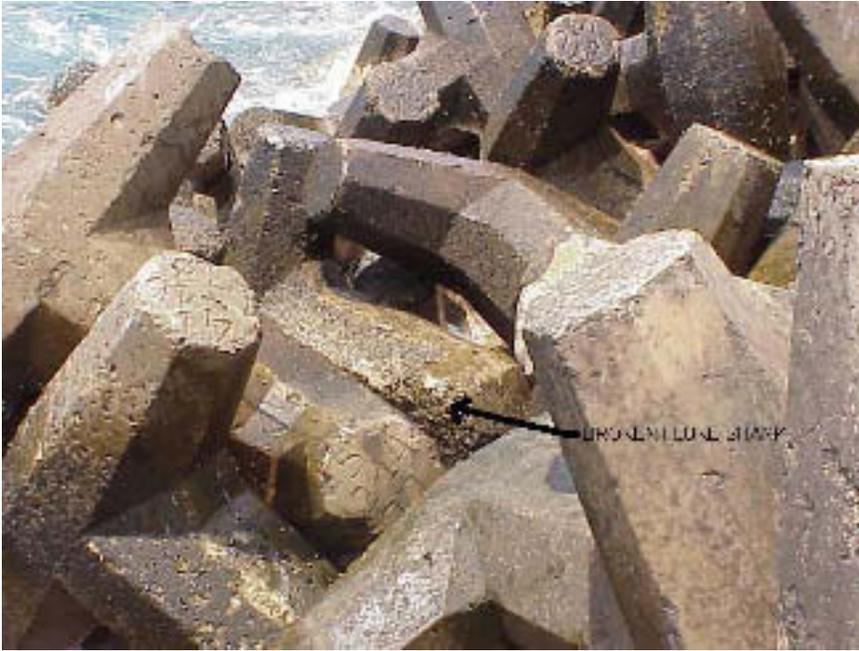
Sta. 15+65, OS: 2 - Dolosse at water line with broken fluke shank below #8, 12-14-77.

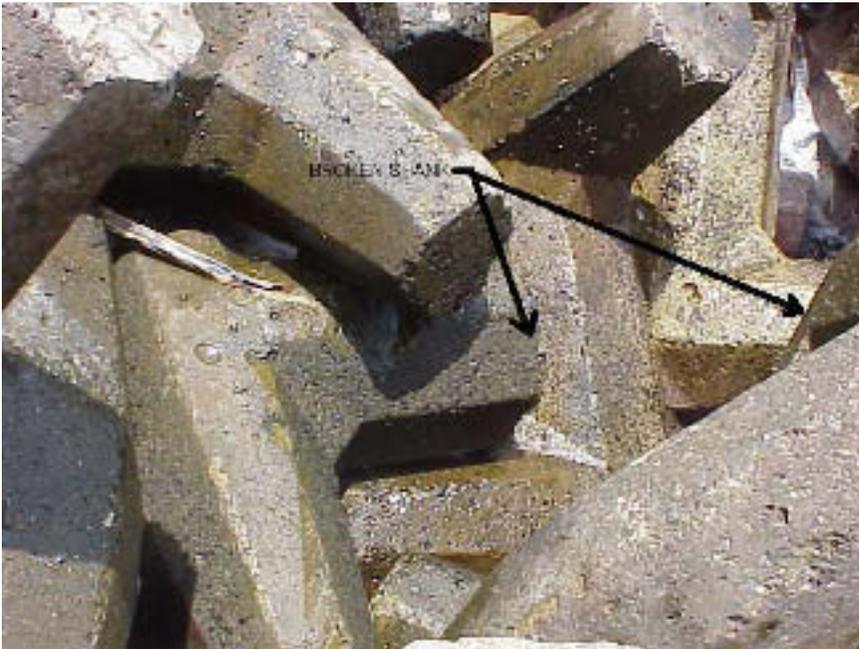
Sta. 15+82, OS: 1 - Dolosse on sideslope with broken shank.

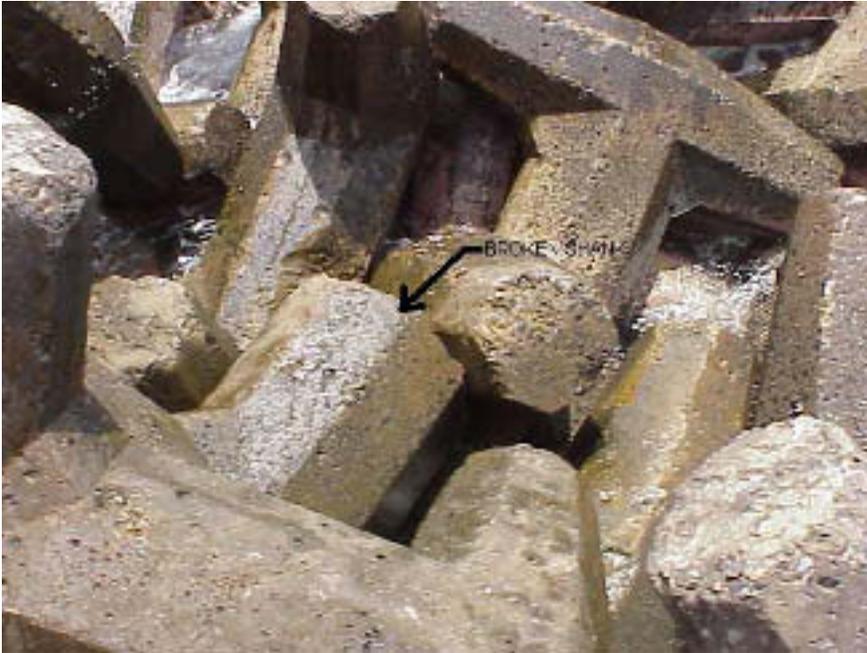
Sta. 15+82, OS: 1 - Dolosse at water line with broken shank.

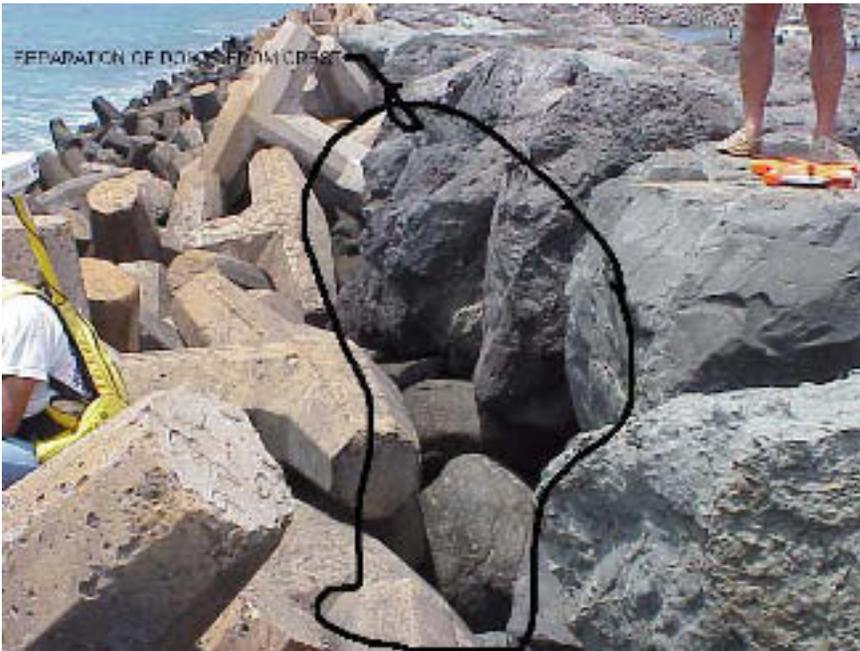
Sta. 15+60 to Sta. 15+95, OS: Separation of dolosse from crest hinge. Sideslope is may be sliding.

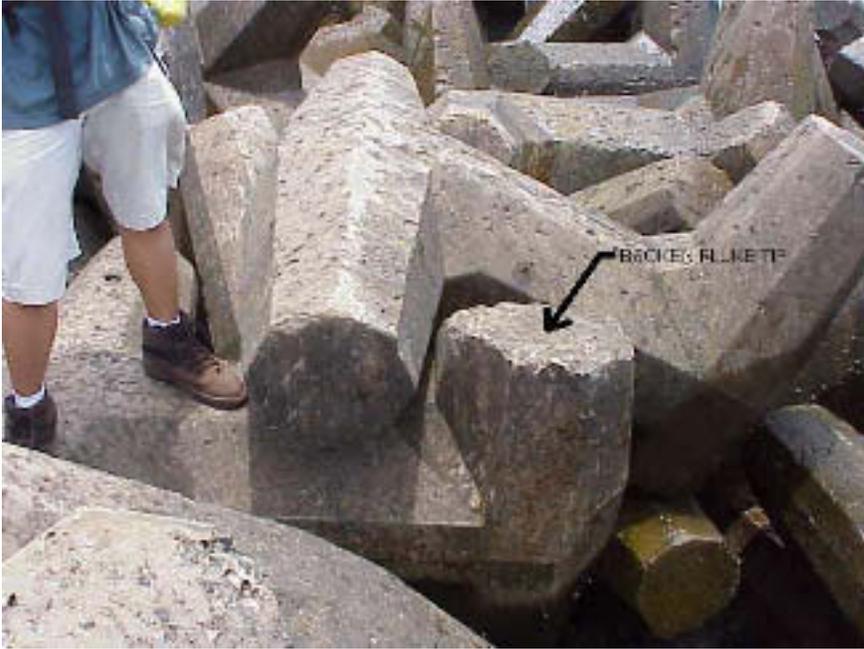
Sta. 16+20, OS: 1 - Dolosse on sideslope with broken fluke tip next to #8, 1-18-78.

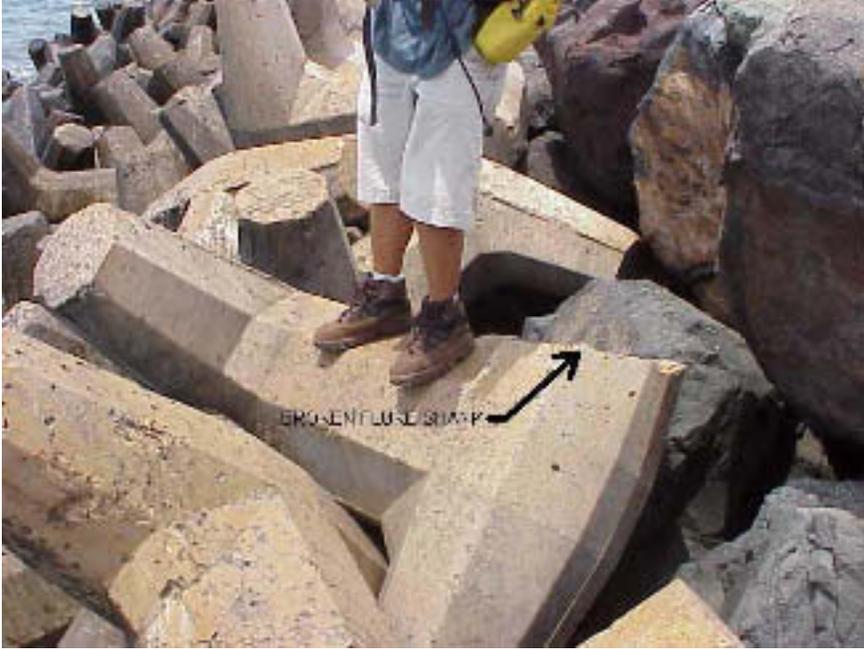
Sta. 16+45, OS: 1 - Dolosse at hinge with broken fluke shank next to #20, 1-13-78.

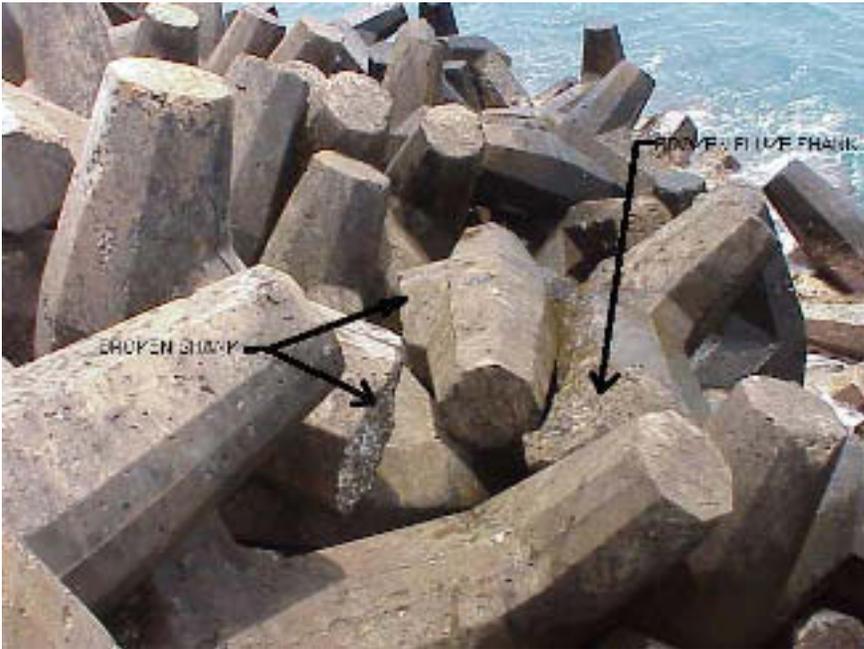
Sta. 16+55, OS: 1 - Dolosse, #25, 11-28-77, on sideslope with broken shank.  
1 - Dolosse on sideslope with broken fluke shank.

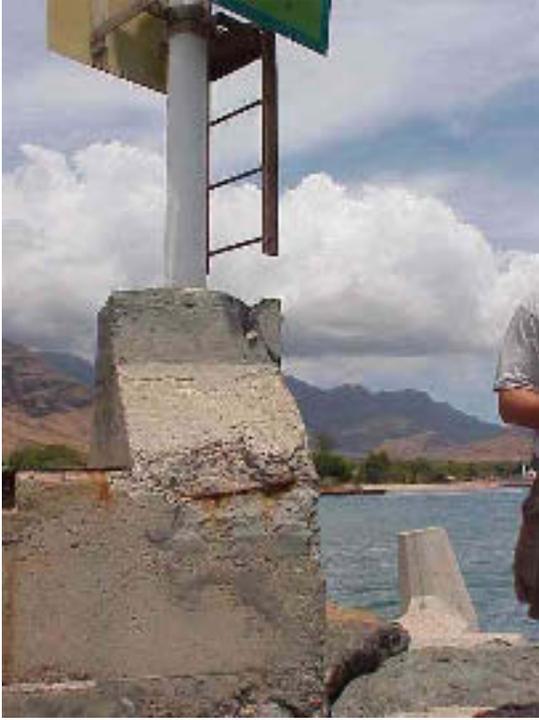
Sta. 16+70, 45Degrees OS: 1 - Navigational monument above headstone with separation from crest.

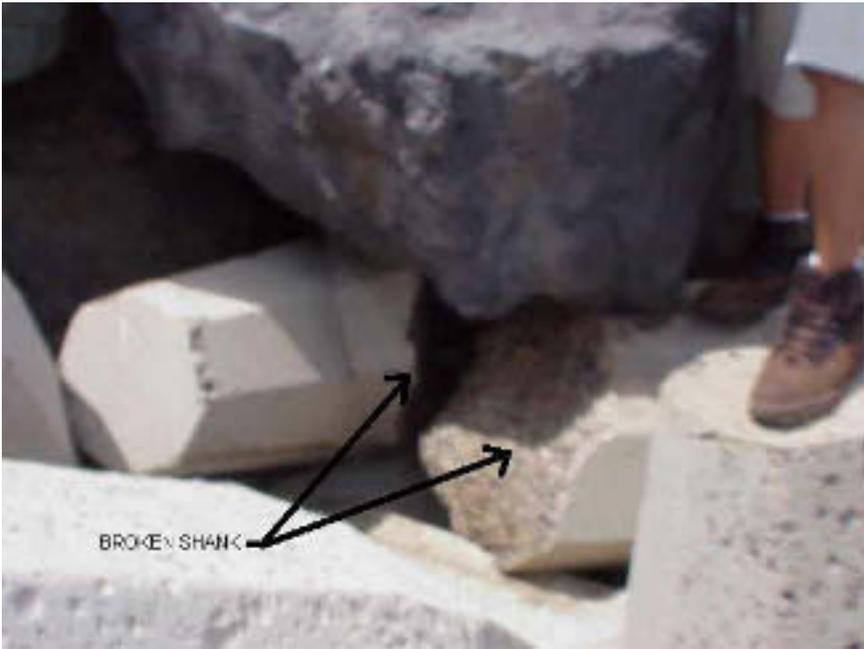
Sta. 16+77, 90Degrees HS: 1 - Dolosse, #21 12-7-77, on sideslope with broken shank.

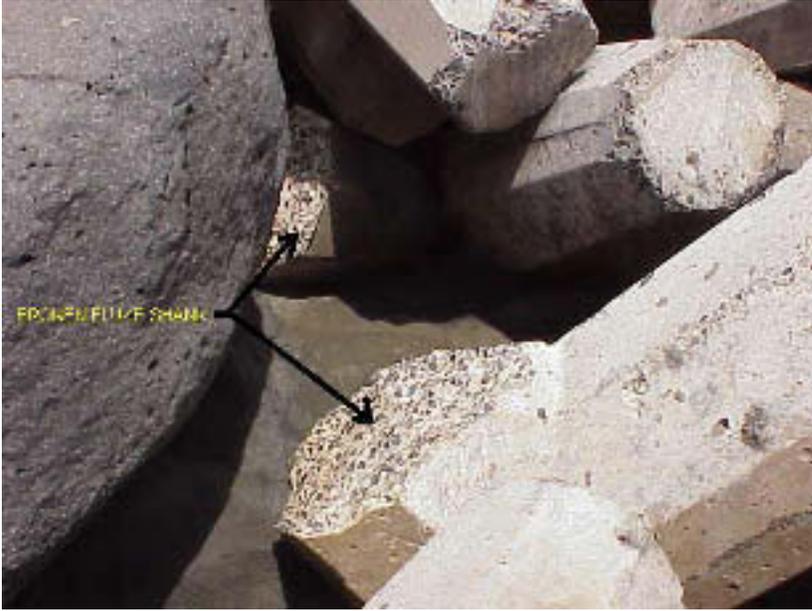
Sta. 16+78, 90 Degrees OS: 1 - Dolosse, #12, 12-7-77, on sideslope with broken fluke shank.

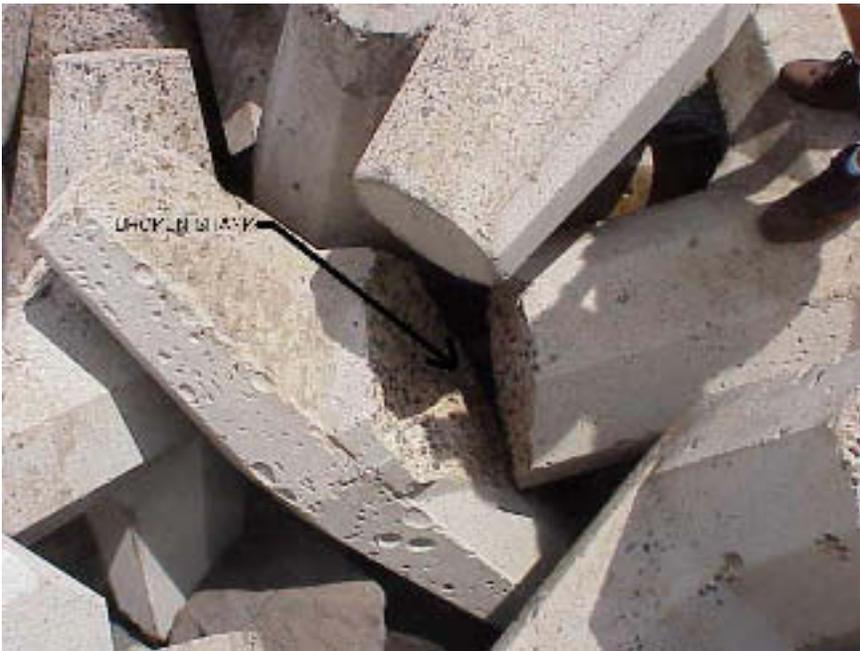
Sta. 16+83, 5 Degrees HS: 1 - Dolosse, #11, 8-15-78, at head section with broken shank.

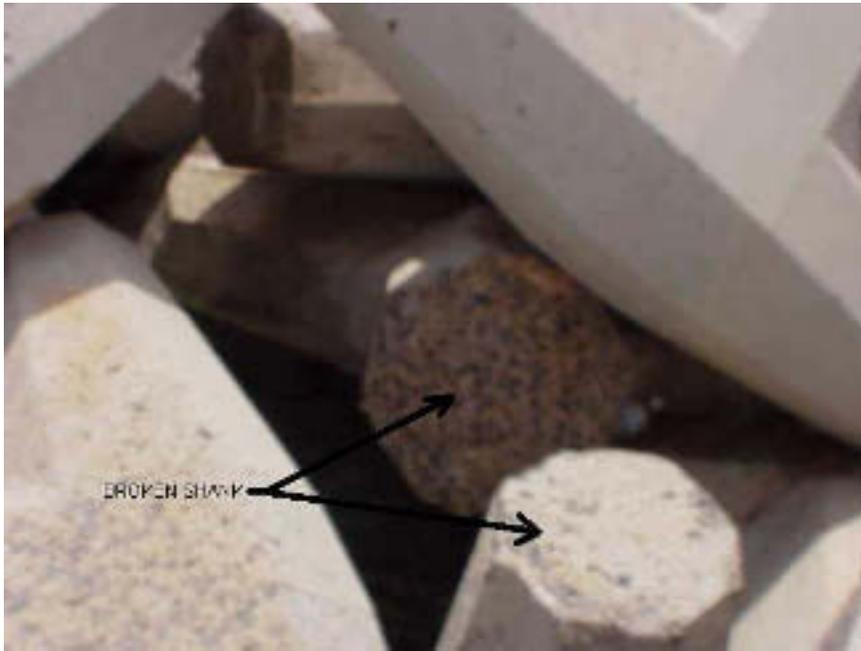
Sta. 16+83, 45 Degrees HS: 1 - Dolosse on sideslope with broken shank below #3, 8-15-78.

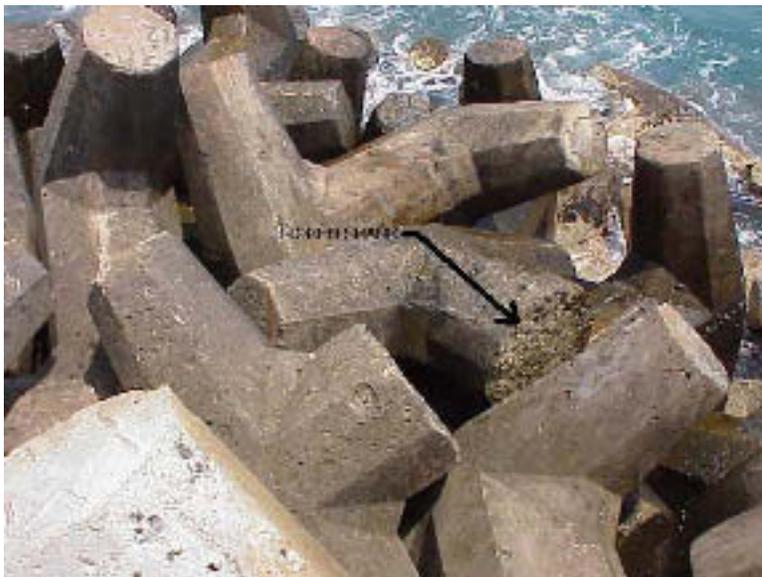
Sta. 16+90, 45 Degrees OS: 1 - Dolosse on sideslope with broken shank next to #30, 12-7-77.

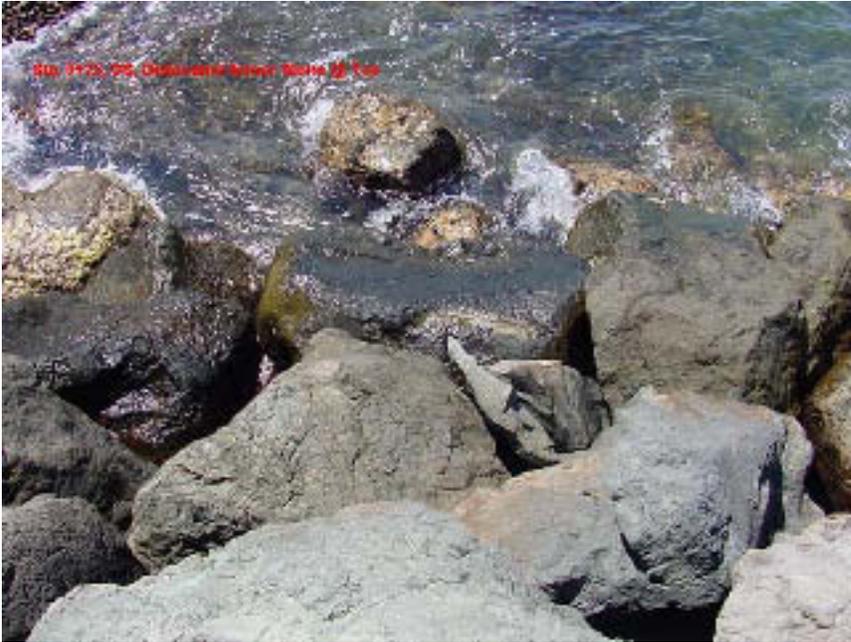
\*Sta. 0+25, OS, 1 dislodged armor stone at toe.

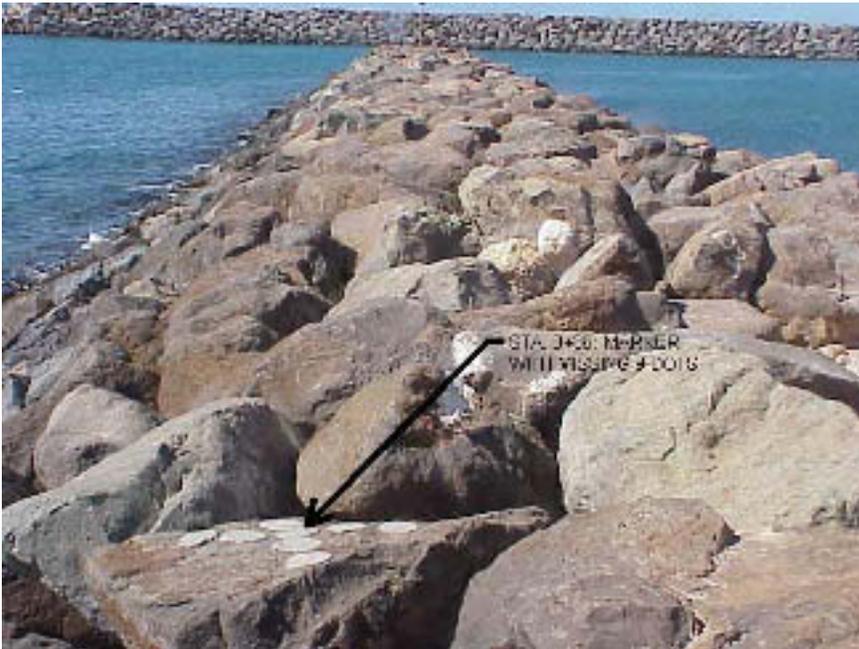
Sta. 0+36, Crest, 9 dot marker with all 9 dots missing.

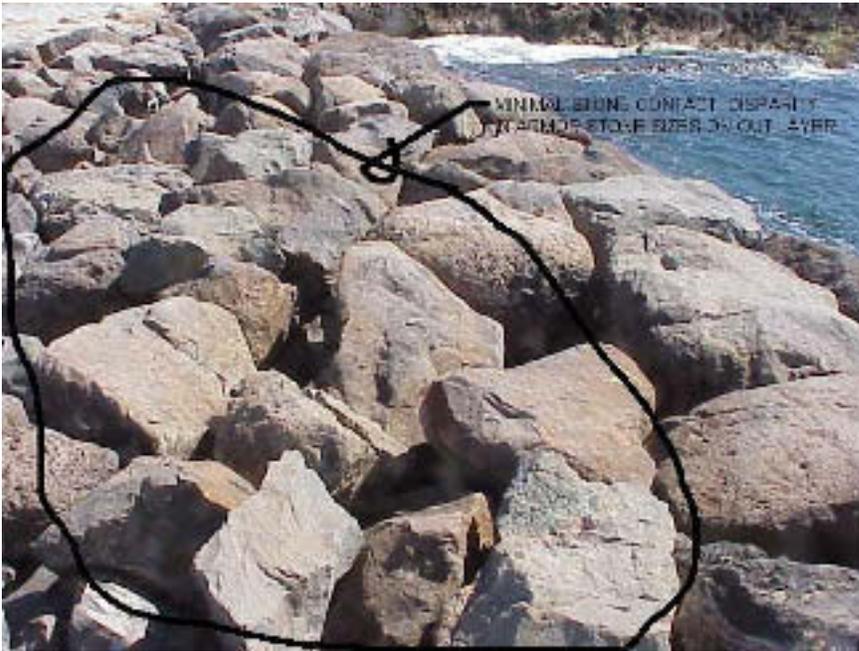
Sta. 0+80 to Sta. 0+90, HS and crest, minimal contact between armor stones. There is a major disparity between some of the armor stone sizes also.

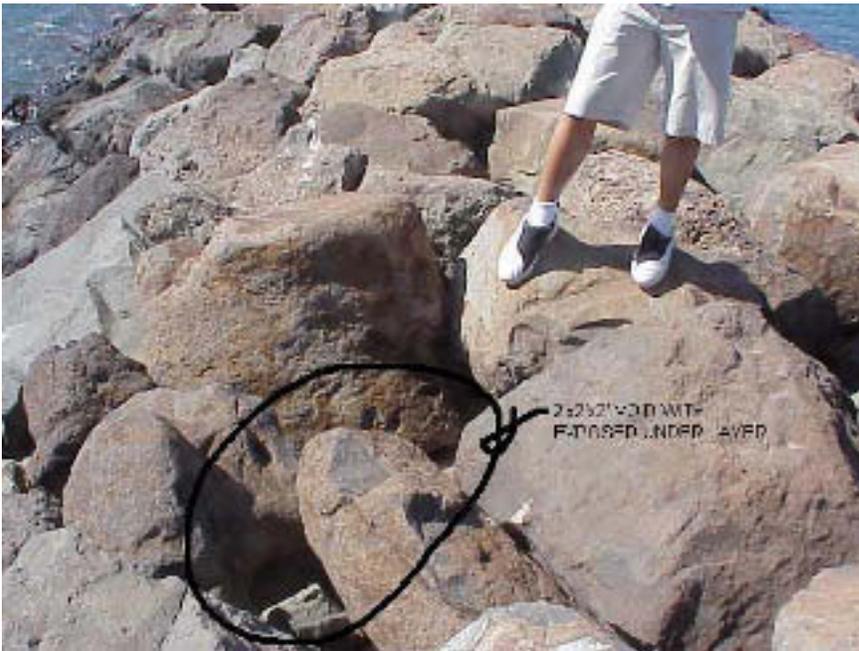
Sta. 1+80, Crest, 2'x2'x2' void with exposed under layer.

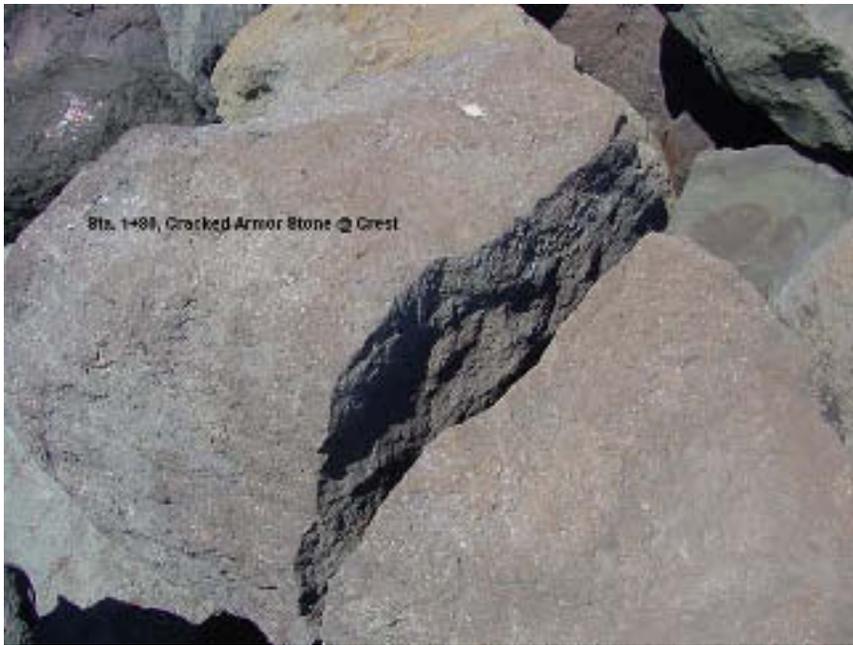
\*Sta. 1+80, OS, 1 fractured armor stone at hinge.

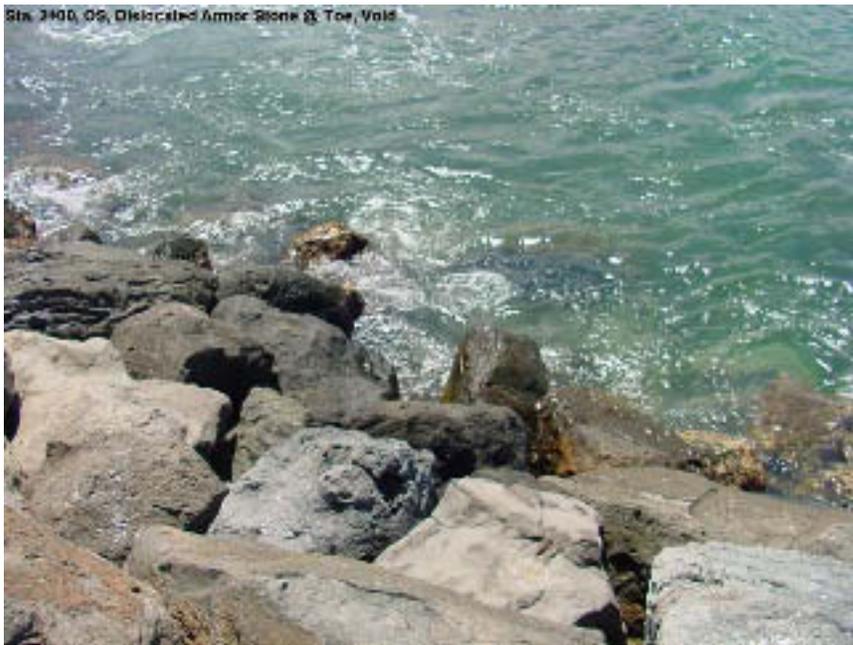
\*Sta. 2+00, OS, 4' void. Underlayer exposed. 1 armor stone displaced 3'.

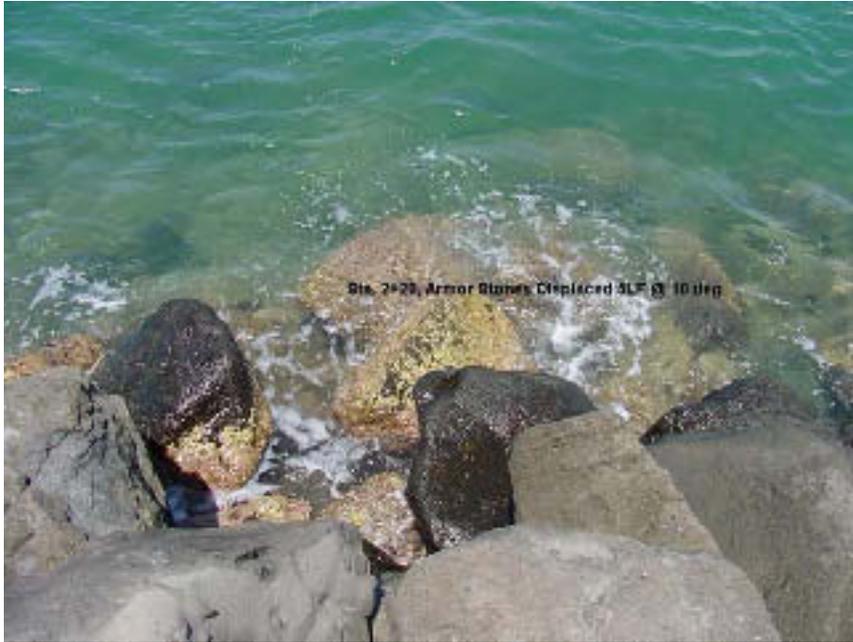
\*Sta. 2+20, OS, 1 armor stone at toe displaced 5' (10 degrees).

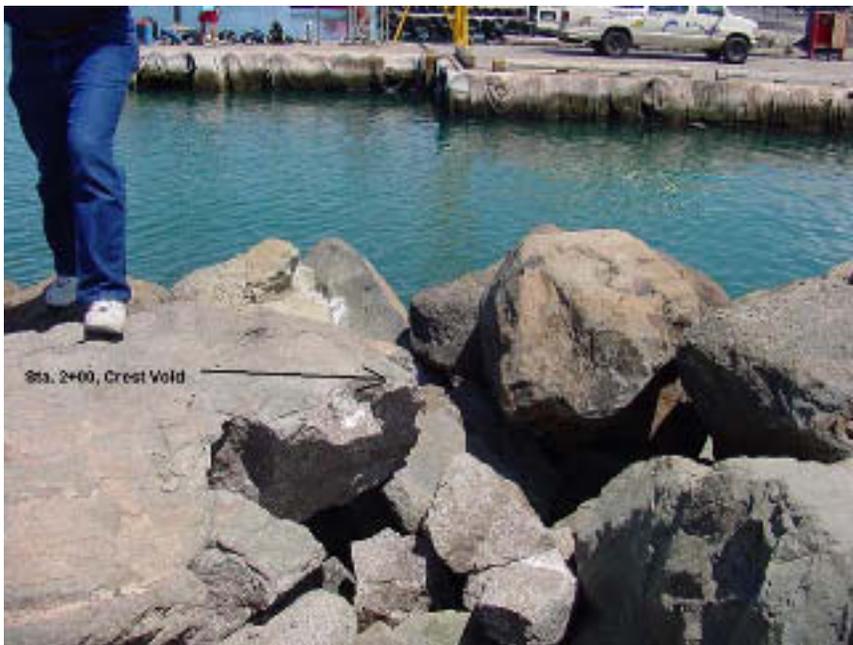
\*Sta. 2+20, HS, 2' void (20 degrees).
