O & M INSPECTION REPORT  
FOR NAVIGATION AND SHORE PROTECTION PROJECTS

1. PROJECT NAME: WAIANAE SMALL BOAT HARBOR

2. DATE OF INSPECTION: 29 AUGUST 2002

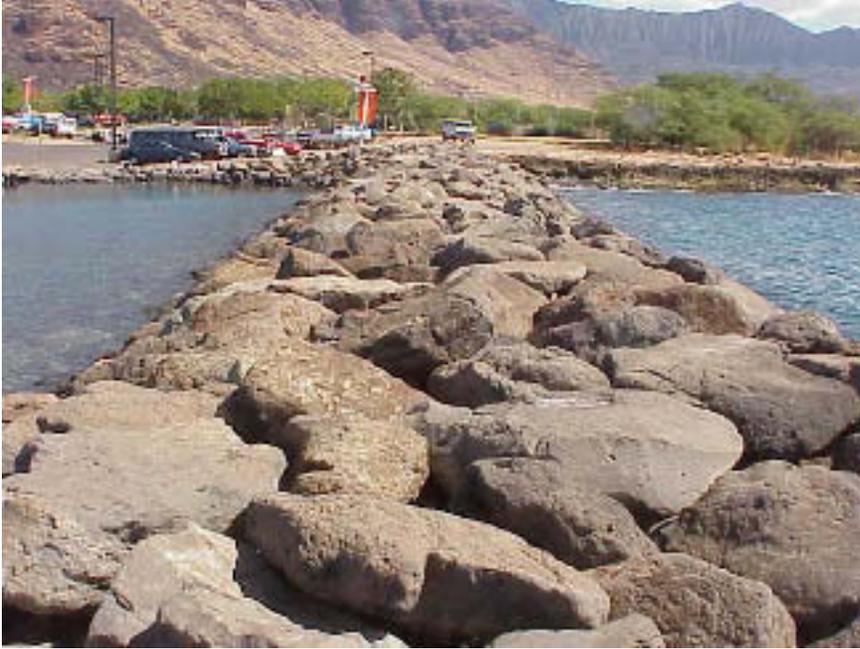
Overview from Sta. 2+20 to Sta 0+00.
